### Sybert Drive and South Leisure Court

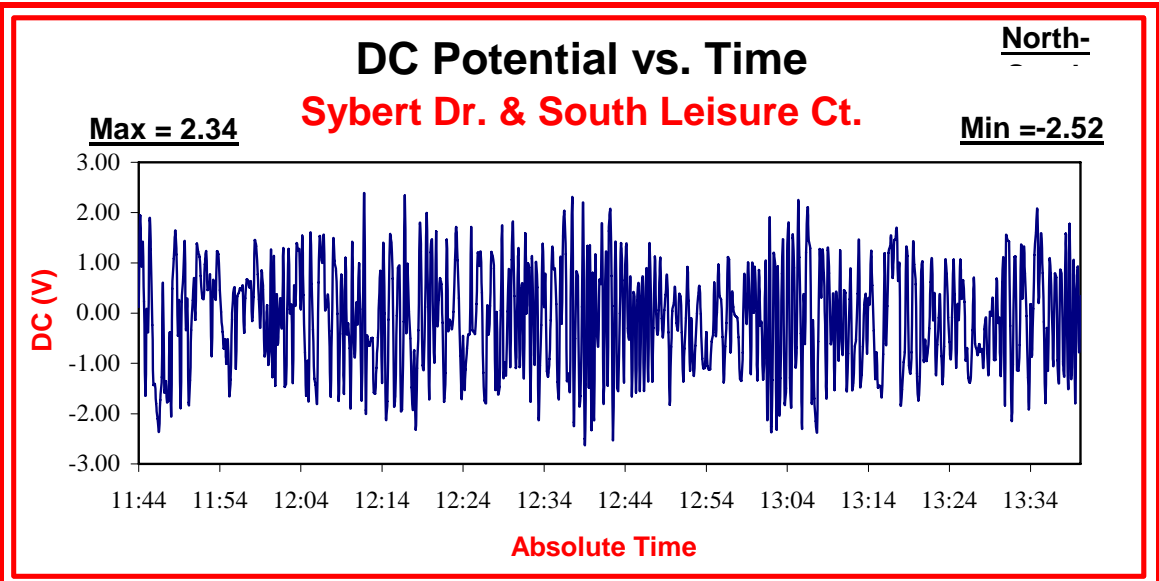
<b>Location:</b>	Sybert Dr. & South Leisure Ct.	
<b>GPS Location:</b>	N 39° 14.609', W 76° 49.545'	
	<b>North-South</b>	<b>East-West</b>
<b>Date:</b>	3/2/2007	3/2/2007
<b>Time:</b>	11:44:04	11:44:04
<b>Maximum (V):</b>	2.34	2.14
<b>Minimum (V):</b>	-2.52	-1.82
<b>DC Potential Shifts (V):</b>	4.86	3.96
