Figure 32 - Stray Current Testing on Ducketts Lane and Marble Hill Entrance

Figure 33 - Stray Current Results for Marble Hill, near Ducketts Lane

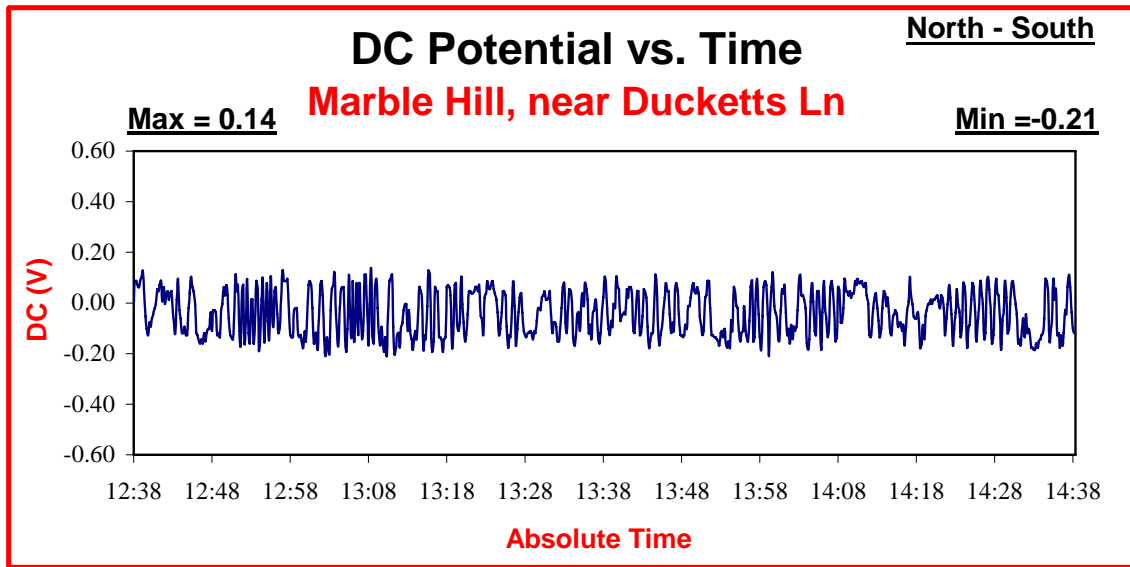
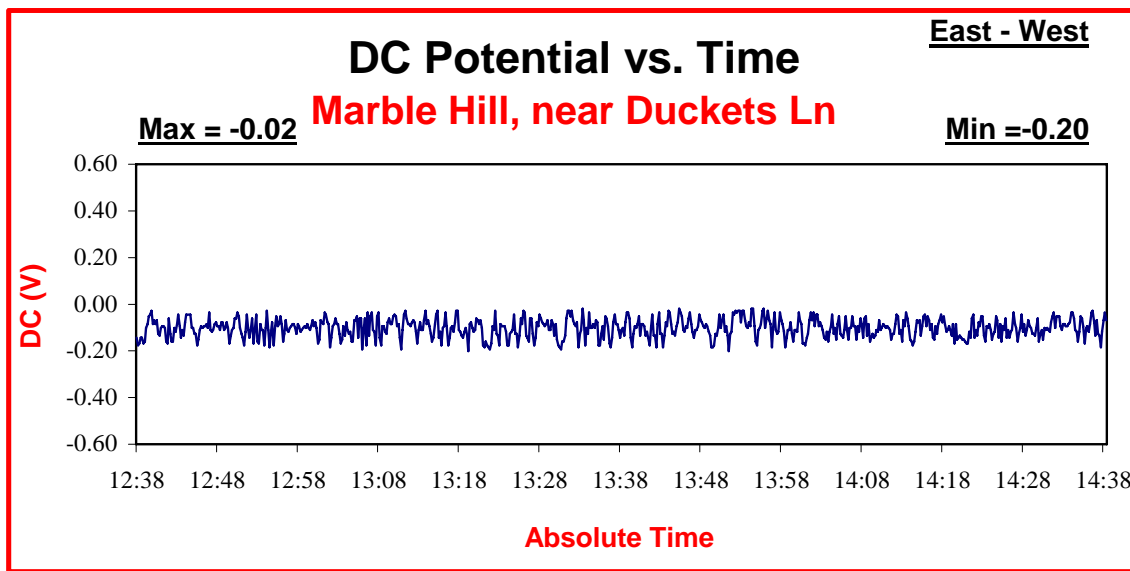
Location:	Marble Hill (W most ent.) and Ducketts Ln	
GPS Location:	N 39° 12.068', W 76° 44.804'	
	North-South	East-West
Date:	10/25/2006	10/25/2006
Time:	12:38:02	12:38:02
Maximum (V):	0.14	-0.02
Minimum (V):	-0.21	-0.20
DC Potential Shifts (V):	0.35	0.18
