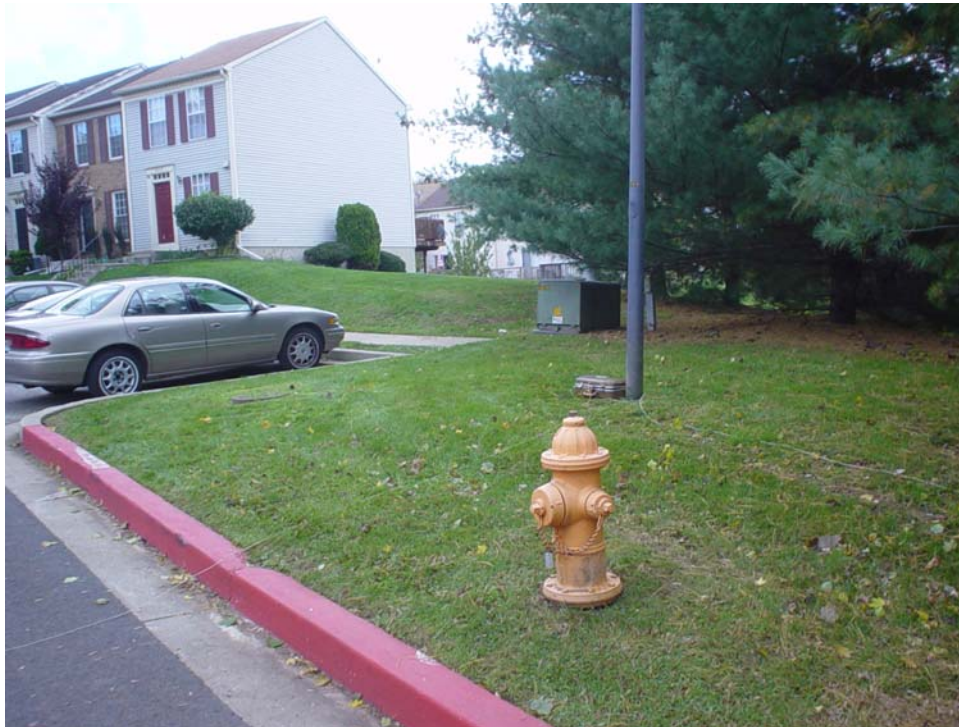
Figure 38 - Stray Current Testing in Marble Hill (Branch F)

1. Branch F close to Ducketts Lane units 6637 & 6778, Figure 38 and Figure 39
2. Branch D close to Ducketts Lane units 6370 & 6374, Figure 40 and Figure 41
3. Intersection of Branch B & C, Figure 42 and Figure 43
4. Branch A close to Ducketts Lane units 6892 & 6896, Figure 44 and Figure 45
5. Branch B close to Ducketts Lane unit 6704, Figure 46 and Figure 47

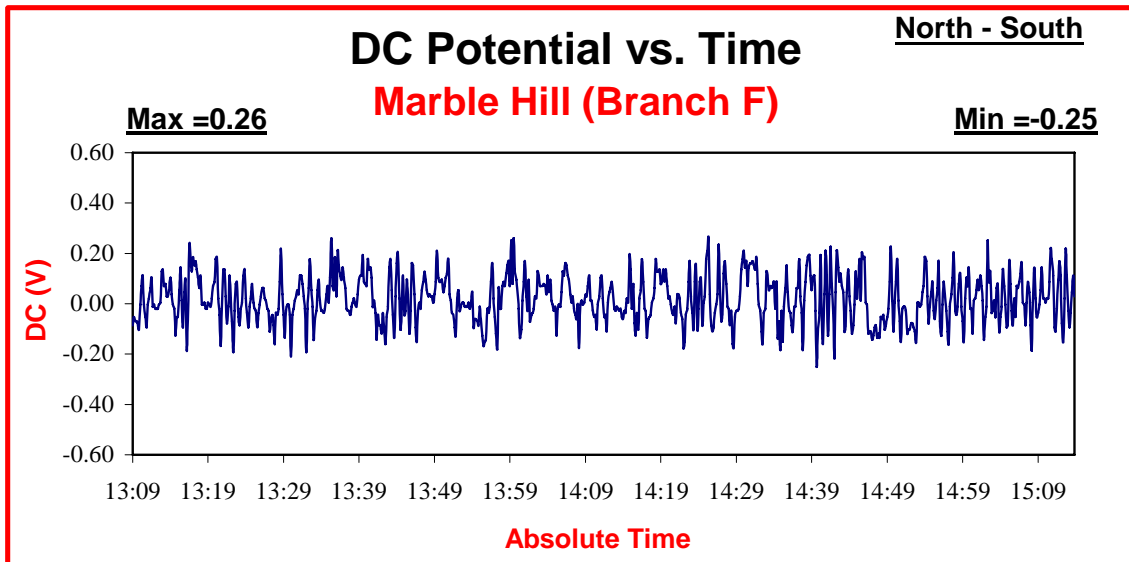
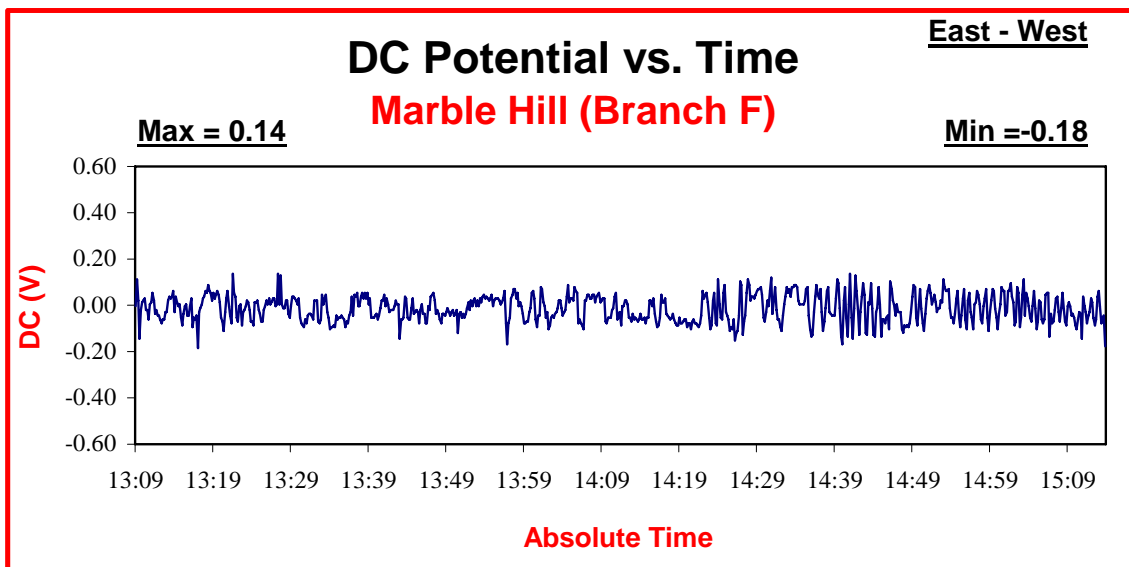
Location:	Marble Hill, near Ducketts Lane 6638 & 6778	
GPS Location:	N 39° 12.013', W 76° 44.809'	
	North-South	East-West
Date:	10/24/2006	10/24/2006
Time:	13:09:11	13:09:11
Maximum (V):	0.26	0.14
Minimum (V):	-0.25	-0.18
DC Potential Shifts (V):	0.51	0.32

Figure 39 - Stray Current Result for Marble Hill (Branch F)
