Figure 7. Location Map for Site 1

Figure 8. Stray Current Survey (AM) for Site 1

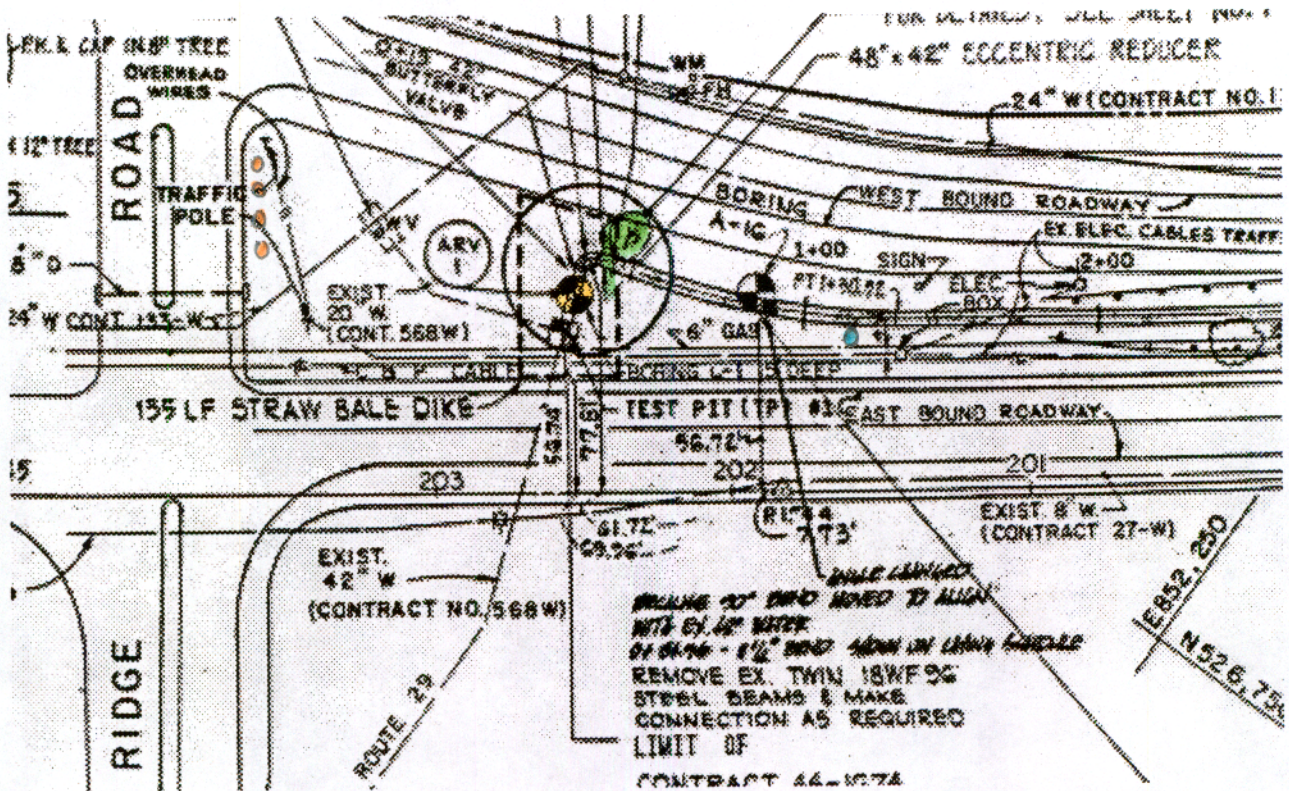
Test Setup:	DC volts between Cu/CuSO ₄ and ARV-1 150' apart; AC volts between ARV-1 and groundbed (4 copper/steel rods 10' apart) 100' apart
Legend:	<ul style="list-style-type: none"> ● Groundbed ● Pipe/Buried Steel Rod ● Cu/CuSO₄ Electrode
