**RESULTS:**  
**ROCKBURN**  
**1. Test stations**

**HOWARD COUNTY DEPARTMENT OF PUBLIC WORKS**  
**CORROSION CONTROL TEST STATION**  
**FIELD DATA SURVEY FORM**

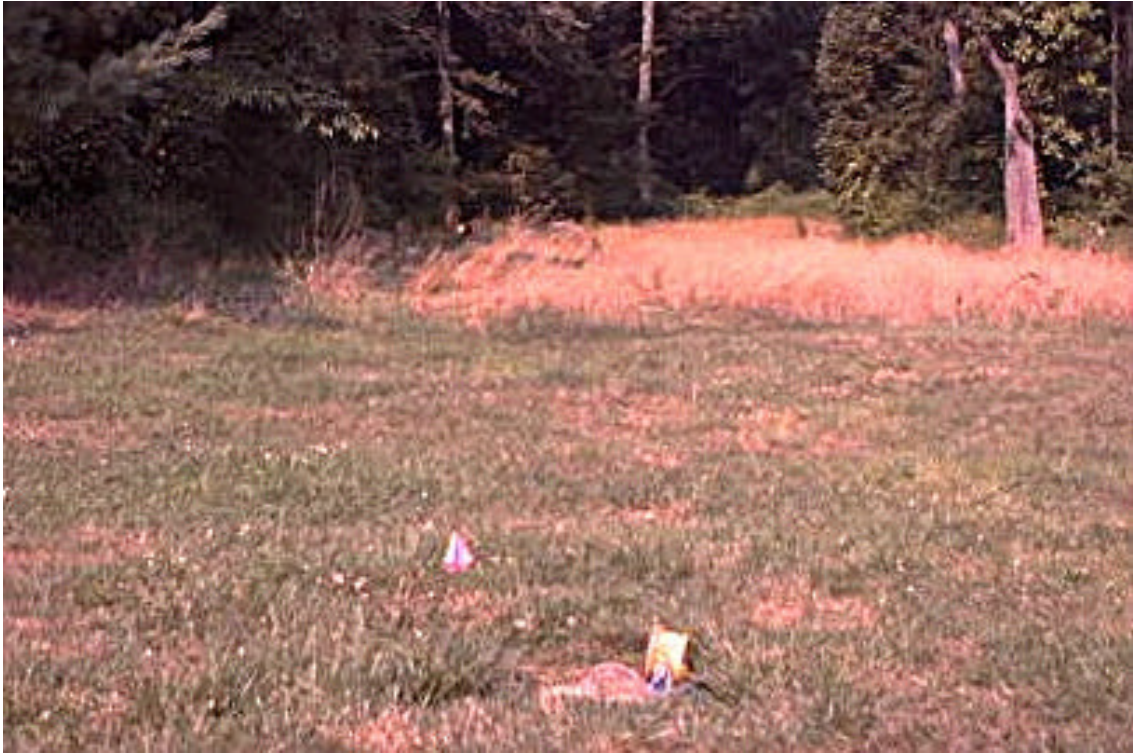
**Test Box :** Good  
**Terminal Board :** Good  
**Wires :** Good  
**Other :** \_\_\_\_\_

**Figure 13 - Test station 12FM1 near Pumping Station**

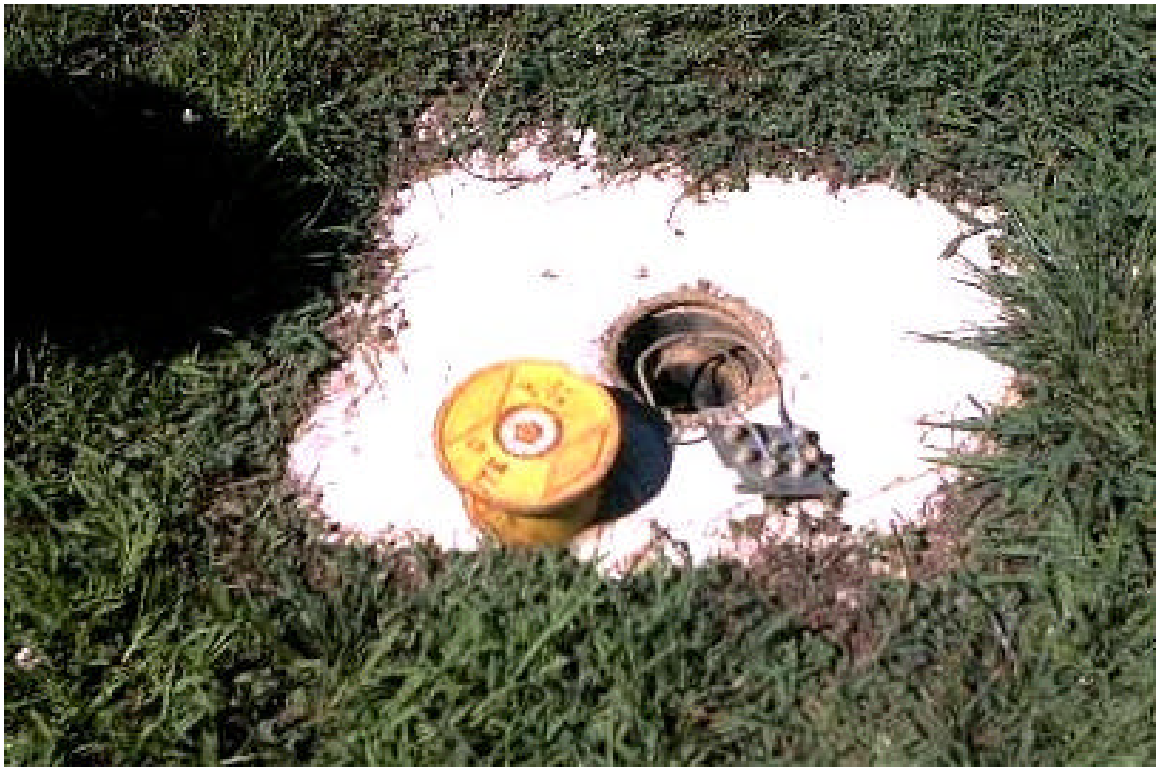
**Figure 14 - Test station 12FM1, close-up**
