**HOWARD COUNTY DEPARTMENT OF PUBLIC WORKS  
CORROSION CONTROL TEST STATION  
FIELD DATA SURVEY FORM**

Location: (15+19) Date Surveyed: 8/15/02  
 T/S #: 175D Surveyed by: DD/MJ  
 T/S Type: ST / w Anode Contract #: L6154  
 Pipe Size: 30"

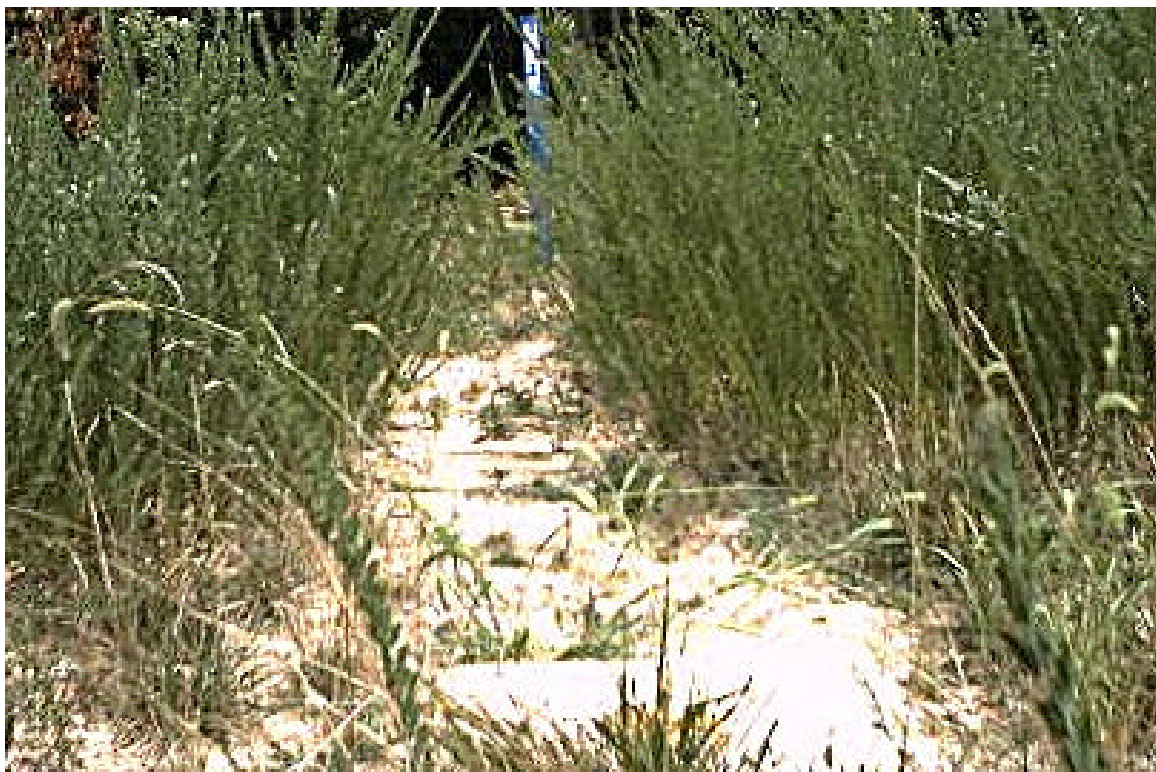
**Figure 65 - Test station 175D**

Test Box : Good  
 Terminal Board : Thin mud film  
 Wires : Good  
 Other : Missing white wire
