**HOWARD COUNTY DEPARTMENT OF PUBLIC WORKS  
CORROSION CONTROL TEST STATION  
FIELD DATA SURVEY FORM**

Location: 19+33 Date Surveyed: 05/29/2007  
 Old Columbia Rd Surveyed by: AS/MJ  
 T/S #: 3a Contract #: 44-3868  
 T/S Type: ST w/Anode Pipe Size: 16"  
 Was the T/S located? YES / NO YES

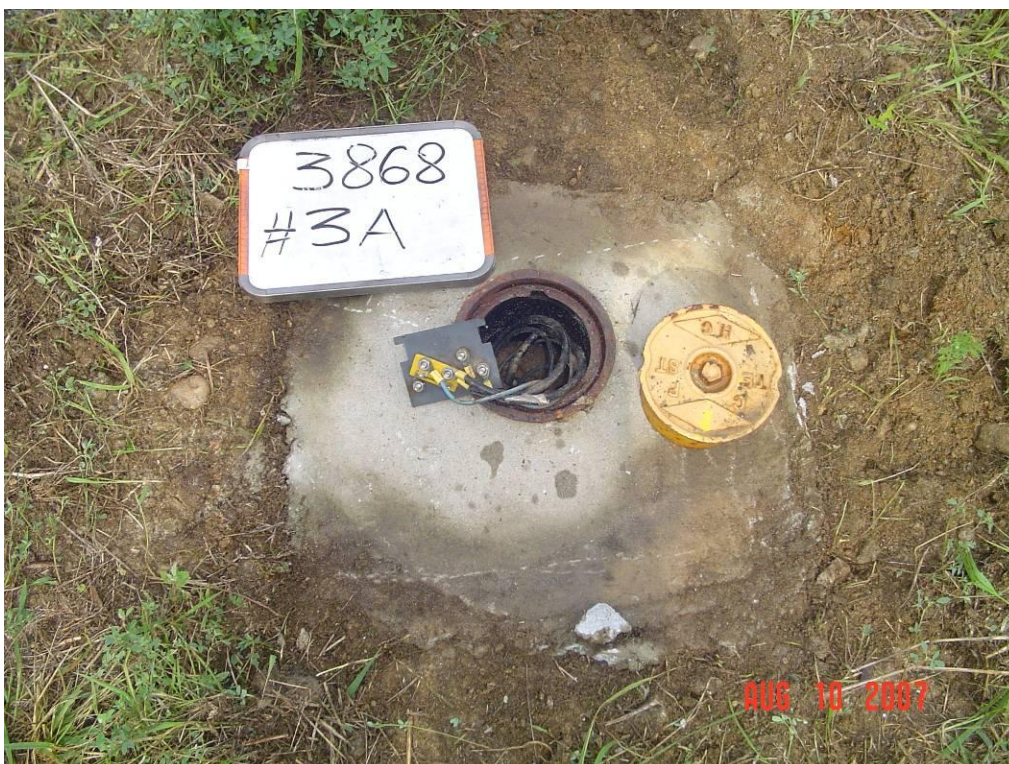
Figure 77 – Test Station 3A close up

Test Box:	Good
Terminal Board:	Good – Slightly covered with soil
Wires:	Good
Other:
