Table 1 - MD Route 108 Test Station 1

HOWARD COUNTY DEPARTMENT OF PUBLIC WORKS CORROSION CONTROL TEST STATION FIELD DATA SURVEY FORM						
Location: <u>(98+50)</u>		Date Surveyed: <u>3/13/2006</u>				
		Surveyed by: <u>MJ/AC</u>				
T/S #: <u>1</u>		Contract #: <u>44-3218</u>				
T/S Type: <u>ST/A</u>		Pipe Size: <u>16"</u>				
Was Test Station located? YES/NO <u>YES</u>						
TEST STATION CONDITION						
Test Box :		<u>Above ground PVC - good</u>				
Terminal Board :		<u>5 terminal - good</u>				
Wires :		<u>good</u>				
Other :						
SURVEY DATA						
Test Wire Size/Description	Color	P/Cu-CuSO ₄ (V)		P/Zn (V)		Anode (mA)
		"On"	"Off"	"On"	"Off"

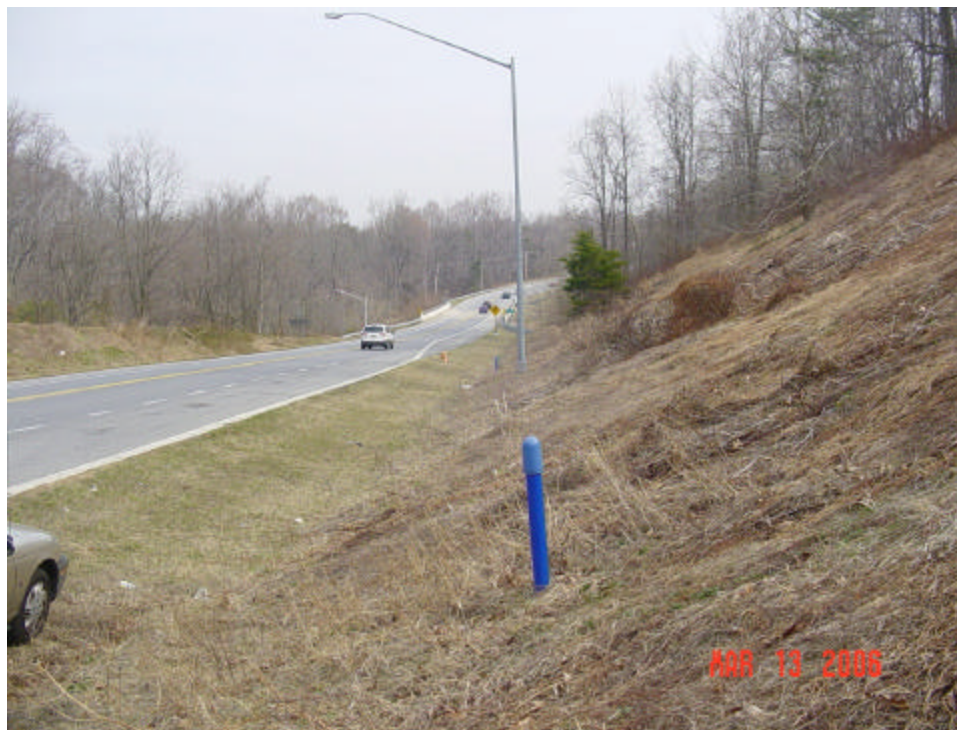
Figure 3 – Test Station 1

A) #12 Pipe	Black	-0.593	-0.425			16.5
B) #8 Anode	Black	-0.599	-1.659			
C) #10 Pipe	Black	-0.598	-0.422			
D) #12 Pipe	Black	-0.598	-0.420			
E) #10 Pipe	Black	-0.599	-0.419
