HOWARD COUNTY DEPARTMENT OF PUBLIC WORKS CORROSION CONTROL TEST STATION FIELD DATA SURVEY FORM						
Location:		<u>5' N of MD 108 / MD 32 Bridge</u>		Date Surveyed:	<u>3/25/2005</u>	
T/S #:		<u>2</u>		Surveyed by:	<u>AC/MJ</u>	
T/S Type:		<u>IJ</u>		Contract #:	<u>44-3231</u>	
				Pipe Size:	<u>12"</u>	
Was Test Station located? YES/NO <u>Yes</u>						
TEST STATION CONDITION						
Test Box :		<u>Good</u>				
Terminal Board :		<u>Good</u>				
Wires :		<u>Good</u>				
Other :						
SURVEY DATA						
Test Wire Size/Description	Color	P/Cu-CuSO ₄ (V)		P/Zn (V)		Anode (mA)
		"On"	"Off"	"On"	"Off"

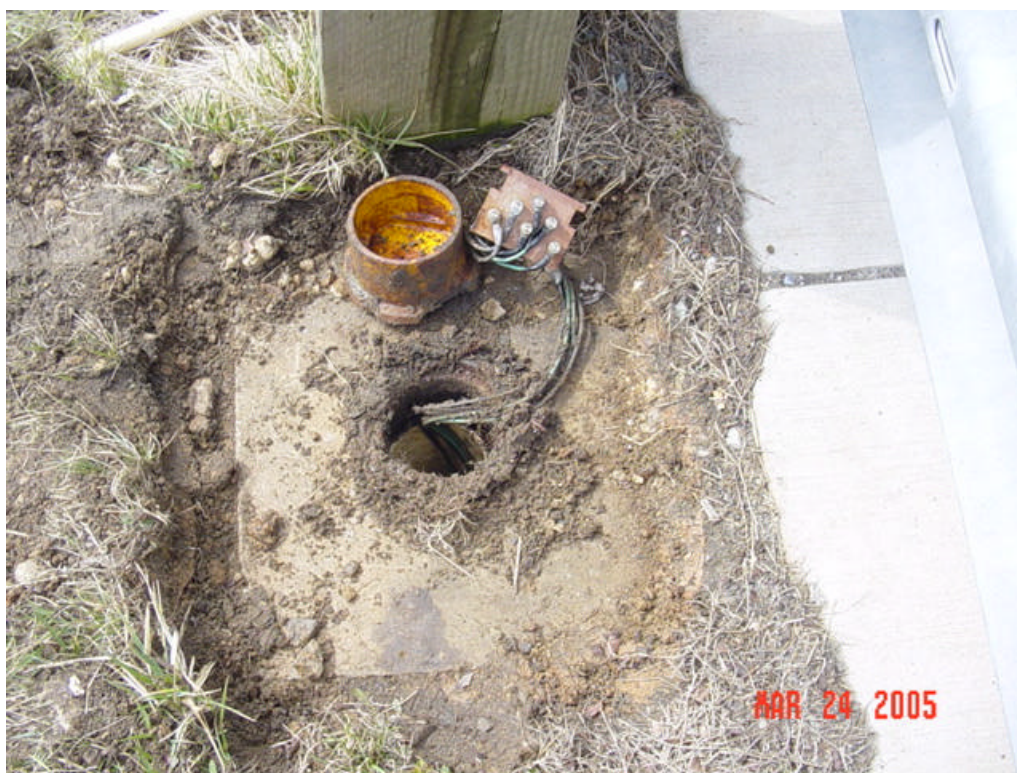
Figure 123 - Test Station 3231-2 close-up

6) #10 AWG	Black		-0.642		-0.424	
7)						
P/Cu-CuSO ₄ = Pipe to Copper - Copper Sulfate Reference Cell P/Zn = Pipe to Zinc Permanent Reference Cell "On" = Reading with Anode(s) connected "Off" = Reading with Anode(s) disconnected I Anode = Current output of anodes						
TESTING THE EFFECTIVENESS OF INSULATING JOINTS						
GROUND BED: CONNECTED TO (B/W):						
CURRENT	(A)	VOLTAGE	(V)	RESISTANCE (ohms):	3	
ON:	3.48	ON:	10.9			
OFF:	0	OFF:	-0.61			
DELTA:	3.48	DELTA:	11.5			
REPAIRS MADE						
Test Box:						
Terminal Board:						
Wires:						
Other:						
Additional Comments/Recommendations:		<u>IJ test indicated effective isolation of the two pipes.</u>
