**HOWARD COUNTY DEPARTMENT OF PUBLIC WORKS
CORROSION CONTROL TEST STATION
FIELD DATA SURVEY FORM**

Location: 200' N of 2200 Marriottsville Rd. **Date Surveyed:** 4/13/2005
T/S #: 4 **Surveyed by:** AC/MJ
T/S Type: IJ w/ Anode **Contract #:** 44-3480
Pipe Size: 12"

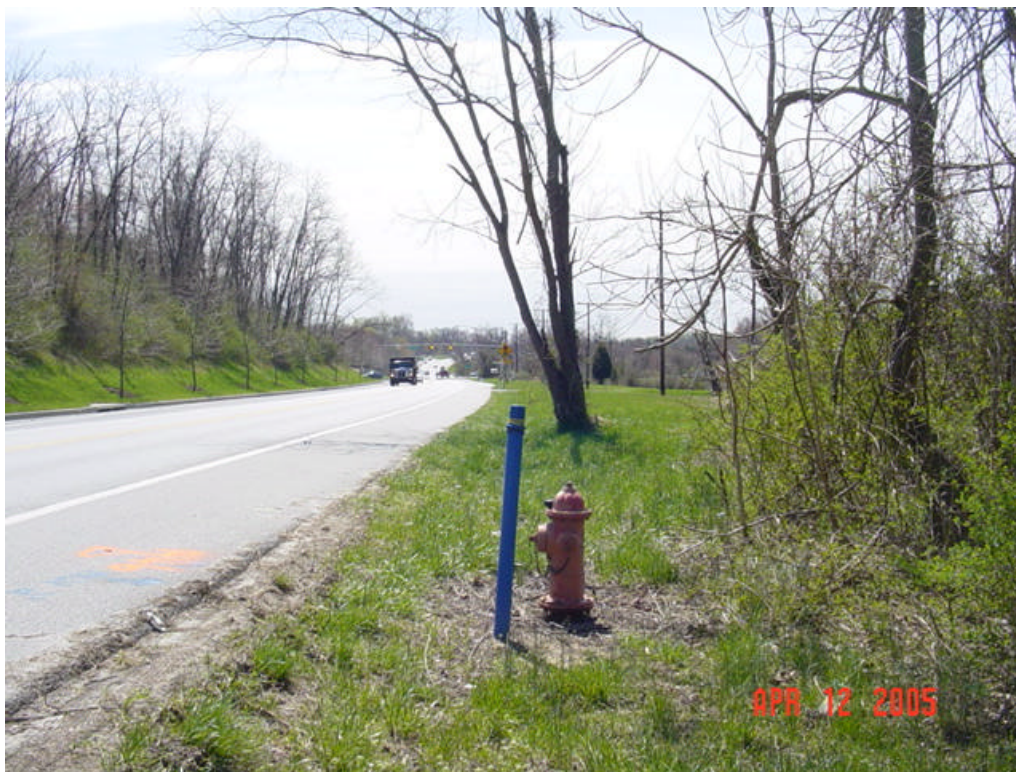
Figure 230 - Location of Test Station 3480-4

Additional Comments/Recommendations: The last time Dacco Sci, Inc visited this test station, it was a flush mount test station. During this visit, it was noted that the test station is now a blue standing post test station.

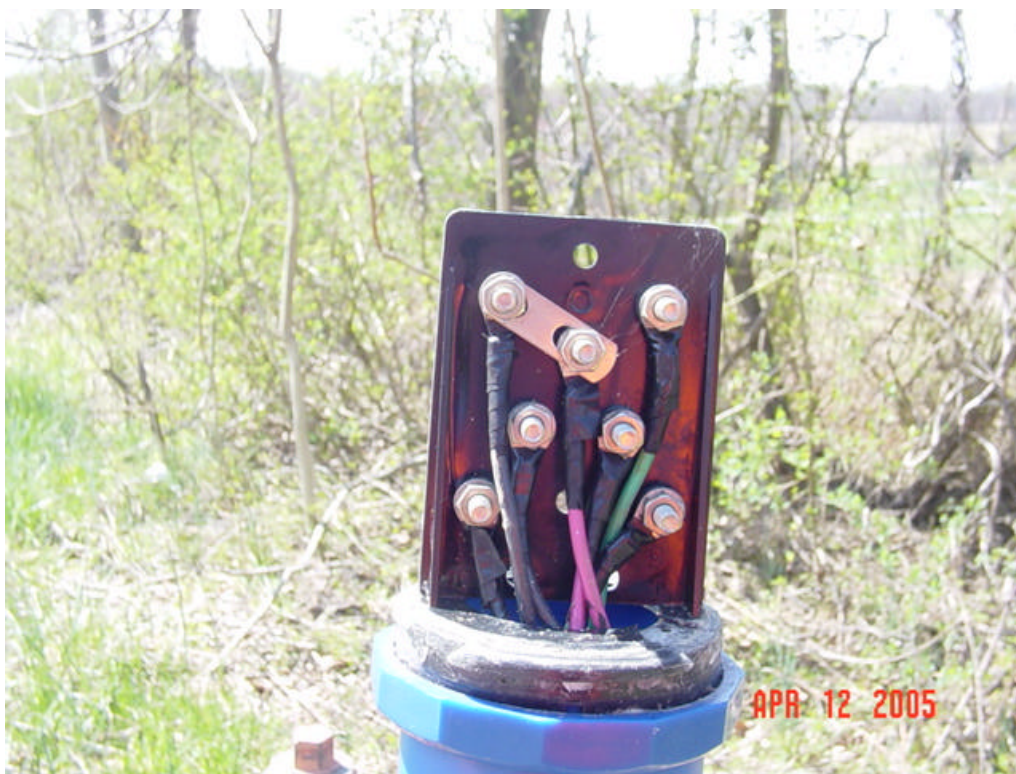
Figure 231 - Test Station 3480-4 close-up

Test Box : Good
Terminal Board : Good
Wires : Good
Other : _____
