**HOWARD COUNTY DEPARTMENT OF PUBLIC WORKS
CORROSION CONTROL TEST STATION
FIELD DATA SURVEY FORM**

Location: 06+50 Date Surveyed: 06/12/2007
 Woodcrest Drive and MD 108 Surveyed by: AS/MJ
 T/S #: 2 Contract #: 44-3327
 T/S Type: ST w/Anode Pipe Size: 36"
 Was the T/S located? YES / NO YES

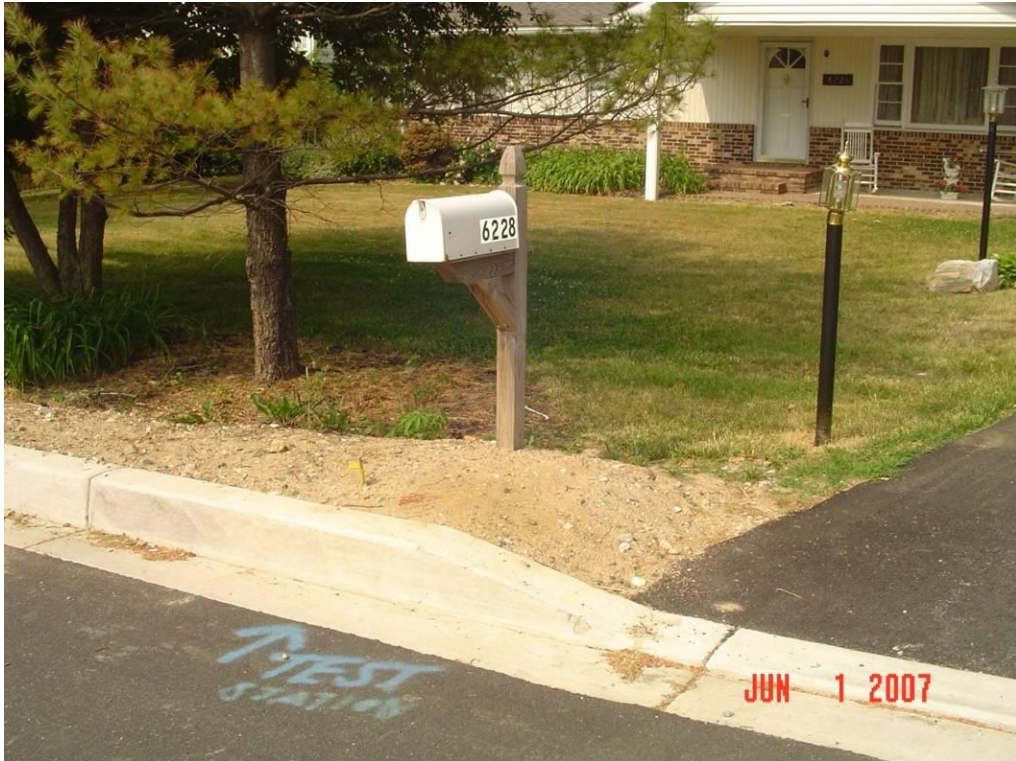
Figure 123 – Location of Test Station 2 - MD 108

Test Box: Good – Test box was dug out by contractors (builders near by)
 Terminal Board: Good
 Wires: Good
 Other:

Test Box: Concrete pad is removed
 Terminal Board: No reference – Changed the color of wire
 Wires:
 Other:
 Comments/Recommendations:
