## HOWARD COUNTY DEPARTMENT OF PUBLIC WORKS CORROSION CONTROL TEST STATION FIELD DATA SURVEY FORM

FIELD L	JAIA JUN	VETFORIVI		
Location:	17+90			Date Surveyed:	6/4/02	
	Across from mail box 613		38	Surveyed by:	DD/MJ	
T/S #:	4			Contract #:	L5267	
T/S Type: ST/Anode		9		Pipe Size:	36"	
Was Test Station	located?	YES/NO	YES			
If NO, then how n			ating?

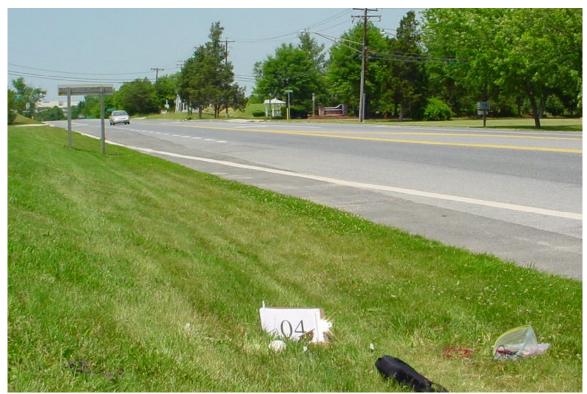
Figure 14 - Test Station #4, across from mail box 6135 on Route 108

•				
TEST STATION C	CONDITION					
Test Box :		CP Flush Mounted - Good				
Terminal Board :		NM Series (7 terminal) - Good				
Wires :		Good				
Other :						
		;	SURVEY D	ATA		
Test Wire		P/Cu-CuSO <sub>4</sub> (V) P		P/Z	Zn (V)	
Size/Description	Color	"On"	"Off"	"On"	"Off"	Anode (mA)

1) #10 AWG	Red	-1.700	-1.608	0.560	0.448	3
2)						
3) #10 AWG	Black	-1.700	-1.715	0.560	0.583	
4) #10 AWG	Green	-1.158	-1.164			
5)						
6) #10 AWG	Black	-1.706	-1.708	0.556	0.580
