**HOWARD COUNTY DEPARTMENT OF PUBLIC WORKS  
CORROSION CONTROL TEST STATION  
FIELD DATA SURVEY FORM**

Location: 21+50 Date Surveyed: 6/4/02  
MD Rt.108 & Old Stockbridge Surveyed by: DD/MJ  
 T/S #: #6 Contract #: L5267  
 T/S Type: CS Pipe Size: 36"

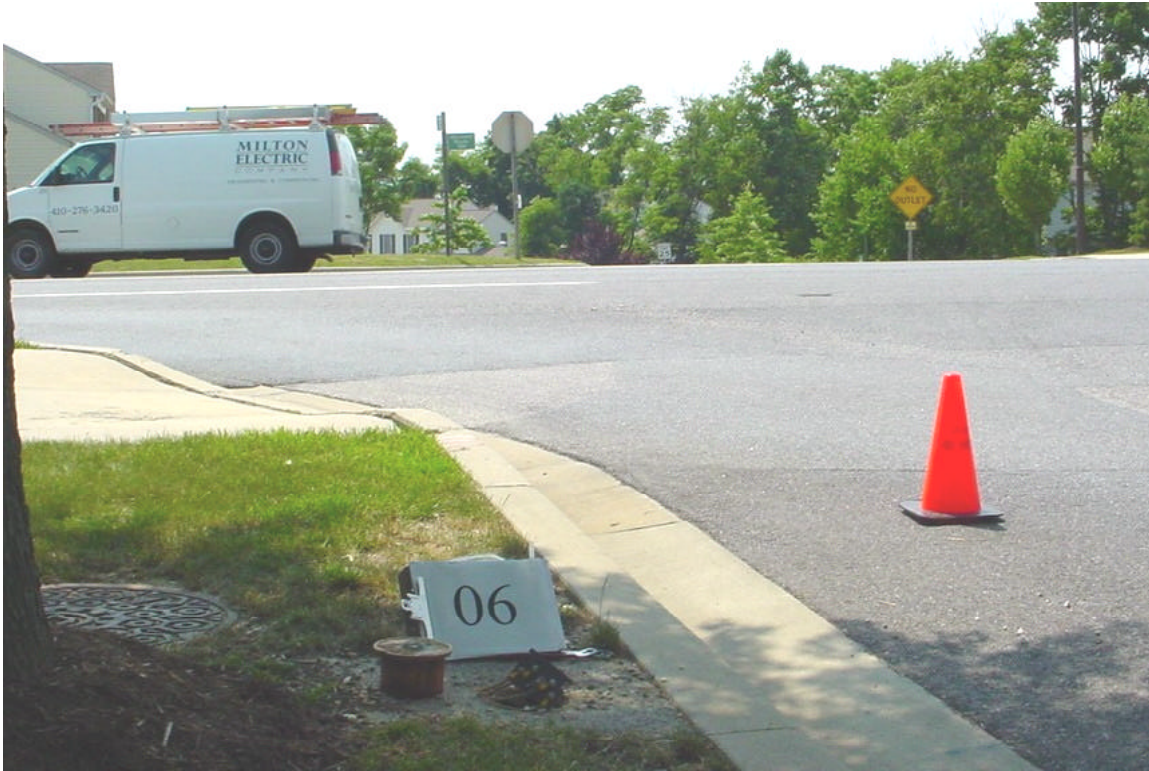
Figure 18 - Test Station #6, Old Stockbridge Drive & Route 108

Test Box : CP Flush Mounted - Good  
 Terminal Board : NM Series (5 terminal) - Good  
 Wires : Good  
 Other : \_\_\_\_\_
