## HOWARD COUNTY DEPARTMENT OF PUBLIC WORKS CORROSION CONTROL TEST STATION FIELD DATA SURVEY FORM

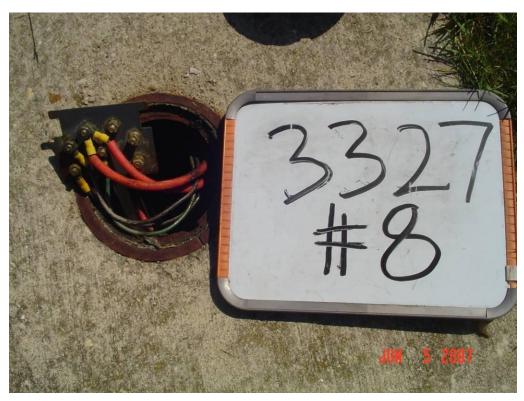
Figure 136 – Test Station 8 close up

Location:	ation: 42+00				<b>d:</b> 06/0	06/05/2007			
Branch Wood & Falling Leaves				Surveyed by: AS		5/MJ			
T/S #:	8					3327			
T/S Type:	ST w/Anode								
Was the T/S		YES							
TEST STATION CONDITION									
Test Box: Good									
Terminal Board: Good									
Wires:	Goo								
Other:									
SURVEY DATA									
Test Wire			P/Cu-CuSO <sub>4</sub> (V)		F	P/Zn (V	Anode		
Size/Description		Color	"On	"On""Off"		Dn""Òf	(mA)
