**HOWARD COUNTY DEPARTMENT OF PUBLIC WORKS
CORROSION CONTROL TEST STATION
FIELD DATA SURVEY FORM**

Location: 44+63 Date Surveyed: 6/4/02
 T/S #: 9 Surveyed by: DD/MJ
 T/S Type: ST/Anode Contract #: L5267
 Pipe Size: 36"

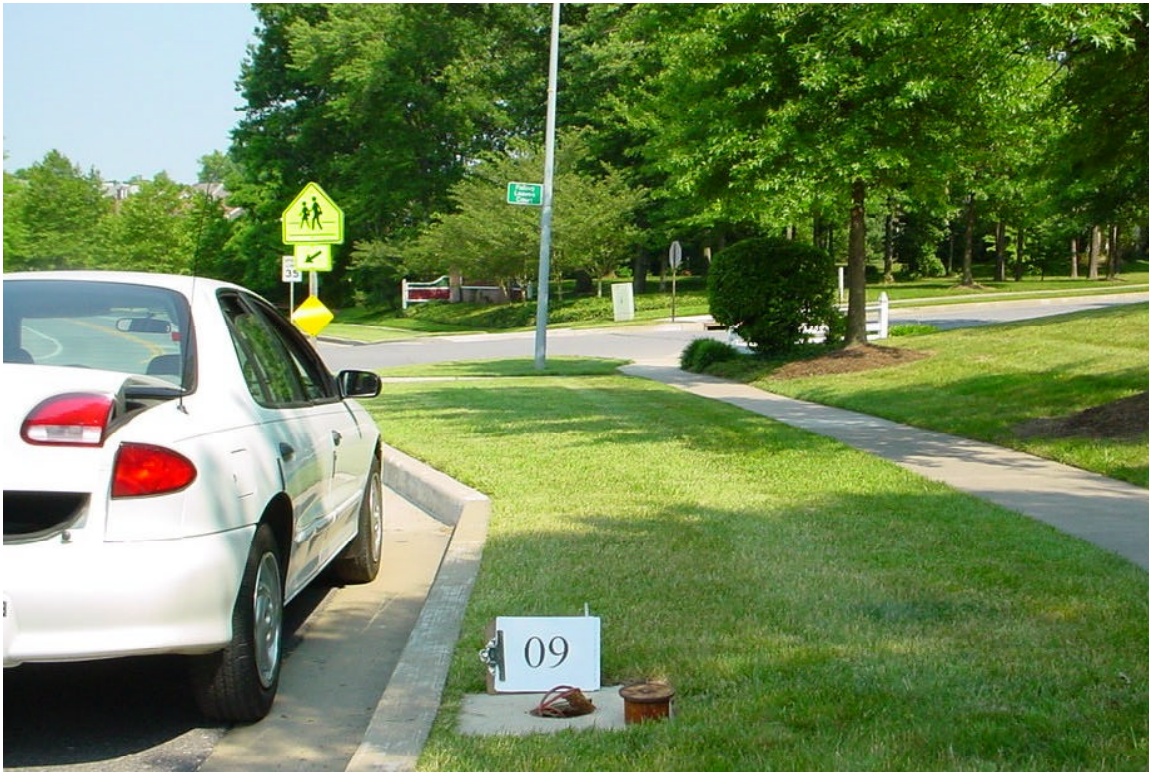
Figure 24 - Test Station #9, 3rd tree before Falling Leaves Court

Test Box : CP Flush Mounted - Good
 Terminal Board : NM Series (7 terminal) - muddy
 Wires : Terminals oxidized
 Other : Full of water
