**HOWARD COUNTY DEPARTMENT OF PUBLIC WORKS
CORROSION CONTROL TEST STATION
FIELD DATA SURVEY FORM**

Location: 60+50 Date Surveyed: 6/5/02
Old Field & Old Stine Bridge Surveyed by: DD/MJ
 T/S #: 12 Contract #: L5267
 T/S Type: ST/Anode Pipe Size: 36"

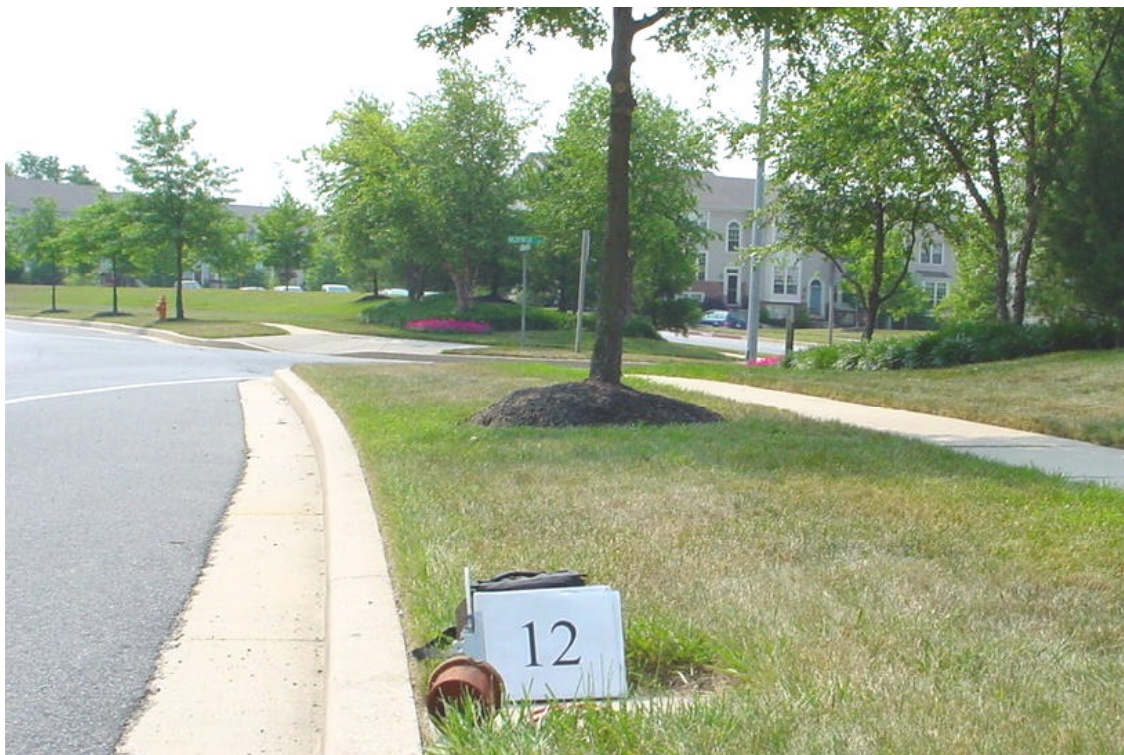
Test Box : CP Flush Mount - Good
 Terminal Board : NM Series (7 terminal) - Good
 Wires : Good
 Other : _____

Figure 30 -Test Station #12, between Oldfield Lane & Old Stockbridge Drive

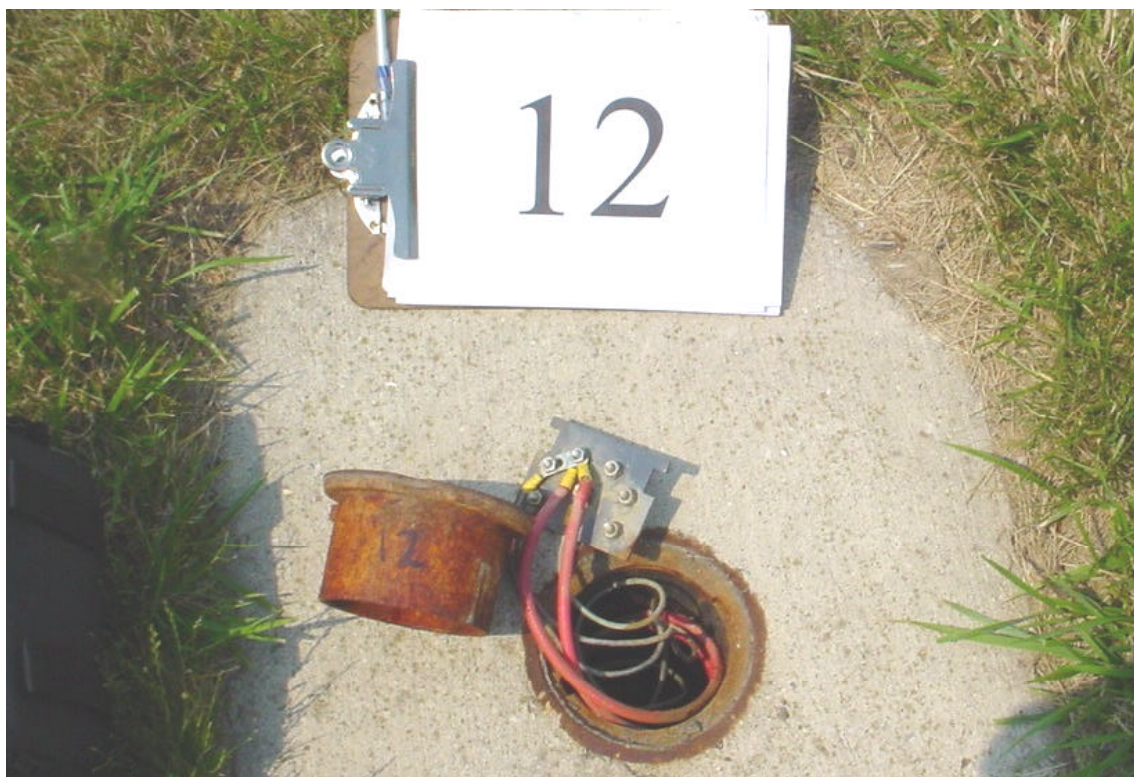
Figure 31 - Test Station #12, close-up
