**HOWARD COUNTY DEPARTMENT OF PUBLIC WORKS
CORROSION CONTROL TEST STATION
FIELD DATA SURVEY FORM**

Location: 03+20 Date Surveyed: 06/07/2007
E. of Meadowridge Road Surveyed by: AS/MJ
 T/S #: 17 Contract #: 44-3327
 T/S Type: ST w/Anode Pipe Size: 36"
 Was the T/S located? YES / NO Yes

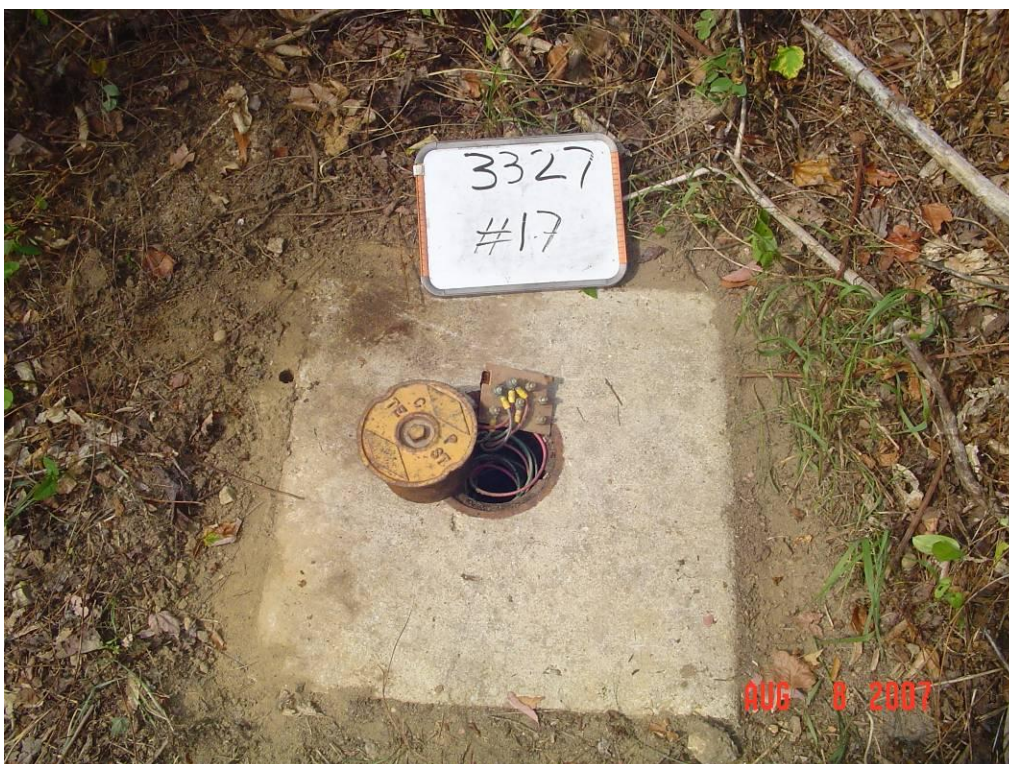
Figure 150 – Test Station 17 close up

Test Box:	<u>Log on the test station concrete padding</u>
Terminal Board:	<u>Good</u>
Wires:	<u>Good</u>
Other:

Test Box:	
Terminal Board:	
Wires:	
Other:	
Comments/Recommendations:	<u>New GPS reading recorded</u>
