**HOWARD COUNTY DEPARTMENT OF PUBLIC WORKS
CORROSION CONTROL TEST STATION
FIELD DATA SURVEY FORM**

Location: 49+00 Date Surveyed: 2/18/2005
Golf Course Surveyed by: AC/MJ
T/S #: 23 Contract #: 44-3327
T/S Type: ST w/ Anode Pipe Size: 36"

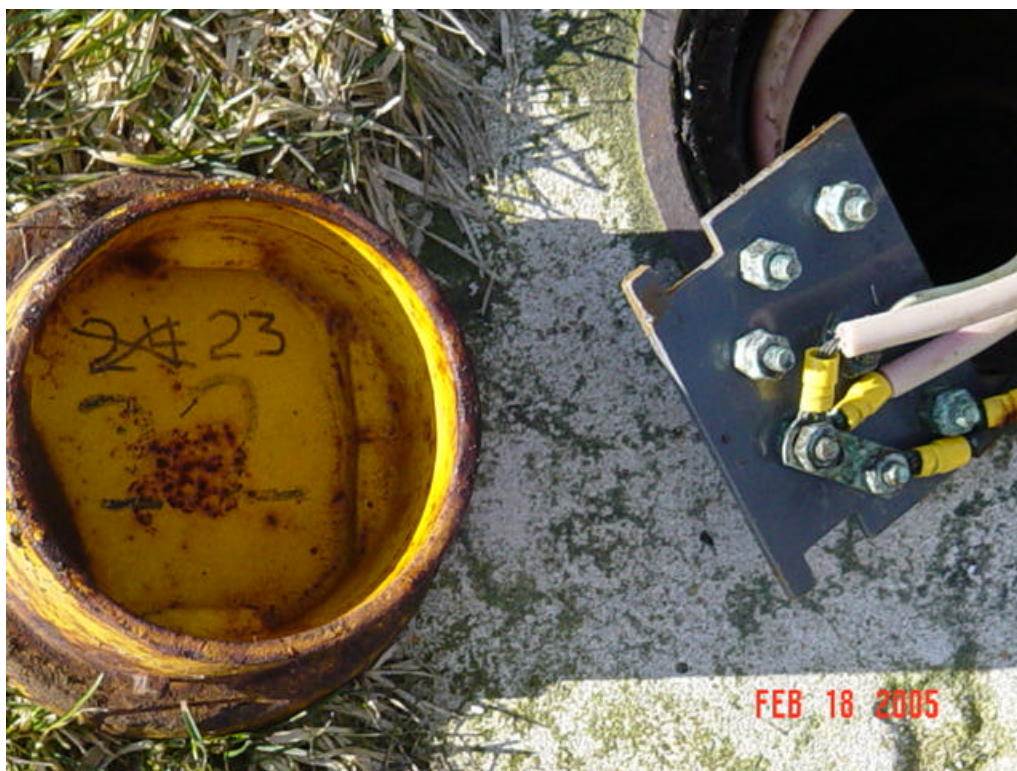
Figure 168 – Test Station 23 close up

Test Box : Good
Terminal Board : Good
Wires : Good
Other : Bolts/Nuts are Oxidized
