**HOWARD COUNTY DEPARTMENT OF PUBLIC WORKS
CORROSION CONTROL TEST STATION
FIELD DATA SURVEY FORM**

Location: 49+00 Date Surveyed: 6/5/02
Golf Course Surveyed by: DD/MJ
T/S #: 23 Contract #: L5267
T/S Type: ST/Anode Pipe Size: 36"

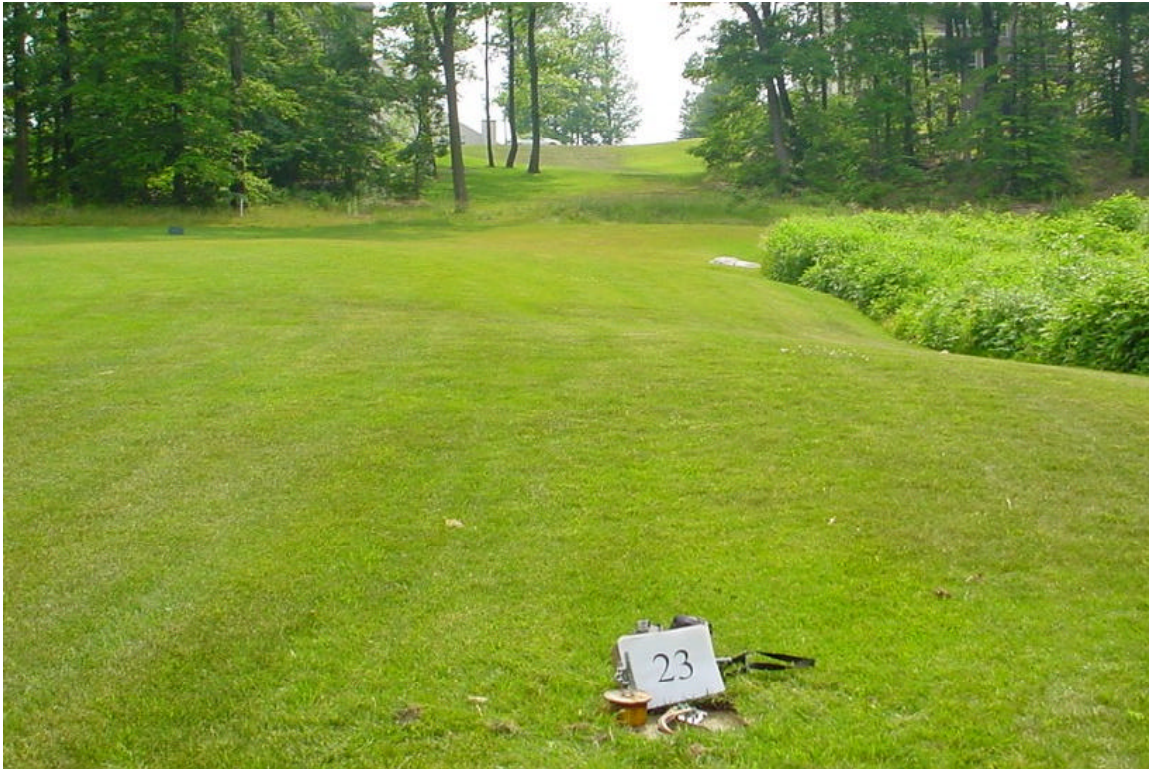
Figure 44 - Test Station #23, North of Sandy Ridge Court

Test Box : CP Flush Mount
Terminal Board : NM Series (7 terminal)
Wires : Colors faded & terminals oxidized
Other : _____
