**HOWARD COUNTY DEPARTMENT OF PUBLIC WORKS  
CORROSION CONTROL TEST STATION  
FIELD DATA SURVEY FORM**

Location: 68+50 Date Surveyed: 06/07/2007  
Behind 7010 Golden Crest Ct. Surveyed by: AS/MJ  
 T/S #: 26 Contract #: 44-3327  
 T/S Type: ST w/Anode Pipe Size: 36"  
 Was the T/S located? YES / NO YES

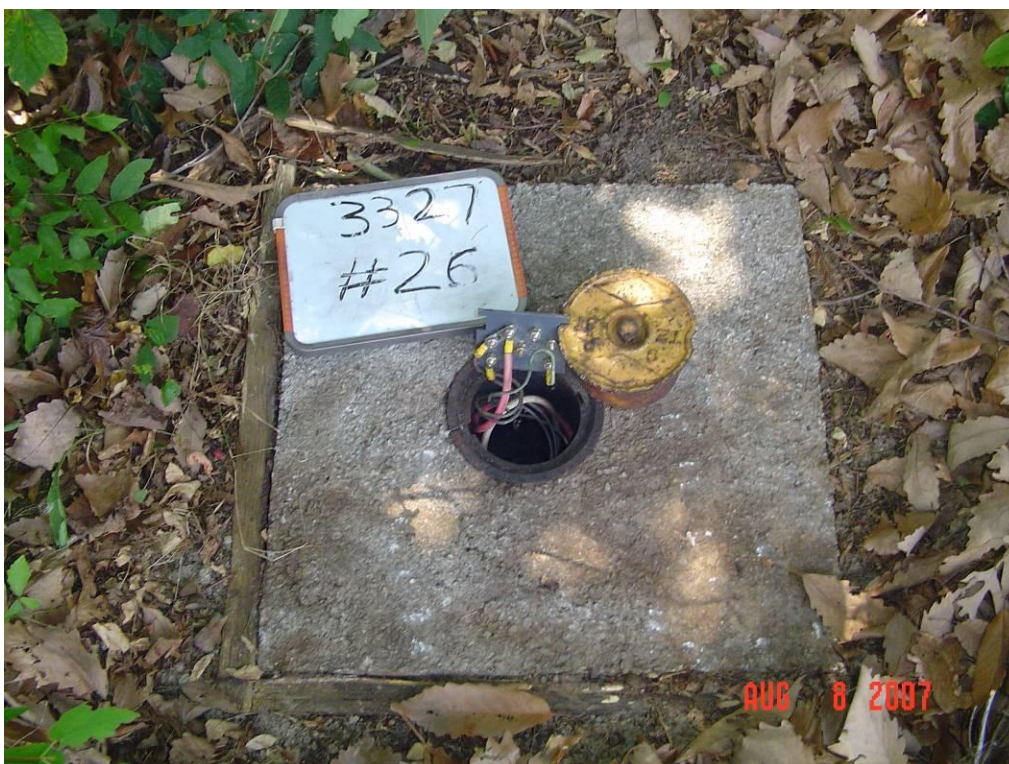
Test Box:	Covered with piles of dead plant and leaves
Terminal Board:	Good
Wires:	Good
Other:

Figure 164 – Test Station 26 close up
