HOWARD COUNTY DEPARTMENT OF PUBLIC WORKS CORROSION CONTROL TEST STATION FIELD DATA SURVEY FORM

Figure 57 - Location of Test Stations on contract 8W

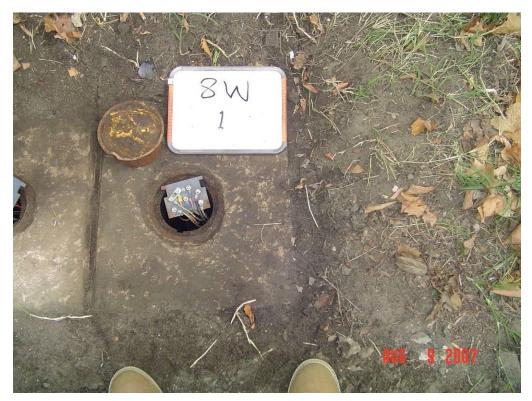
Figure 58 - Test Station 8W-1 close-up

Location:	_ocation: (00+20)					d: 07/	07/06//2007					
	(00:20)			te Surveye rveyed by:		AS/MJ						
T/S #:	1				Contract #: 8-W							
T/S Type:	ST w/Anode			Pipe Size: 24'								
	located? YE		YES									
TEST STATION CONDITION												
Test Box: Buried under soil												
Terminal Bo	ard: Good	ł										
Wires:	Good	k										
Other:												
SURVEY DATA												
Test Wire			P/Cu-CuSO₄ (V)				P/Zn (Anode				
Size/Description		Color		"On""Off"			On""((mA)

Test Box:	Clea	ed soil										
Terminal Board:												
Wires:												
Other:												
Comments/Recommendations: Anode current is not noticeable.
