**HOWARD COUNTY DEPARTMENT OF PUBLIC WORKS
CORROSION CONTROL TEST STATION
FIELD DATA SURVEY FORM**

Location: 31+90 Date Surveyed: 06/21/2007
 T/S #: 6 Surveyed by: AS/MJ
 T/S Type: ST w/Anode Contract #: 44-4227
 Pipe Size: 48"
 Was the T/S located? YES / NO YES

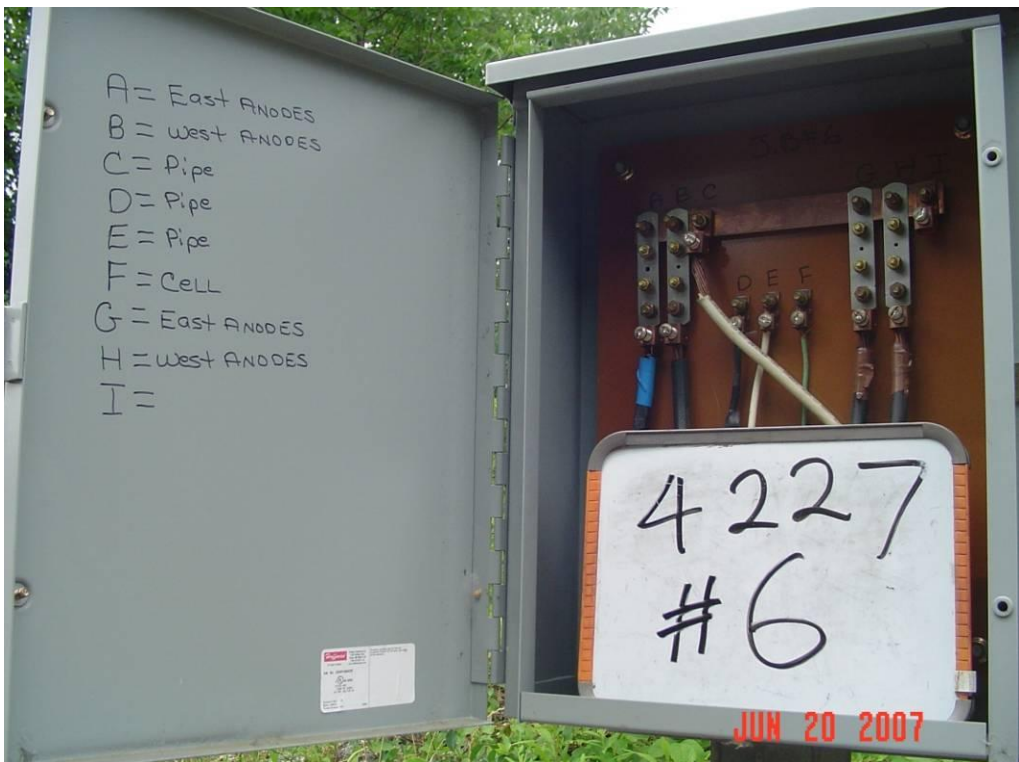
Figure 241 - Test Station 4227-6 close-up

Test Box: Above ground
 Terminal Board: 7 terminals in good condition
 Wires: Good
 Other: _____

Test Box: Removed Plastic Washers
 Terminal Board: _____
 Wires: _____
 Other: _____
 Comments/Recommendations: _____
