Howard County Traffic Signal Inspection Summary Report:

Signal Number: 018
Location: Guilford Rd. at Broken Land Parkway
Inspection Date: May 1, 2018

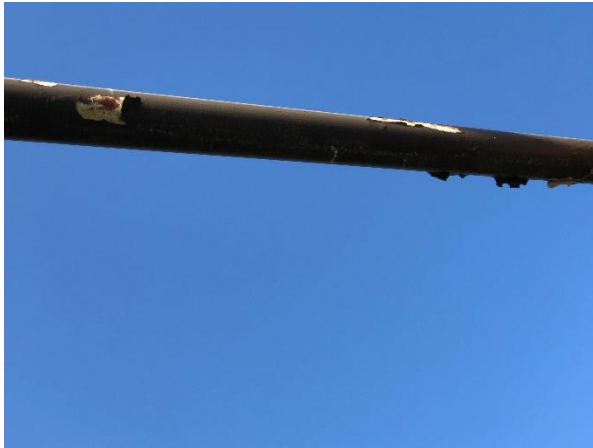
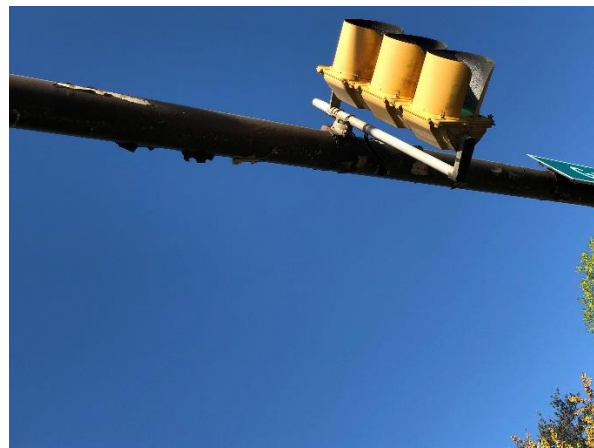
One galvanized single mast-arm structure in good condition. One painted twin mast-arm structure in fair condition. Paint coating is also in fair condition, with large areas of coating failure and areas of rust beginning to form especially on the mast-arms.

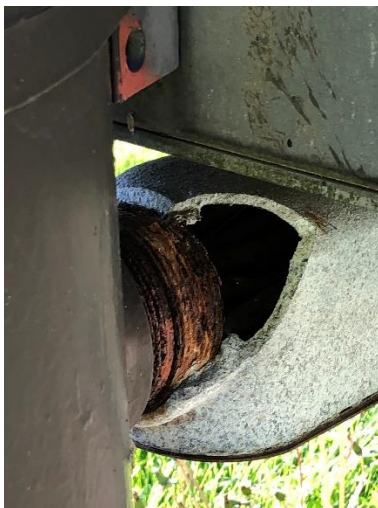
Broken cabinet elbow cover plate.
