Howard County Traffic Signal Inspection Summary Report:

Signal Number: 020
Location: Oakland Mills Rd. at Home Spun Dr./Malindy Circle
Inspection Date: Dec. 14, 2017

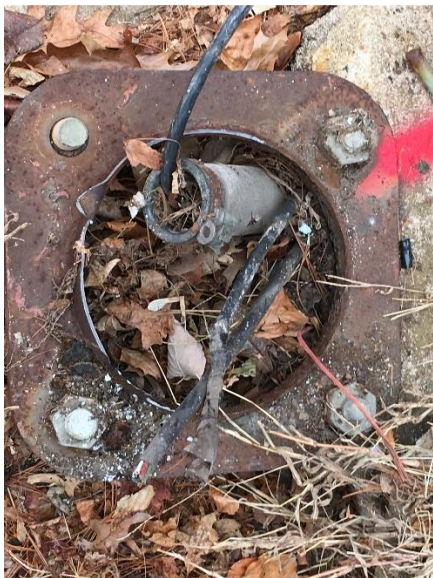
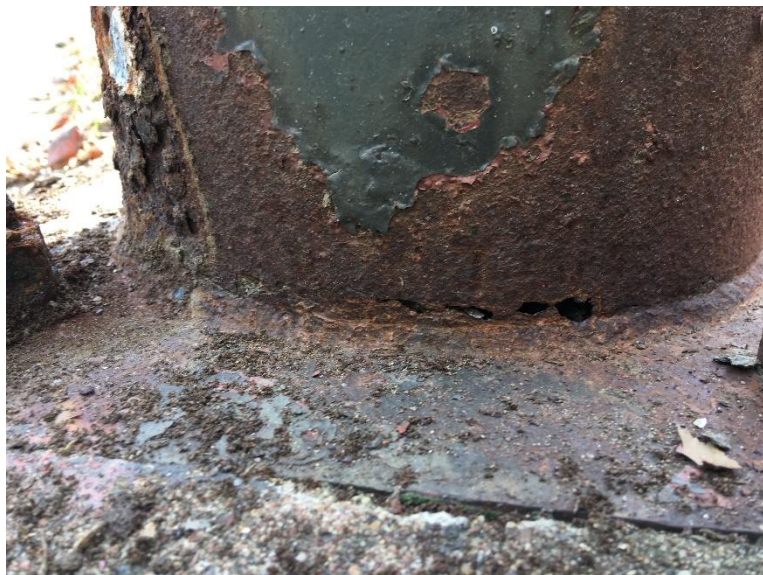
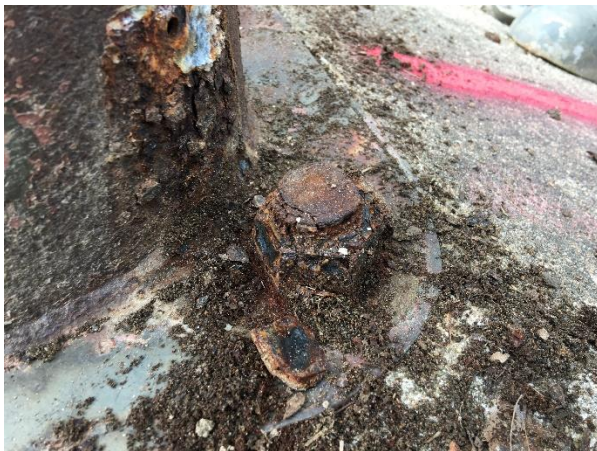
NE Corner signal structure failed on Dec. 13, 2017. NW Corner signal structure was inspected and found to have significant deterioration and cracking around the base plate weld area. Immediate removal of this pole was recommended.
