## Howard County Traffic Signal Inspection Summary Report:

**Signal Number:** 039  
**Location:** Harpers Farm Rd. at Beaverkill Rd.  
**Inspection Date:** April 12, 2018

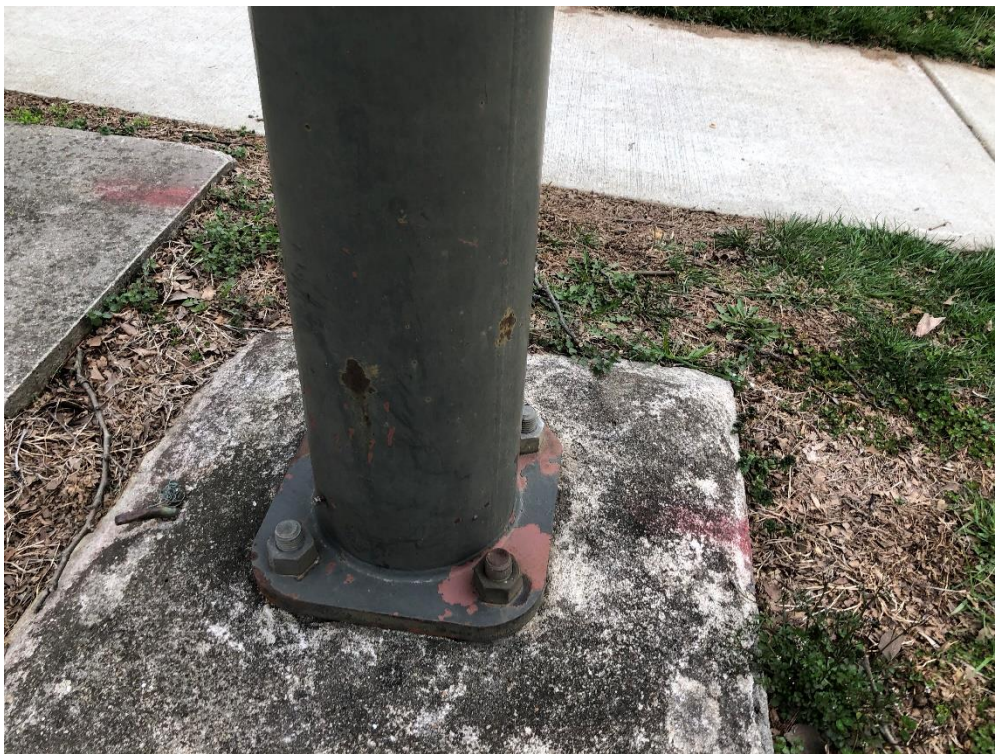
Poles are in overall good condition. Paint coating is in good condition with a few small areas of coating failure and surface rust forming. Recommend clean, prime, and re-paint.
