Howard County Traffic Signal Inspection Summary Report:

Signal Number: 045
Location: Snowden River Parkway at Minstrel Way
Inspection Date: May 2, 2018

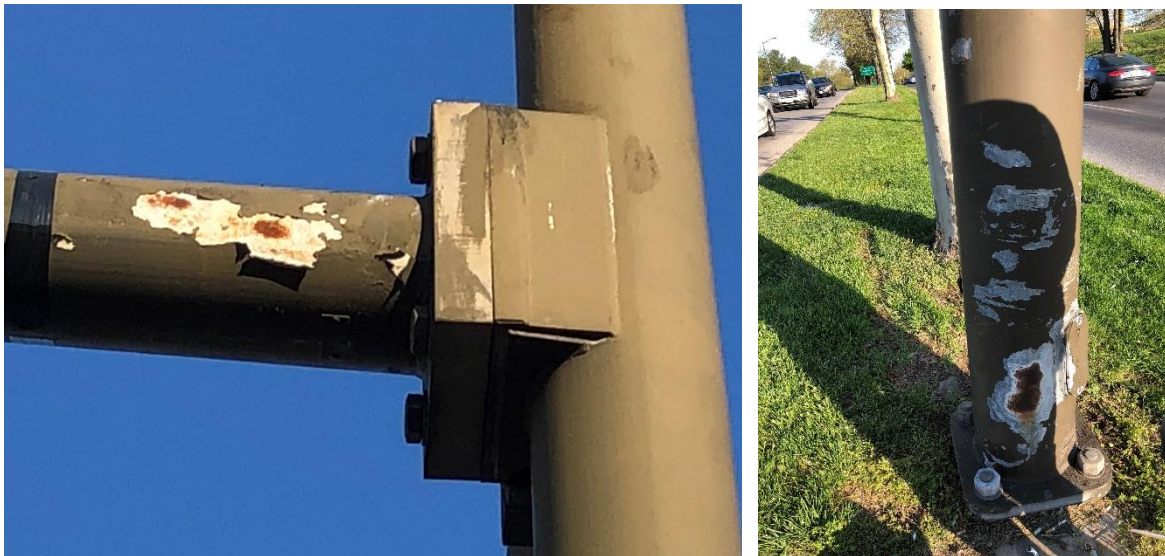
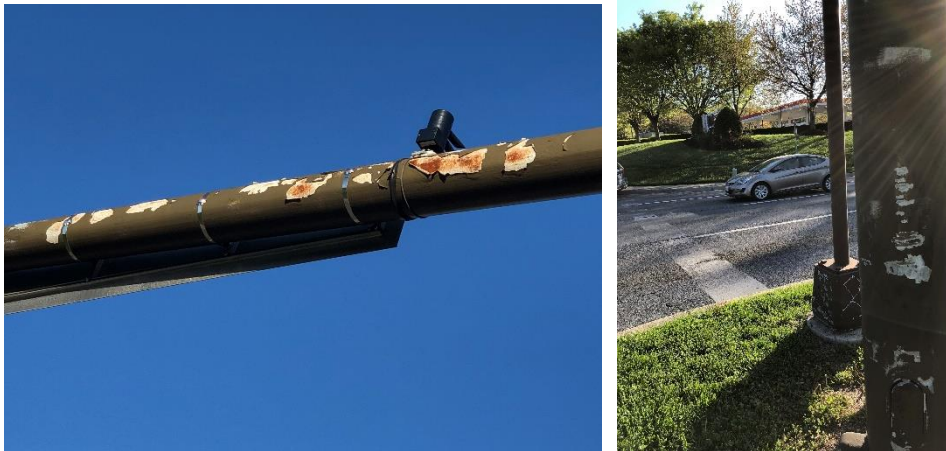
Poles in overall fair condition. Paint coating is in fair condition with some areas of coating failure and rust beginning to form.

West Median – loose tightening nuts. Overgrowth needs to be trimmed away from structure.
