Howard County Traffic Signal Inspection Summary Report:

Signal Number: 062
Location: Snowden River Parkway at Tamar Dr.
Inspection Date: April 12, 2018

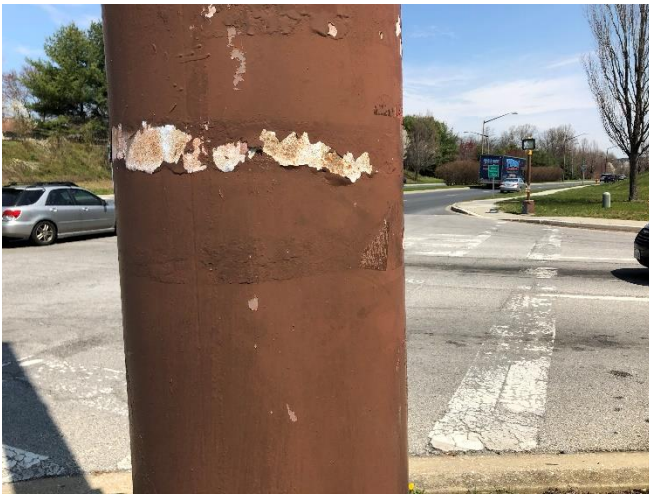
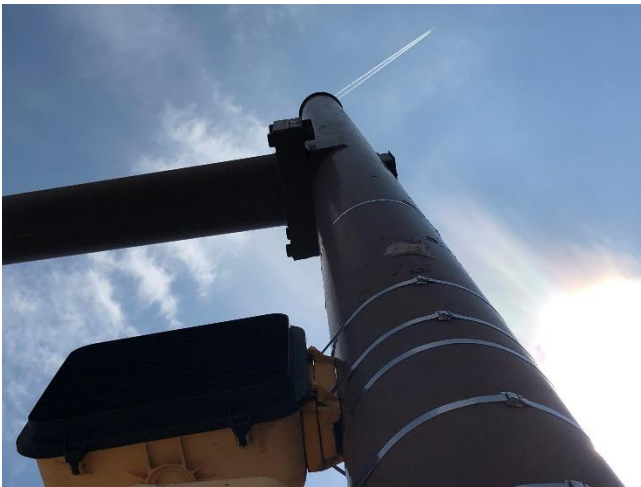
Poles in overall good condition. East Median Pole has vehicle impact damage. Paint coating is in fair condition, with some areas of coating failure and rust beginning to form.
