## Howard County Traffic Signal Inspection Summary Report:

**Signal Number:** 080  
**Location:** Robert Fulton at Solar Walk/Snowden Square  
**Inspection Date:** April 23, 2018

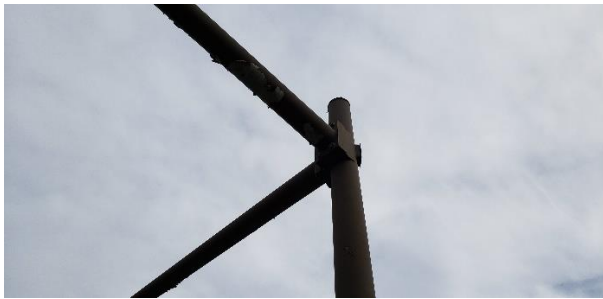
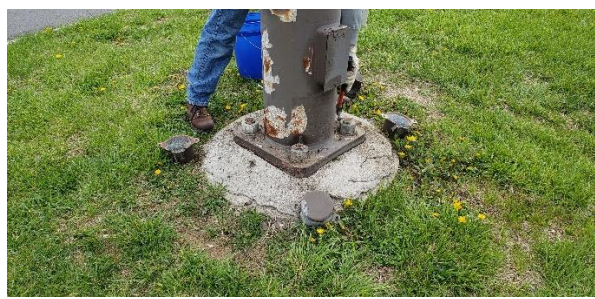
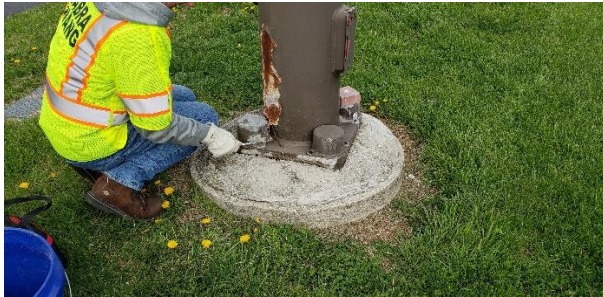
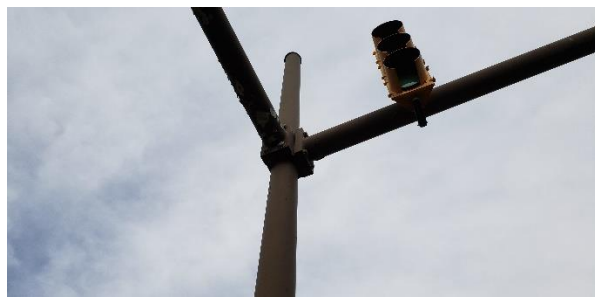
Poles in overall fair condition. Paint coating in poor condition, with large areas of coating failure and surface rust beginning to form.

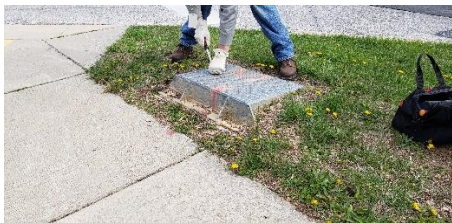
Damaged electrical service conduit.  
Hand holes retaining water.  
Trip hazard – hand hole collar above grade.
