## Howard County Traffic Signal Inspection Summary Report:

**Signal Number:** 086  
**Location:** Great Star Drive at Summer Sunrise  
**Inspection Date:** May 24, 2018

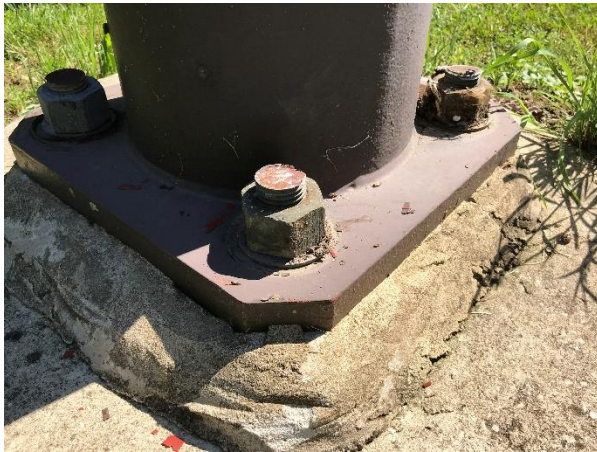
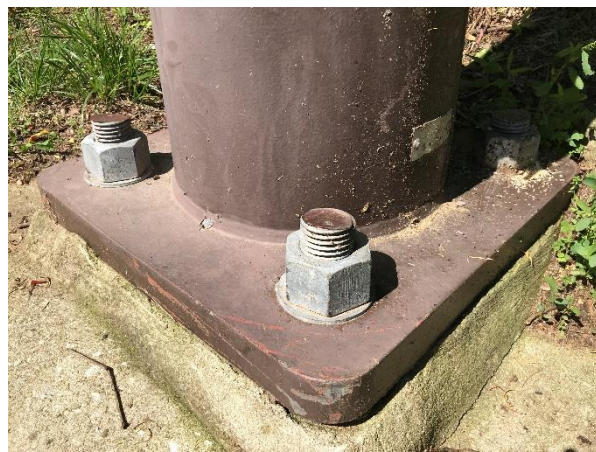
Poles are in overall good condition. Paint coating is in good condition.

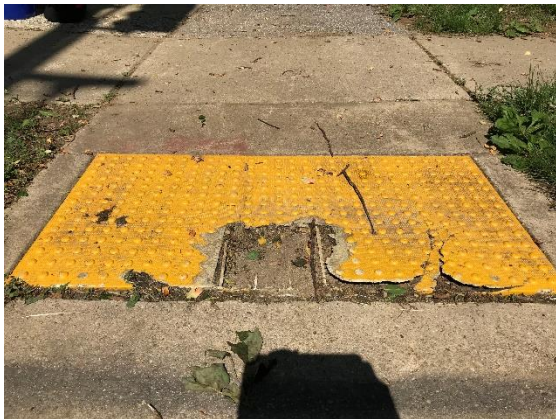
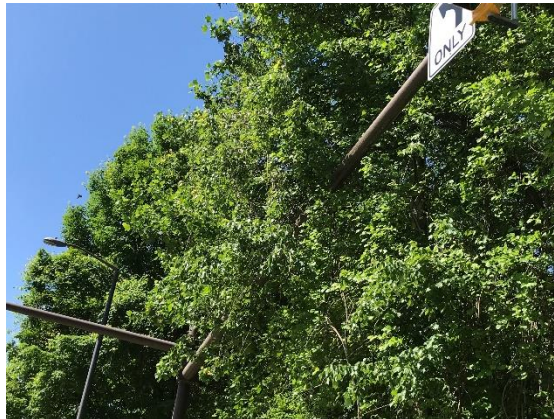
SW Corner – damaged tactile warning pad.  
Two shifted hand hole lids.  
Overgrowth should be trimmed from around structures.
