# National Register of Historic Places Registration Form

historic name "Montrose"

other names/site number HO-85

street & number 13370 Brighton Dam Road  not for publication

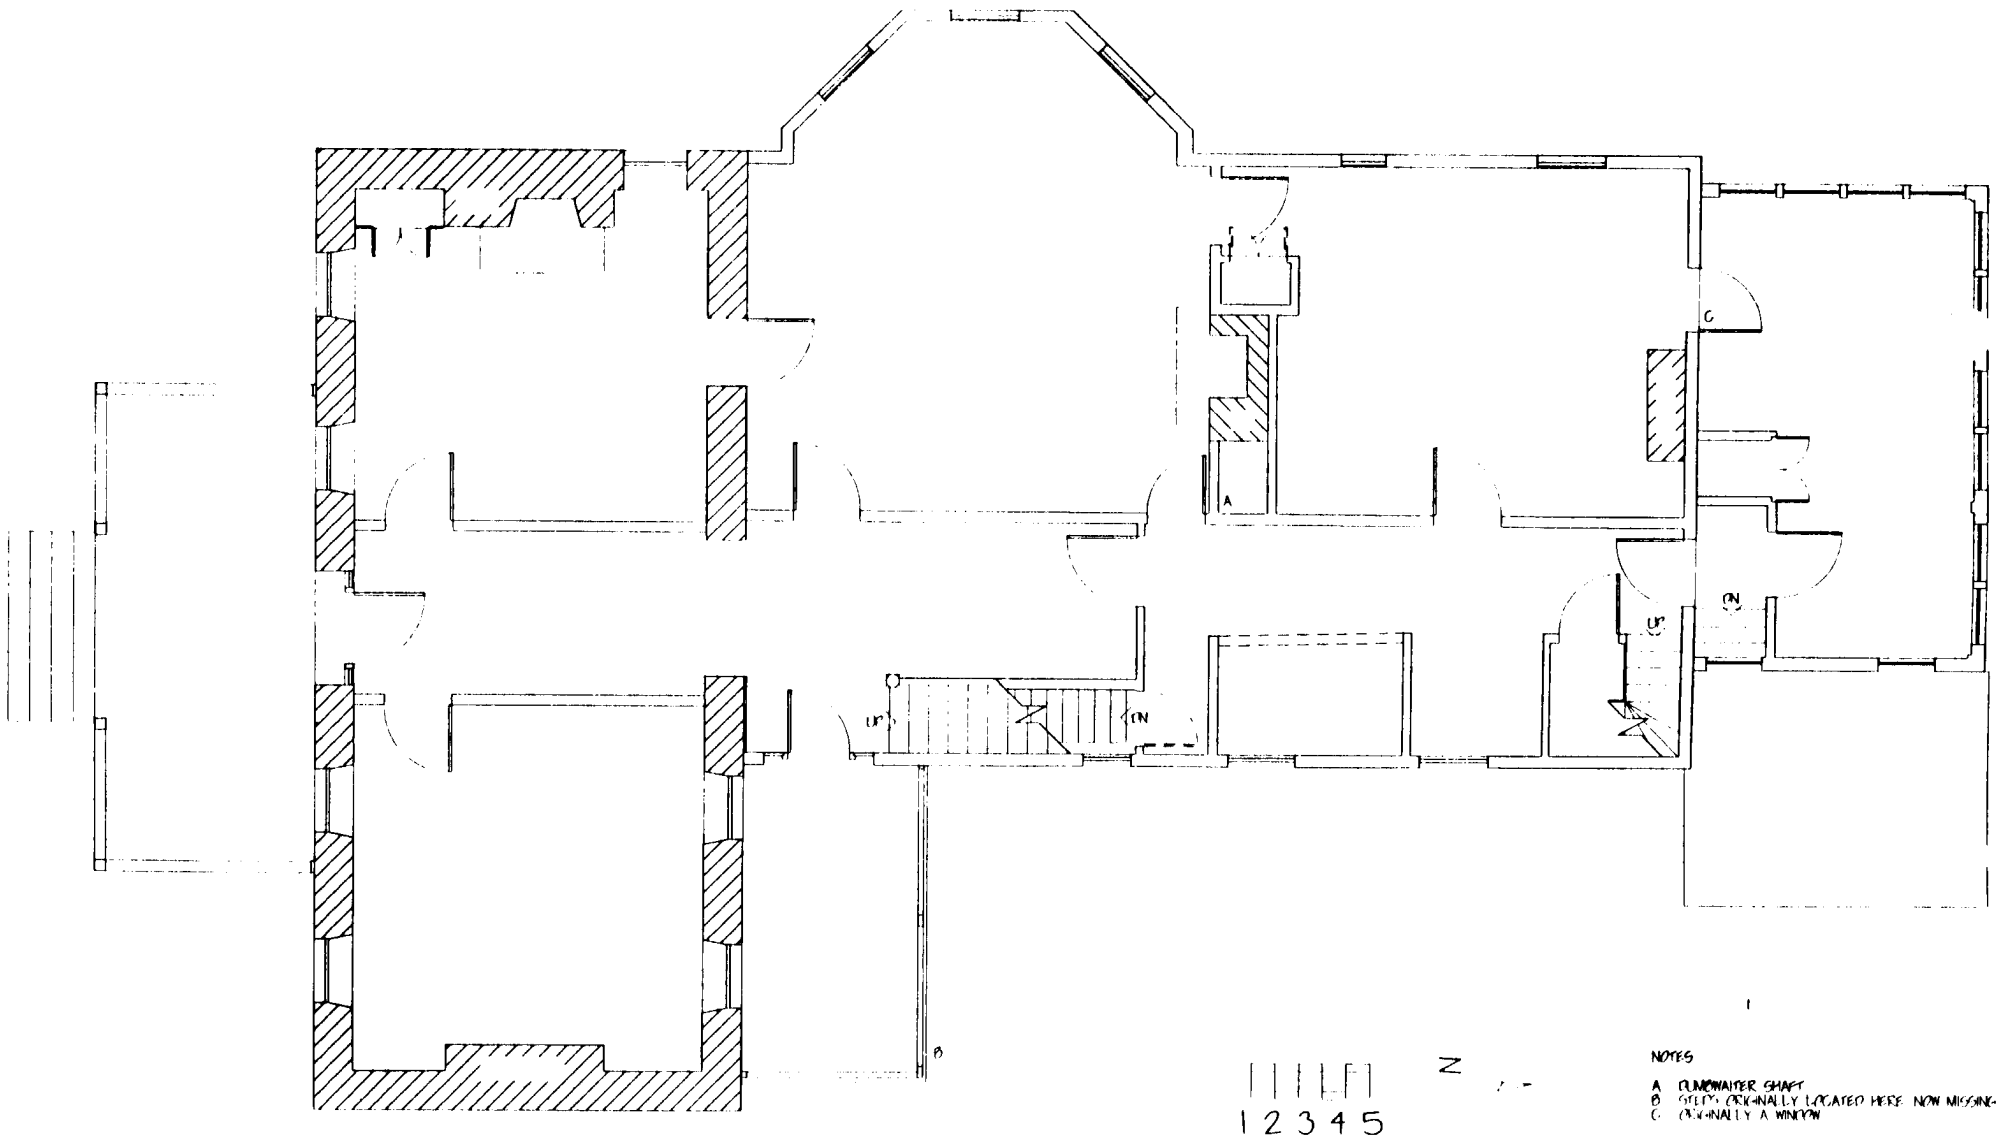
FIRST FLOOR PLAN MEASURED BY KEN SHORT, STEVE SHORT, & SUSAN SHORT DRAWN BY KEN SHORT MARCH 2000

NOTES  
 A PLUMB/WATER SHAFT  
 B SLEEPER ORIGINALLY LOCATED HERE NOW MISSING  
 C ORIGINALLY A WINDOW

The first story has a center-passage, single-pile plan in the stone section, with a stair hall to the north of the passage and a narrow passage to the north of the stair hall. There are two rooms to

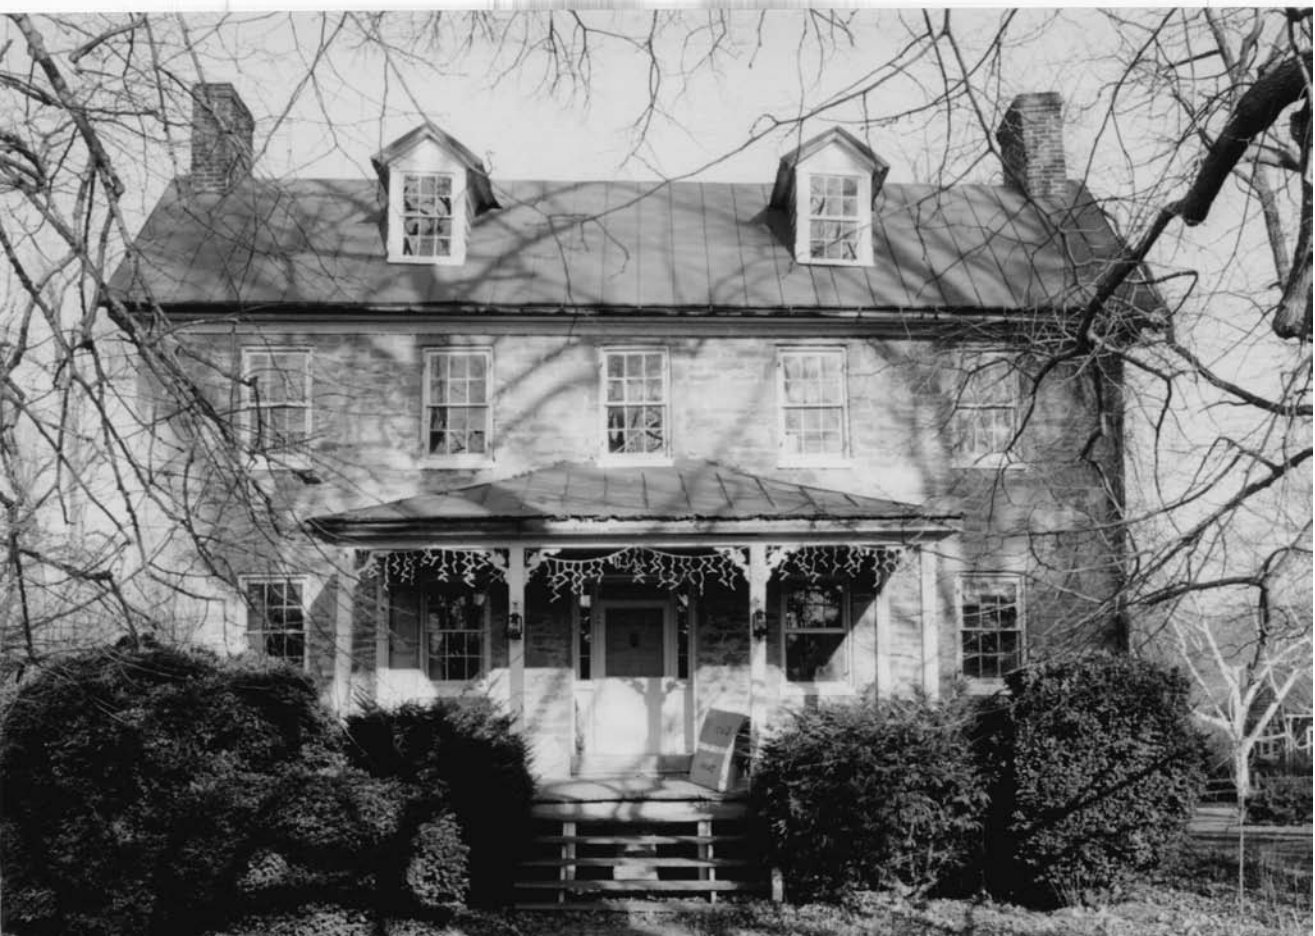
1/21

House. S. elev.

On the south elevation of the stone house, all of the openings have large stone lintels. In the foundation, the west bay has a six-over-three double hung sash in a beaded-interior-edge frame. The west-center bay has a three-over-three double hung sash, and the east-center bay has in-fill of vertical boards set inside of the window frame. The east bay has a six-light sash. The first story has a center entrance with a stone sill that has a wash. The door has six small panels over two tall panels, and the panels have sunk fields and quirked Greek ogee panel moulds. There is a porcelain knob. The entrance has a three-light transom and side lights with four lights over one panel. The soffit and jambs have one panel each, with the same moulds as the door. The doorway has a bullnose-moulded frame and a large stone lintel. There are two six-over-six double hung sash to each side of the opening. They are set in bullnose-moulded frames, with wood sills and cast iron shutter hardware. These sash are typical for the stone portion of the house. There is a three-bay, one-story, hipped roof porch with standing seam metal roofing. The porch is supported by three stone piers. The west elevation of the west pier is parged and contains traces of red paint. The east pier is parged on the east elevation and painted white. The porch has a wood deck, four chamfered posts, jig-sawn balusters and brackets, and a wood box cornice with two Greek ovolo mouldings. The second story has five typical six-over-six sash, and there is a wood box cornice. There are dormers over the west-center and east-center bays, with six-over-six double hung sash, architraves with two fillets, and gable roofs with a north-south ridge and standing seam metal. The sides of the dormers have wood shingles. There are two lightning rods on the ridge.

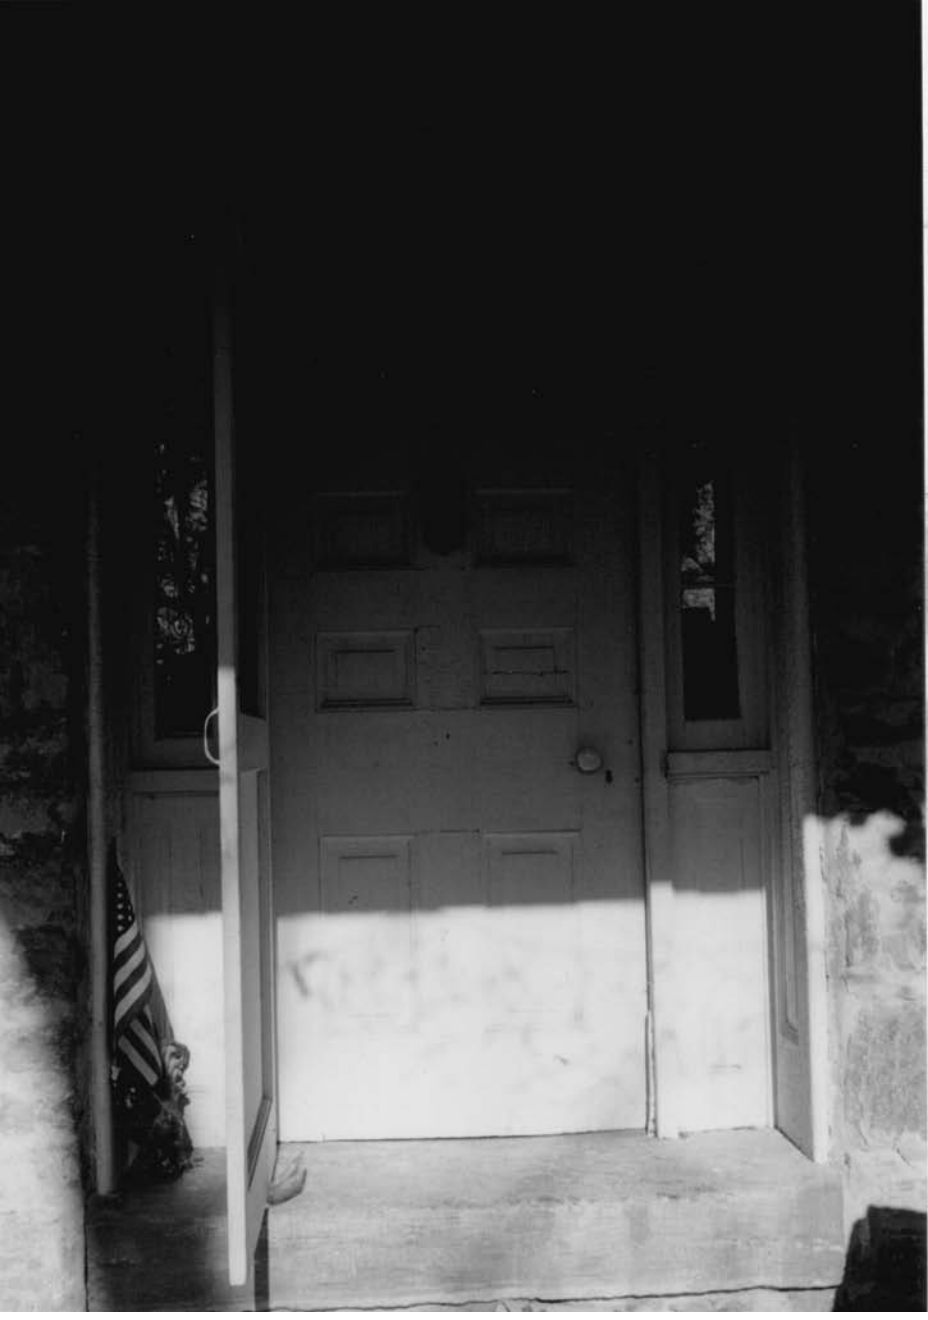
2/21

S. elev. <sup>2136 N-T-T T-15R 03 035V 0010ND5416</sup> - front door

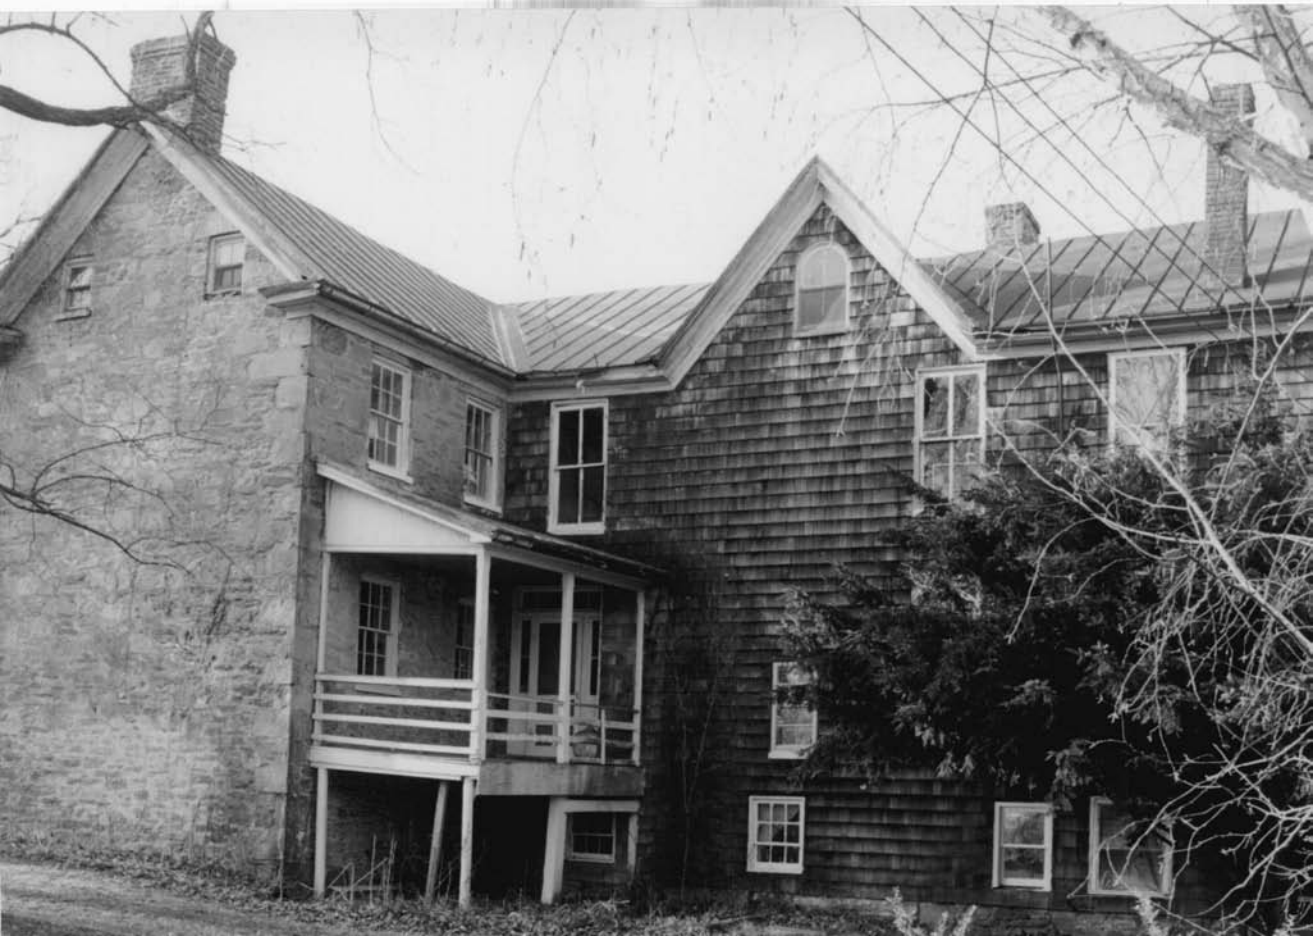
3/21

House - E. elev

The east elevation of the large addition, at the basement level, has two six-over-three double hung sash to the south, a later one-over-one sash just north of center, and two windows, each with paired four-light casements and plain head-cut trim, to the north. The first story has a door in the south bay that has four panels with sunk fields and ogee-and-bevel panel moulds. There are sidelights with two lights over one panel, and a three-light transom. The south-center bay has a small two-over-two double hung sash set lower on the wall than the other openings. There are two two-over-two sash to the north. The second story has three typical two-over-two sash, with no opening in the south-center bay. There is a cross gable over the south-center bay that has a semi-circular arched two-over-two sash. There is a box cornice with returns.

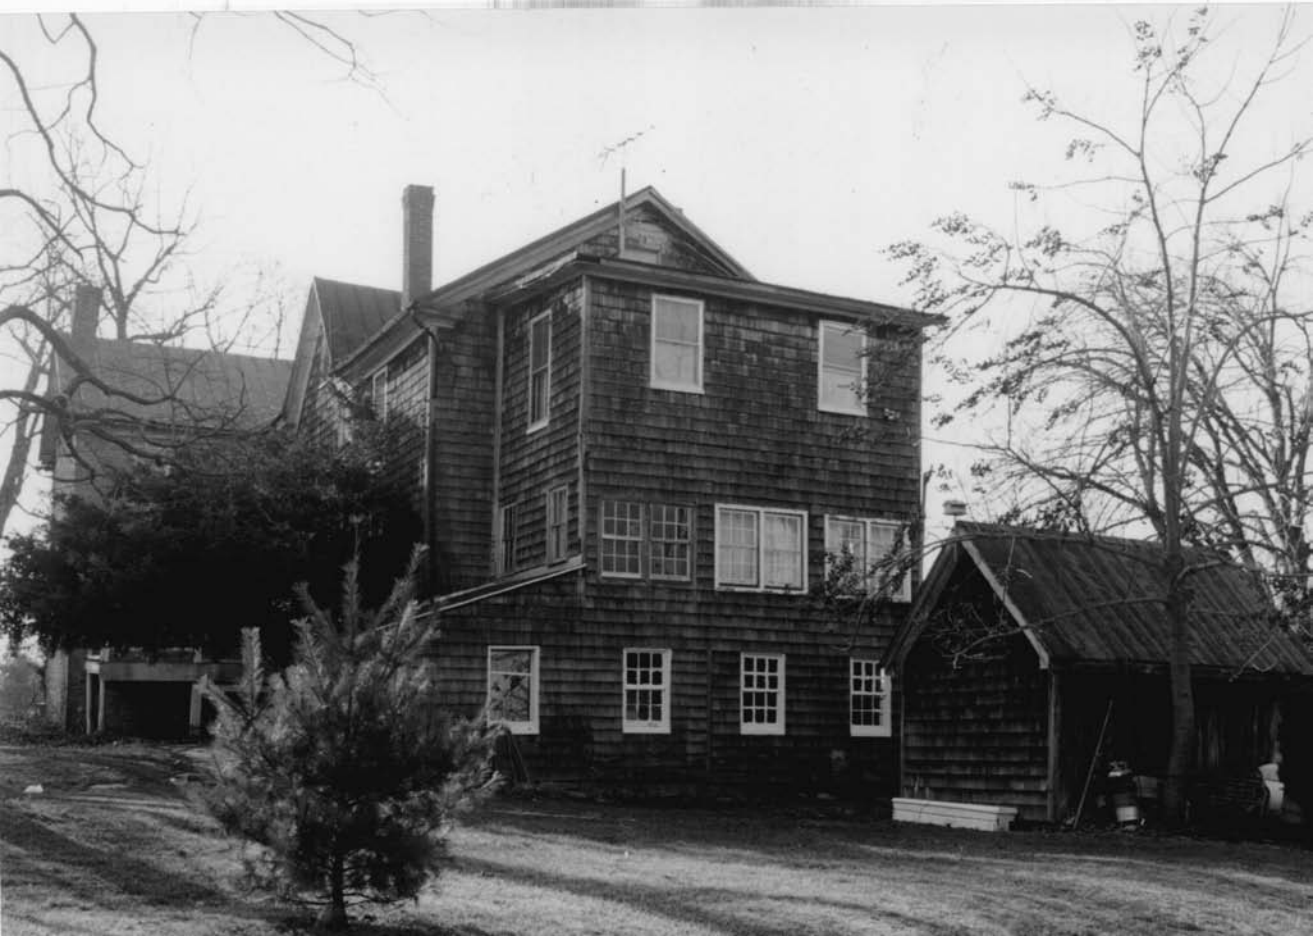
4/21

House - N. elev.

The north elevation of the stone section retains traces of whitewash over traces of red paint on the basement. The first story has two typical six-over-six sash, with traces of whitewash on the walls and traces of red paint beneath the window sill level. There is a one-story, shed-roof porch with

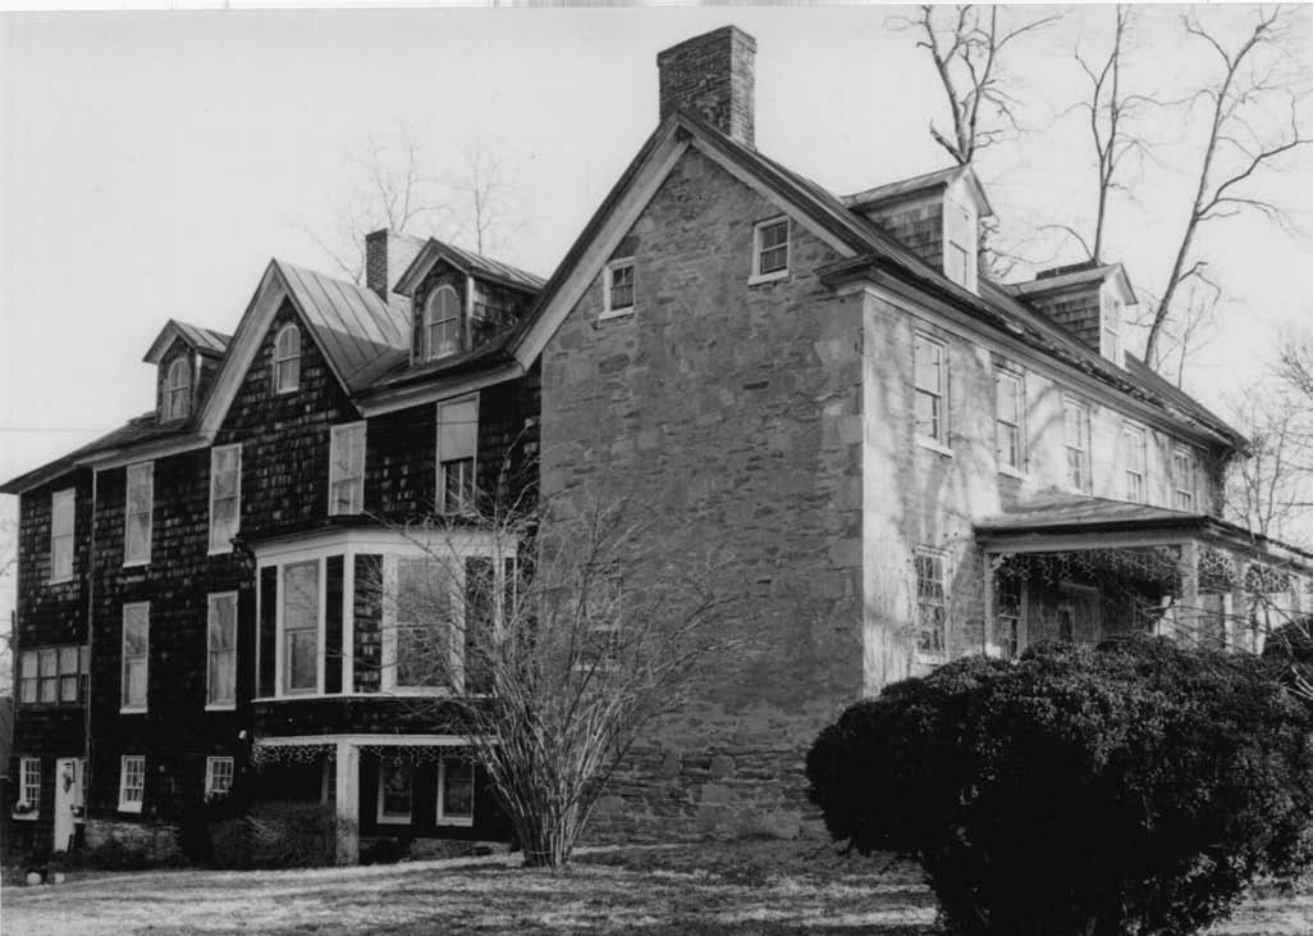
5/21

House - W & S elevs

The west elevation of the stone section has a typical six-over-six sash in the north bay of the first story, with no opening in the south bay. The second story has no openings. The gable end has two two-over-two double hung sash in bullnose-moulded frames, with wood sills. There is a boxed raking cornice. The west elevation of the wood section has a basement story consisting of a low

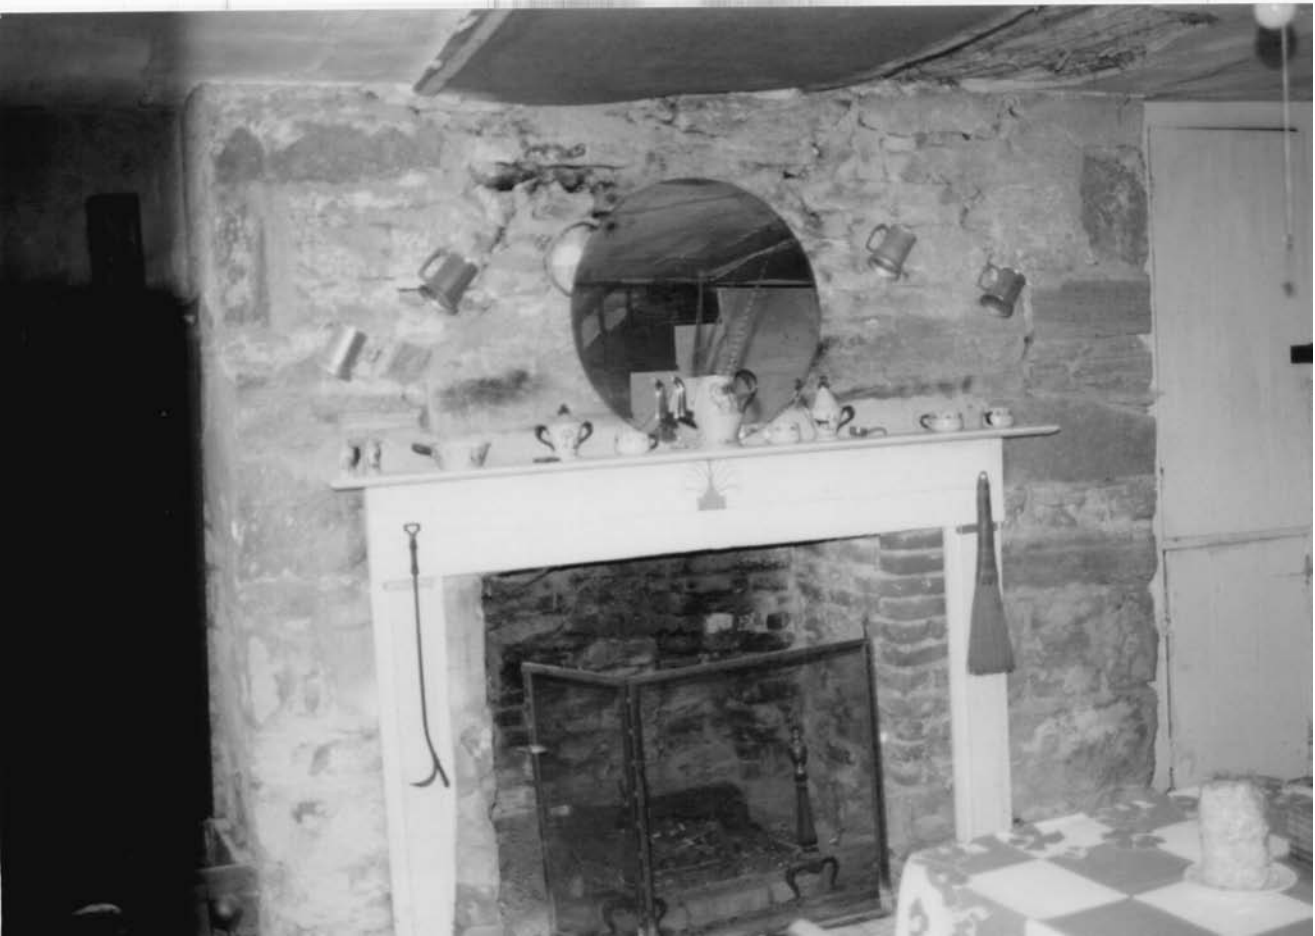
6/21

SW cellar Rm - w elev.

The southwest cellar room has random-width pine flooring 3 ½ to 4 ½ inches wide. The flooring runs east-west, is set on sleepers, and is very deteriorated. The walls have plaster on stone, and the ceiling is plaster on circular sawn lath that is fastened with cut nails. The east elevation has a straight run, open stringer stair to the first story. It has square-in-plan balusters, a three-quarter-round handrail, and a square, chamfered newel post. There is a beaded-edge vertical-board door beneath the stair that leads to a closet. The door has a wood stock lock that is stamped with the number "3" on the end. The doors are hung on cast iron butt hinges marked "N. ENG. BUTT C<sup>o</sup>" both the lock and hinges are fastened with gimlet screws. The partition wall has circular sawn lath and the door frame is constructed with cut nails. The door has two plugged holes for earlier latches; these holes are blocked by the present lock. South of the stairs is a beaded-edge vertical-board door leading to the southeast cellar. The door is constructed with three wide boards and has a cast iron box lock with a mineral knob. The door is hung on cast iron butt hinges that are marked "W. H. CARR<sup>m</sup>" and "PATENT." The south elevation has a ghost of a window to the east that has been lathed and plastered over. To the west is a window with splayed, plastered jambs, mortised and tenoned and pegged sash, and a wood sill. The sash do not have parting beads. The west elevation has a fireplace with splayed jambs. The south jamb is stone, but the north jamb has brick in-fill to narrow the opening. The fireplace has a segmentally-arched brick lintel with two iron bars supporting the brick. Above the brick is a large stone lintel that spans the original opening width. There is a wood mantel with plain pilaster strips, a broken frieze, and no bed moulding. The mantel fits the current opening size, not the original size of the fireplace. There is a stove pipe hole with a terra cotta lining above the stone lintel. North of the fireplace is a built-in cupboard with beaded-edge vertical-board doors consisting of a single door set above a smaller single door. The cupboard has beaded-interior-edge architrave. The top door has a small cast iron rim lock, and is hung on plain cast iron butt hinges fastened with gimlet screws. The north elevation has the ghost of a window, which has been lathed and plastered over, to the west. The east bay has a circular-sawn vertical-board door.

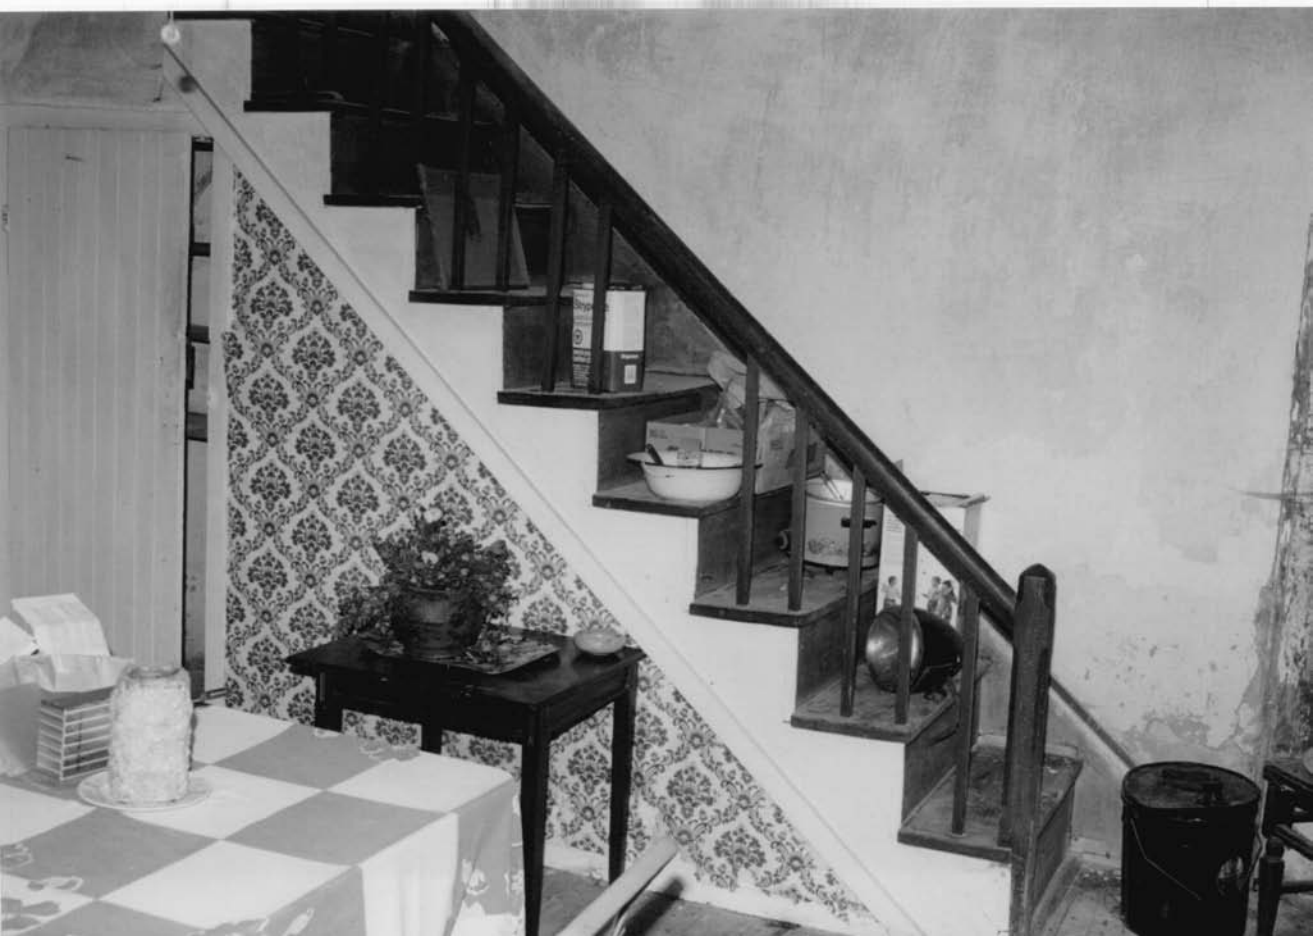
7/21

SW Cellar Rm - E. elev.

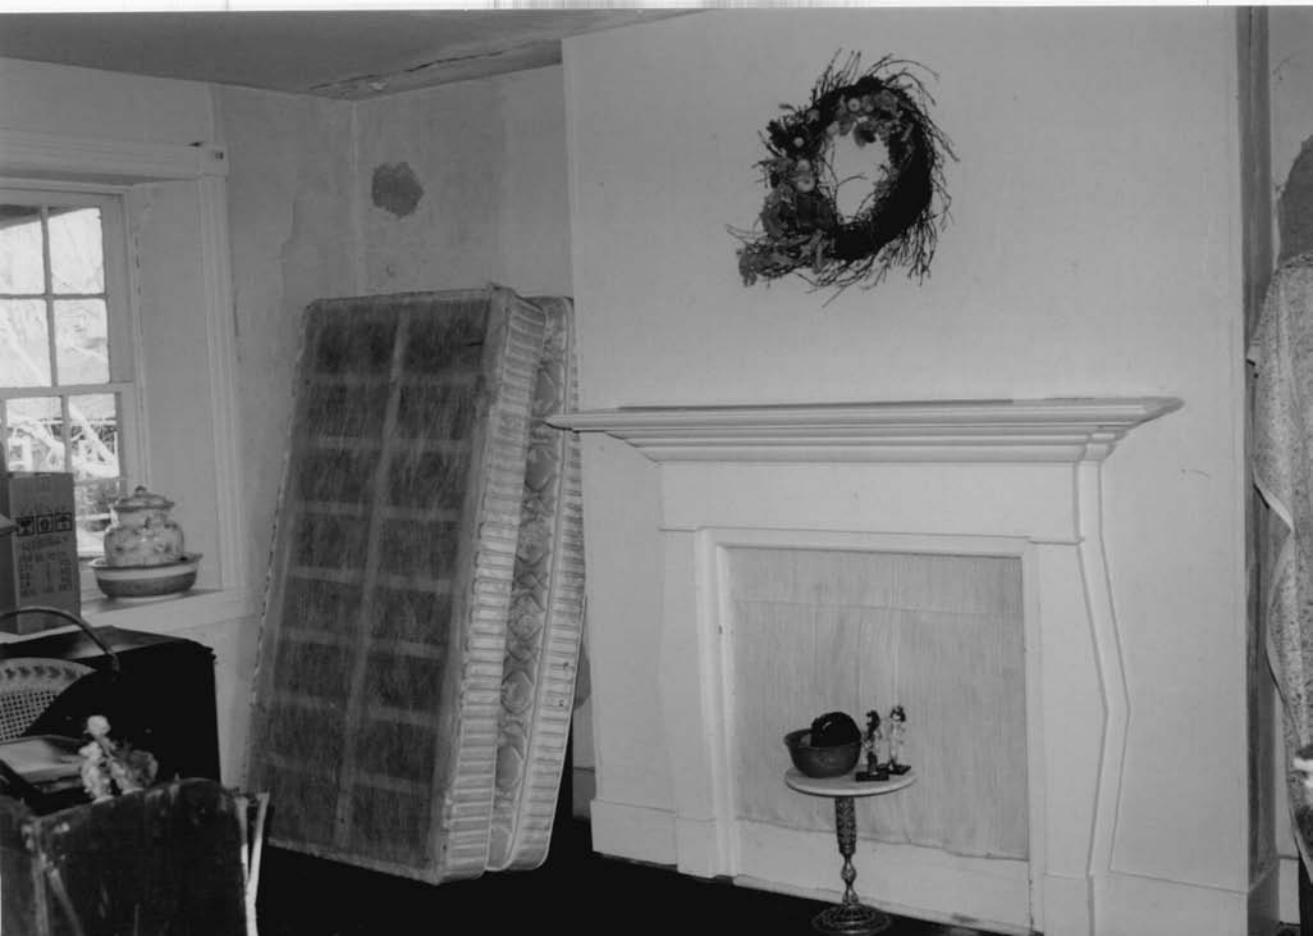
8/21

SE Rm - vw NE

The southeast room has random width oak or chestnut flooring that is 4 ¾ to 7 ½ inches wide, and runs east-west. The windows have splayed jambs with mortised and tenoned and pegged sash that have parting beads. The architrave in this room matches that of the front door. The baseboards are plain, and are rather wide and deep. There is a fireplace on the east elevation that is closed off and has no hearth. It appears that this was never a functional fireplace, but was always meant for a stove. The wood mantel has plain pilaster strips that are angled outward on the outer edge, as if meant to be exaggerated entasis. It has a plain frieze and a bed mould with three Greek ovolos. There is also a Greek ovolo moulding on the edge of the mantel shelf. The mantel has been pulled off the wall and re-fastened.

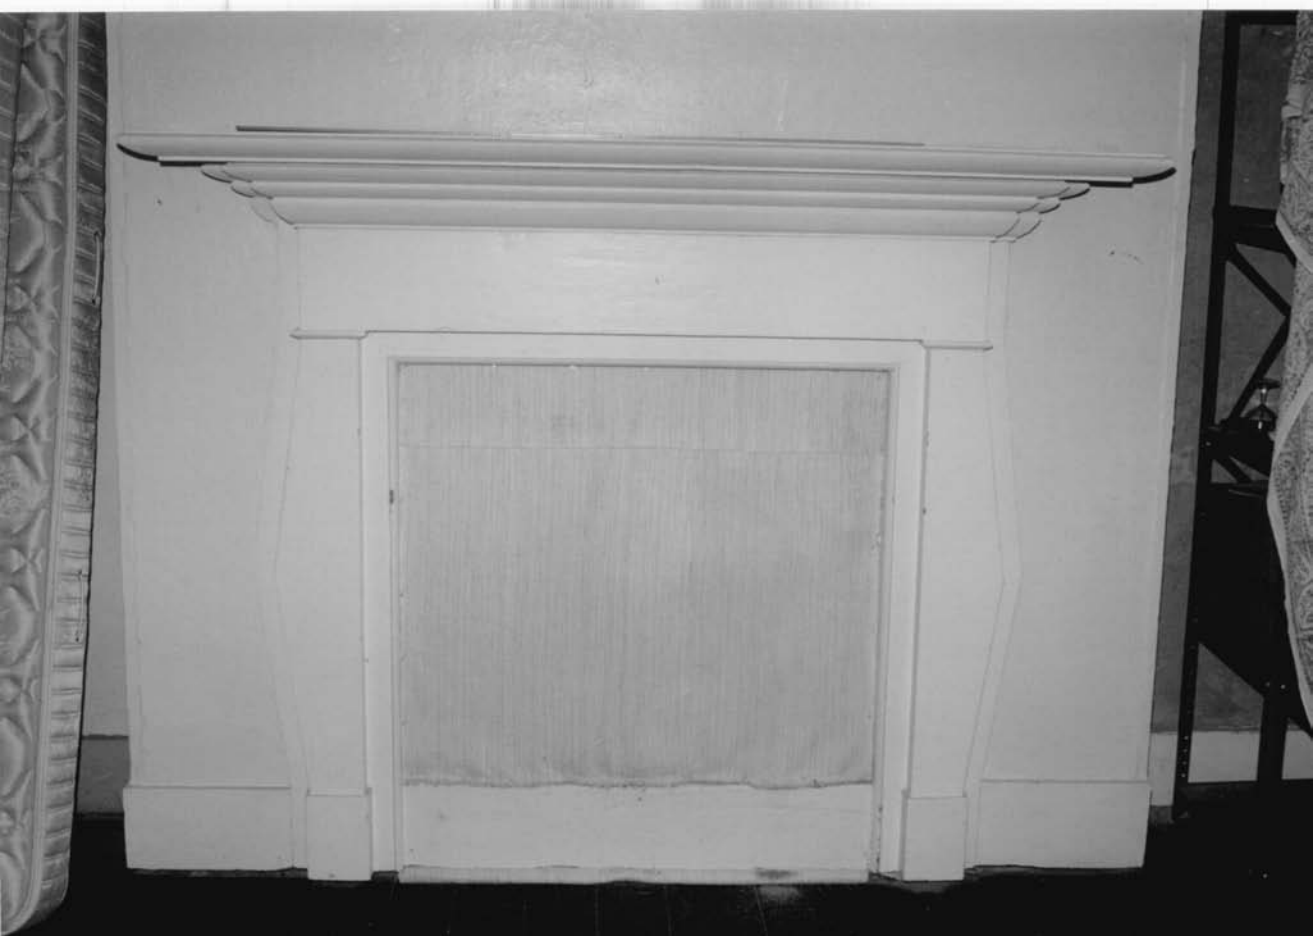
9/21

SE Rm mantel

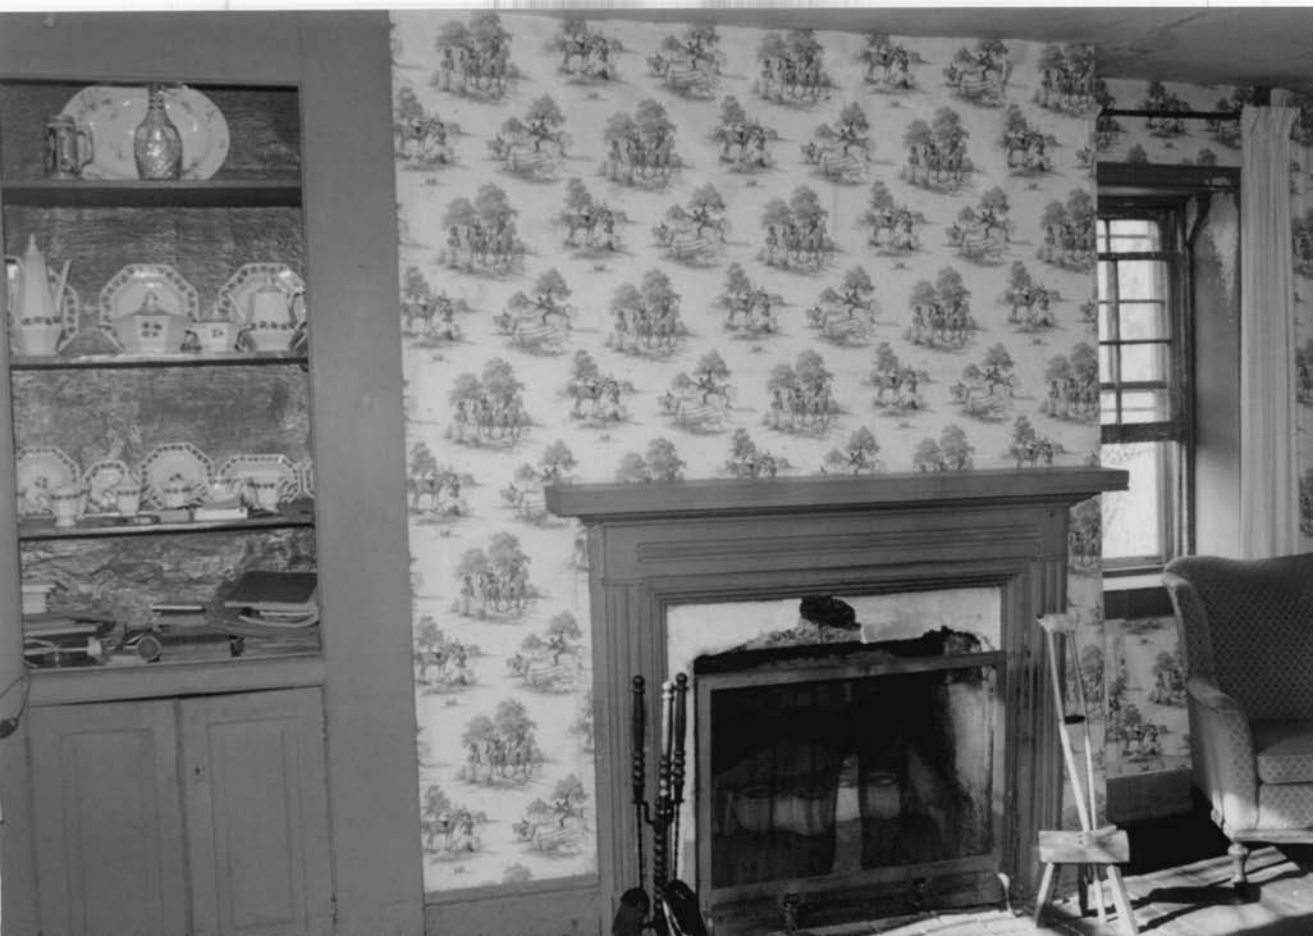
10/21

SW Rm - W. elev

The southwest room has the same flooring, base board, and architrave as the southeast room. There is a fireplace on the west elevation that has a brick hearth and splayed, plastered jambs. The wood mantel has architrave trim of two beads in a sunk field, used both as pilaster strips and in the frieze. It has plain impost blocks, two Greek ovolo mouldings on the bed mould, and a shallow groove on the face of the mantel shelf. To the south of the fireplace is a cupboard with two one-panel doors below that have sunk fields and no panel moulds. They are hung on cast iron butt hinges that appear to be plain. The top doors are now missing. The north elevation has a doorway with typical architrave, and one panel on the soffit and each jamb that has sunk fields and no panel moulds. There is a four-panel door here with sunk fields, small ogee panel moulds, and a mortise lock with a porcelain knob.

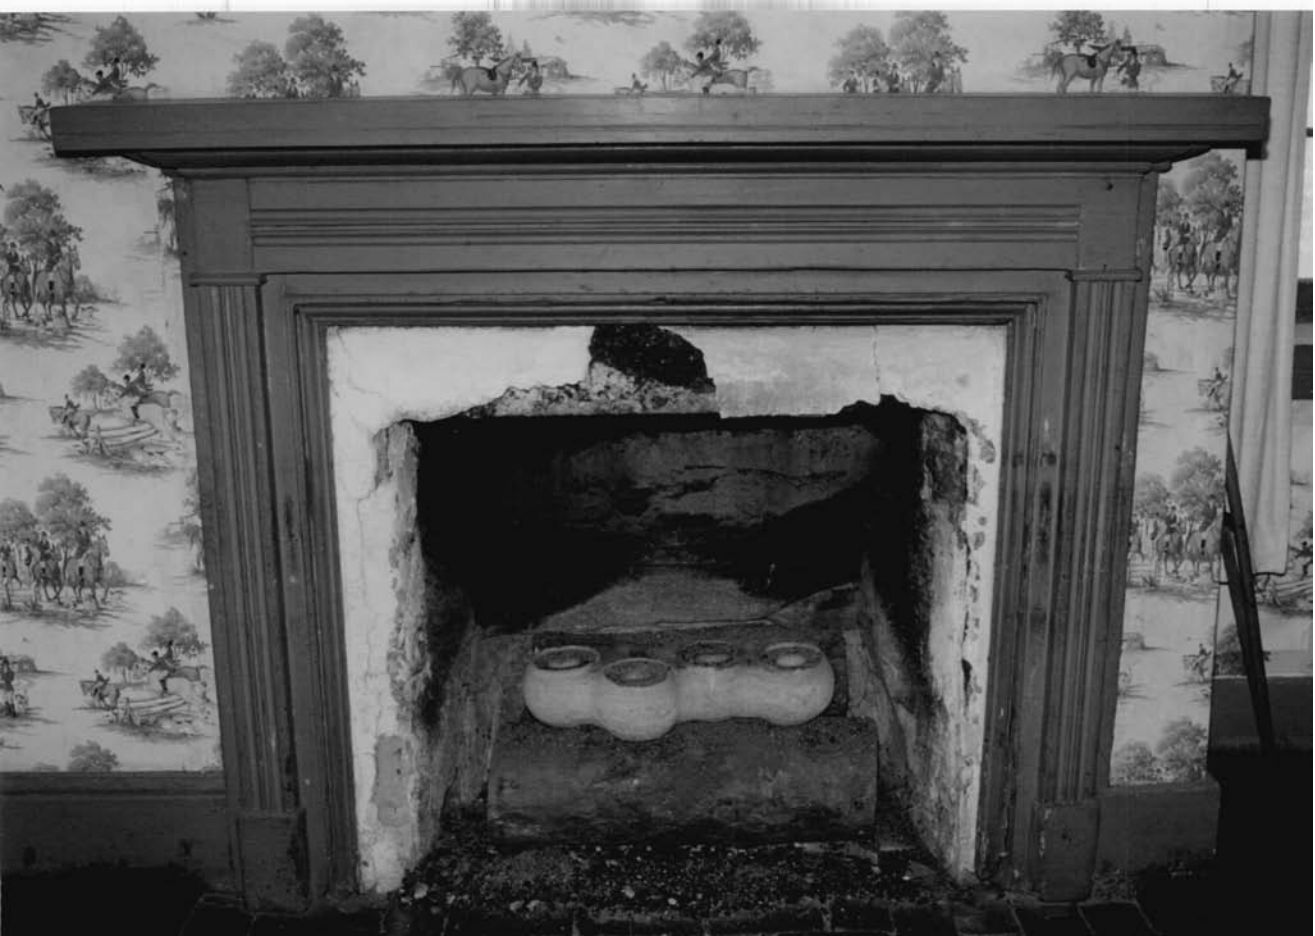
11/21

SW Rm. mantel

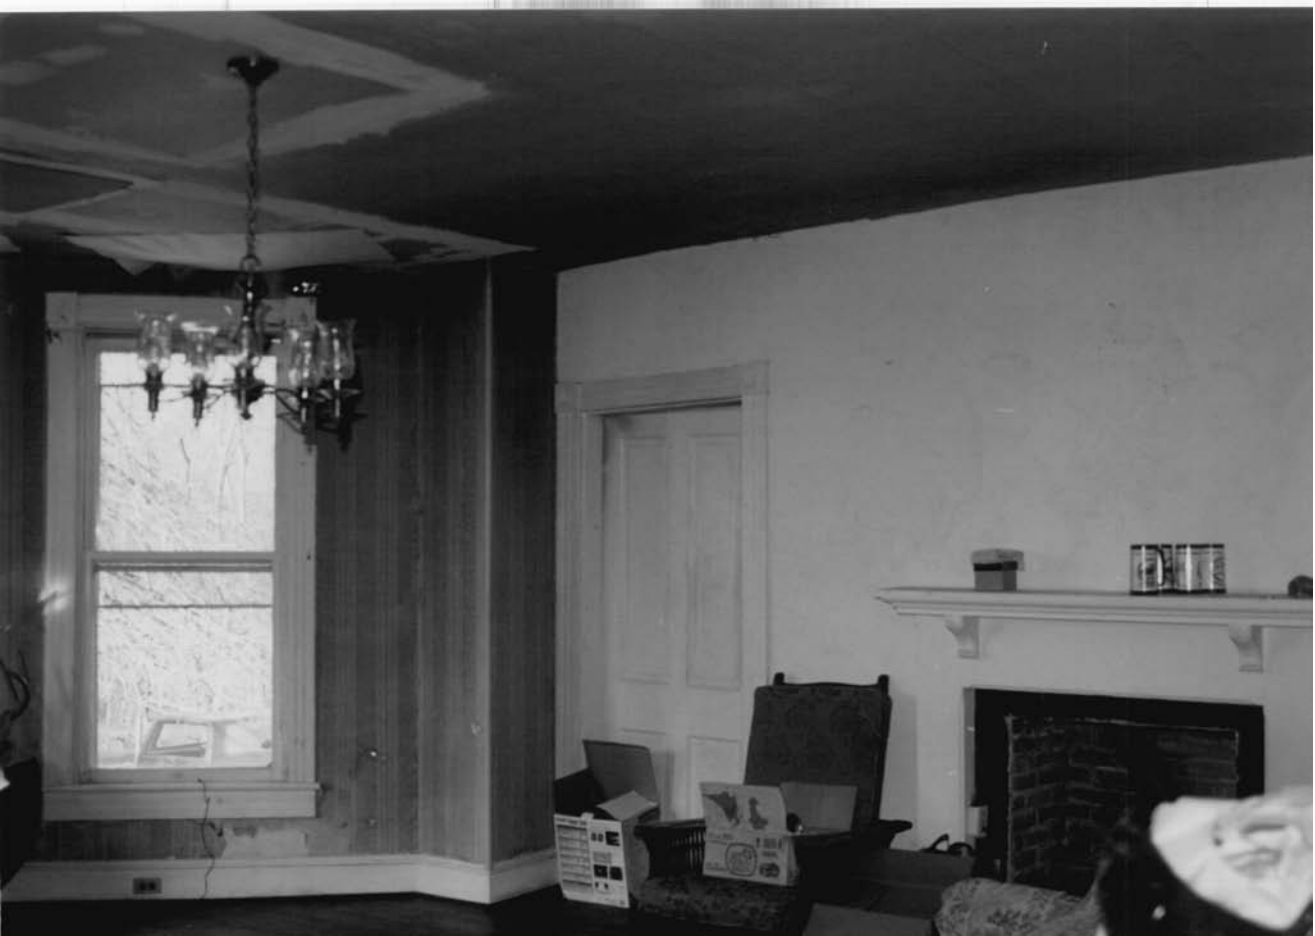
12/21

West. center rm - vw NW

The west-center room has 2 inch wide oak flooring that runs east-west and is laid on top of earlier flooring. There is a large three-sided bay window on the west elevation that has the same architrave as found in the passage and stair hall. The ceiling at the juncture where the bay window meets the house is very deteriorated, with much plaster missing or replaced by various patches. On the north elevation, to the east, is a fireplace with a brick hearth, straight brick jambs, and plastered surround. According to the Randalls, there was originally a coal-burning insert here. The wood mantel has two scroll brackets with acanthus leaves, and an egg and dart moulding on the mantel shelf. It appears that this mantel was applied later, or has been removed and re-fastened, as it abuts the plaster wall rather than having the plaster applied up to it.

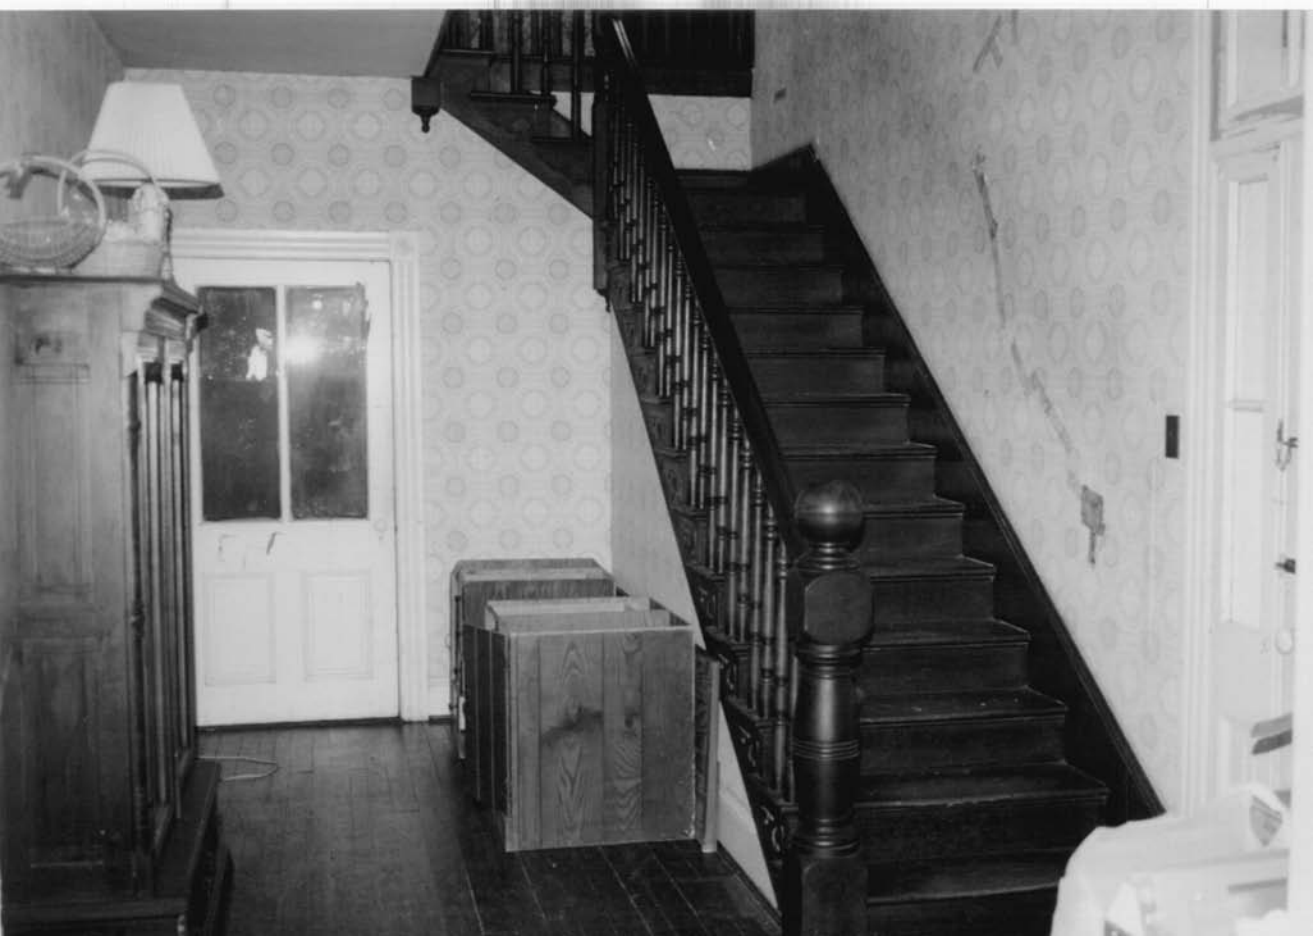
13/21

Passage: vw N.

The north wall of the passage is opened up almost as wide as the passage itself, and the opening contains the same architrave as is found on the interior doorways of the passage. The jambs of this wide opening each have a sunk, flat panel. There is a dog-leg stair on the east that has a large turned walnut newel post, a moulded walnut handrail, and turned oak balusters. It has an open stringer with sawn brackets, and the baseboard matches that of the front passage. On the east

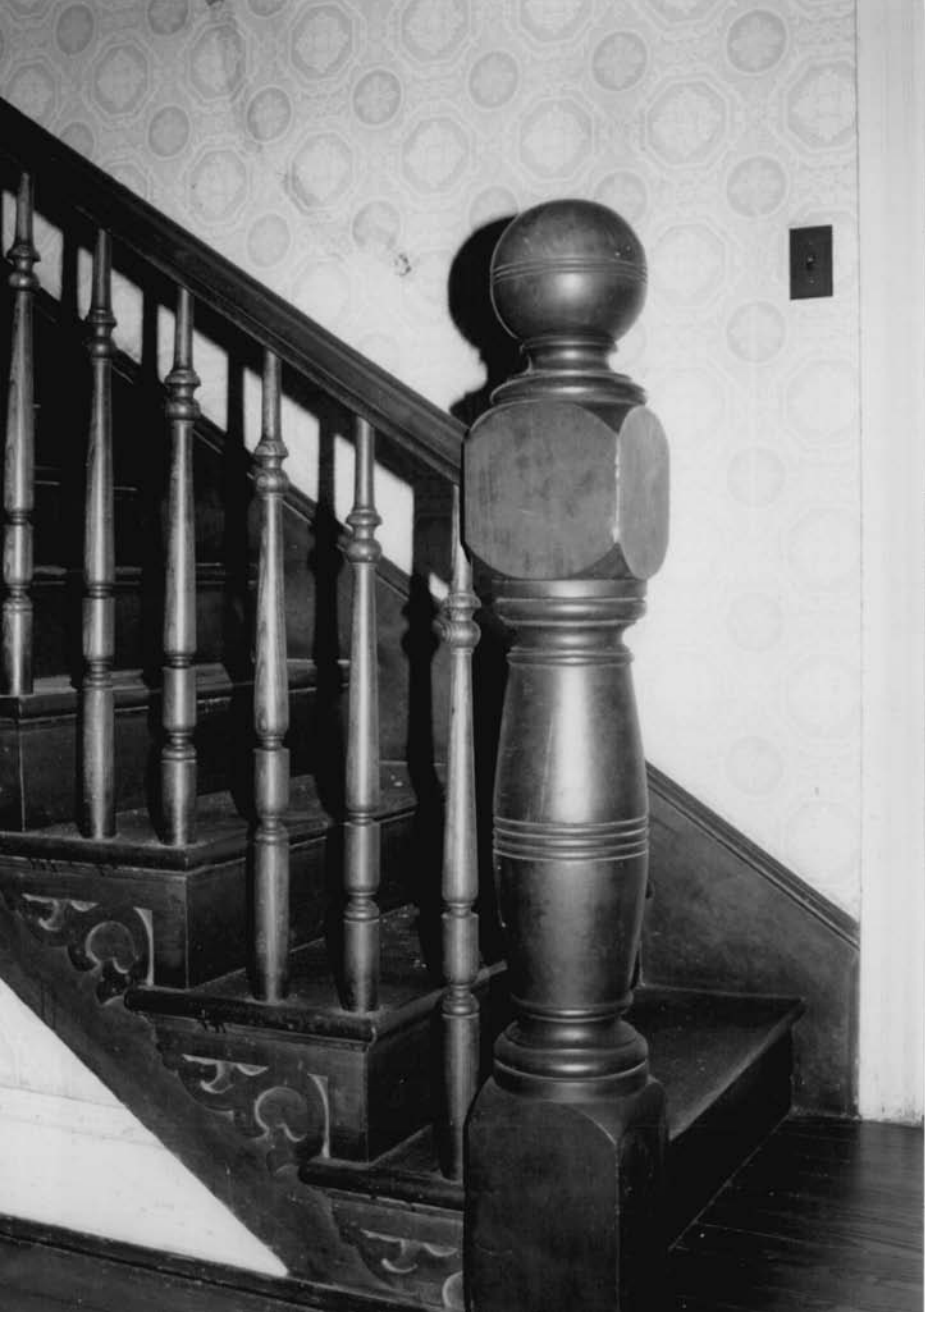
14/21

Stair newel
