# National Register of Historic Places Registration Form

historic name "Montrose"

other names/site number HO-85

street & number 13370 Brighton Dam Road  not for publication

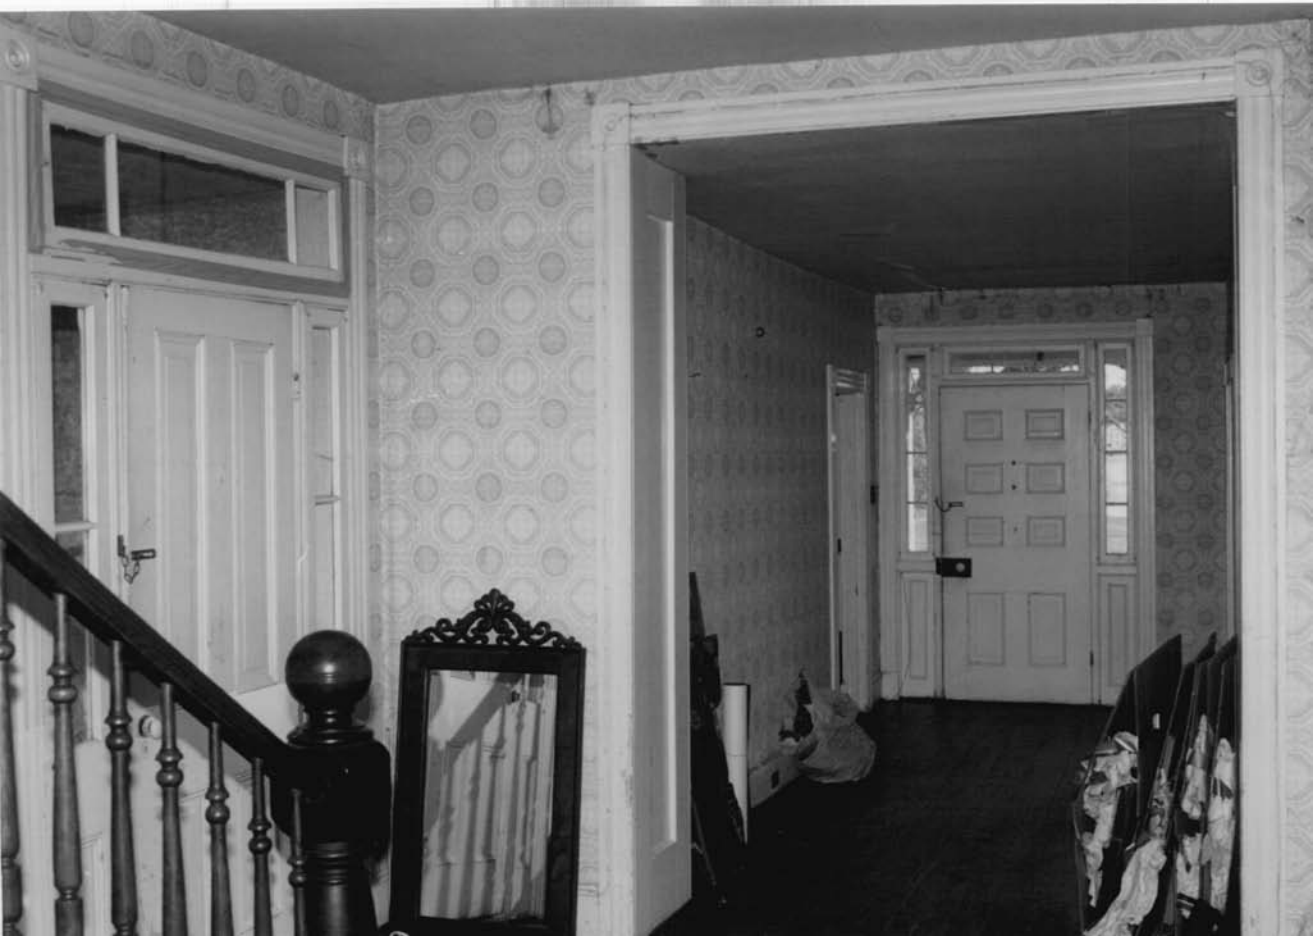
15/21

Center Passage, 1<sup>st</sup> St, UW SE.

the west and two small rooms and a winder stair to the east of the passage. The passage has 2 ½ to 3 ¼ inch wide pine flooring throughout it that runs north-south. The baseboard has a quirked Greek ogee and bevel on the top of it. The front door has quirked Greek ogee moulds, and a large, plain cast iron rim lock with a porcelain knob. This lock may be a Carpenter lock, but it is missing a seal. The architrave here has two fillets and a beaded interior edge. There are plain corner blocks. The doors to the southeast and southwest rooms have two tall panels with sunk fields and no panel moulds. The architrave here has two reeds on either side of a pulvinated frieze, with a beaded interior edge. Here there are bull's-eye corner blocks. The cast iron butt hinges are heavily painted. There is a cast iron rim lock with porcelain knob that is marked "D. M. & C<sup>o</sup> New Haven" on the east door, while the rim lock on the west door is unmarked. Neither one of these locks is original, as there are ghosts of earlier, larger locks.

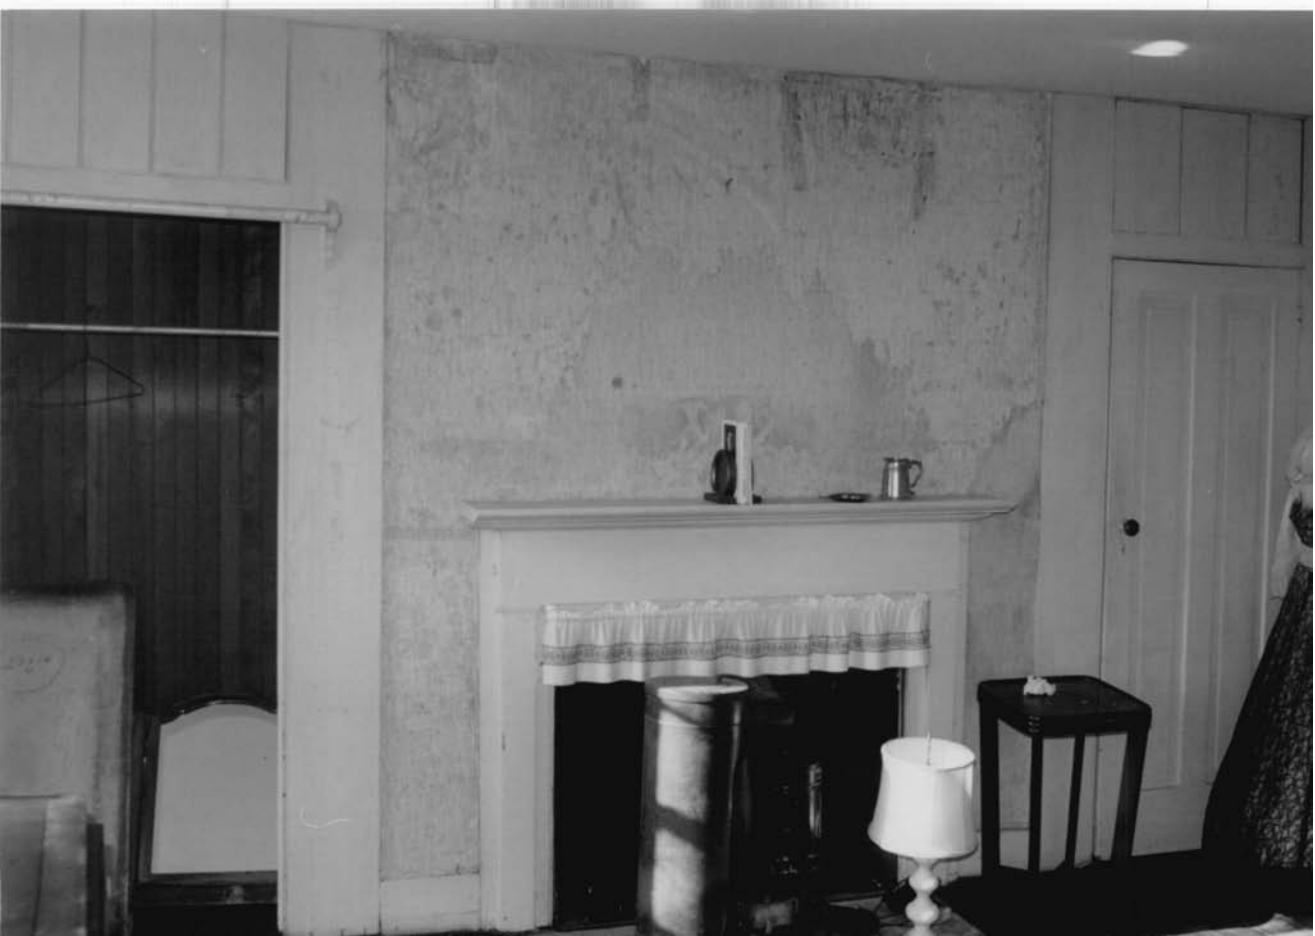
16/21

SW Chamber, W. elev.

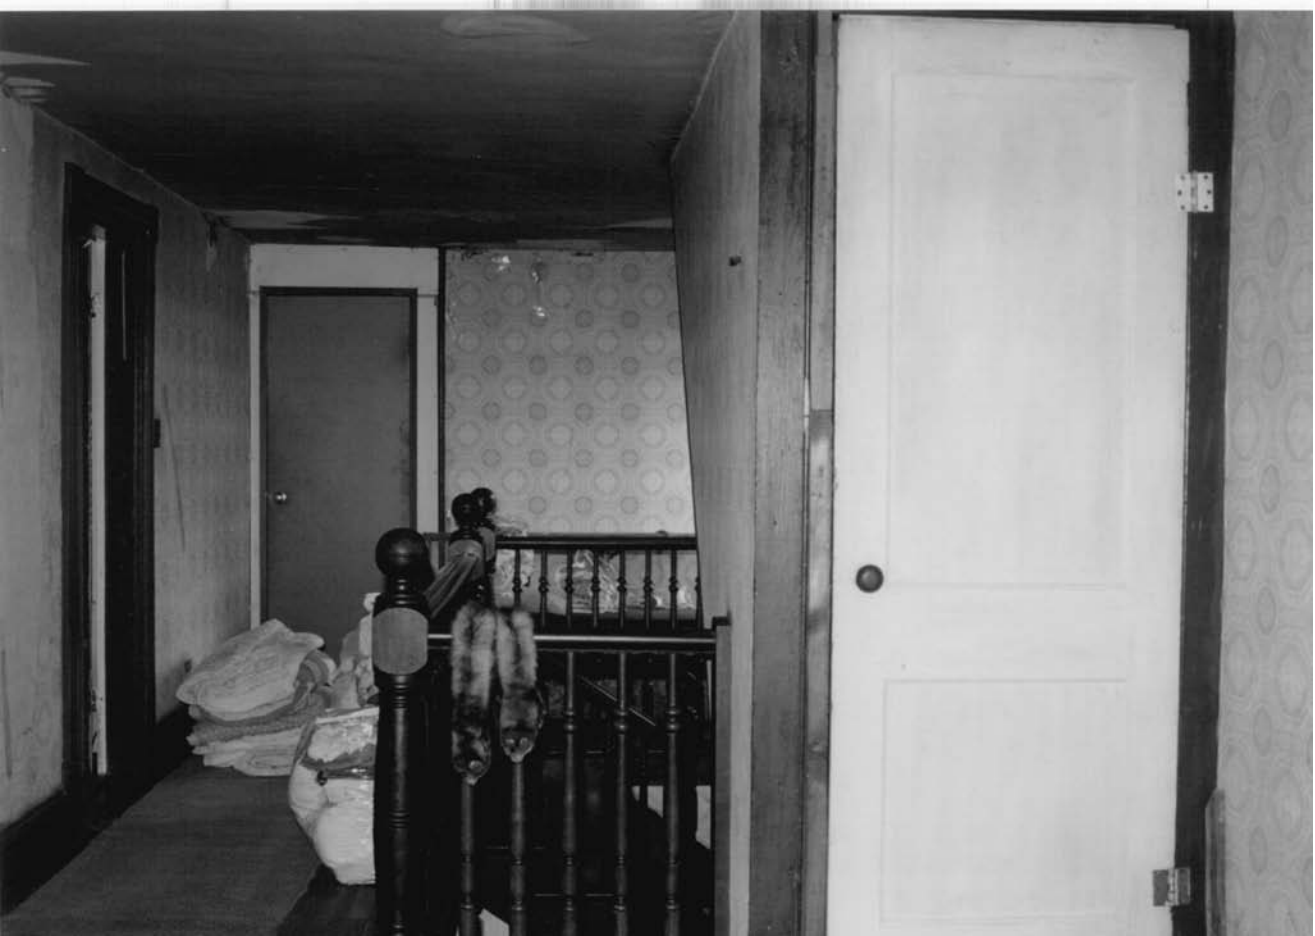
17/21

Passage - 2<sup>nd</sup> sty - VW N.

The second story floor plan is identical to the first story. The south passage has plain baseboard, and the architrave has a broken field with a beaded interior edge and plain corner blocks. The doors have two tall panels like those to the rooms below. The cast iron rim locks have porcelain knobs, and are not original to the doors, as there are ghosts of earlier locks. There is an enclosed winder stairway to the attic along the west wall. The stairway ascends from the north to the south. The doorway to the stairs has plain, mitered architrave with a beaded interior edge. There is one step set below the opening, and this opening never had a door. At the south end of the stairway is a closet with a door that has two tall panels. This door has been cut down on the bottom. It is hung on cast iron butt hinges that are heavily painted. The door framing is of reused material but the architrave is not. It is plain, mitered trim with a beaded interior edge, and does not have old mortises for hinges, while the door frame does. The stairway here originally ascended from the south to the north, and the floor at the southeast corner of the stairway enclosure has mortises for two rectangular-in-plan balusters that were originally located here. When the stairway was altered, most of the floor at the north end was replaced, and there is new flooring in the closet as well. The stairway is built with wire nails.

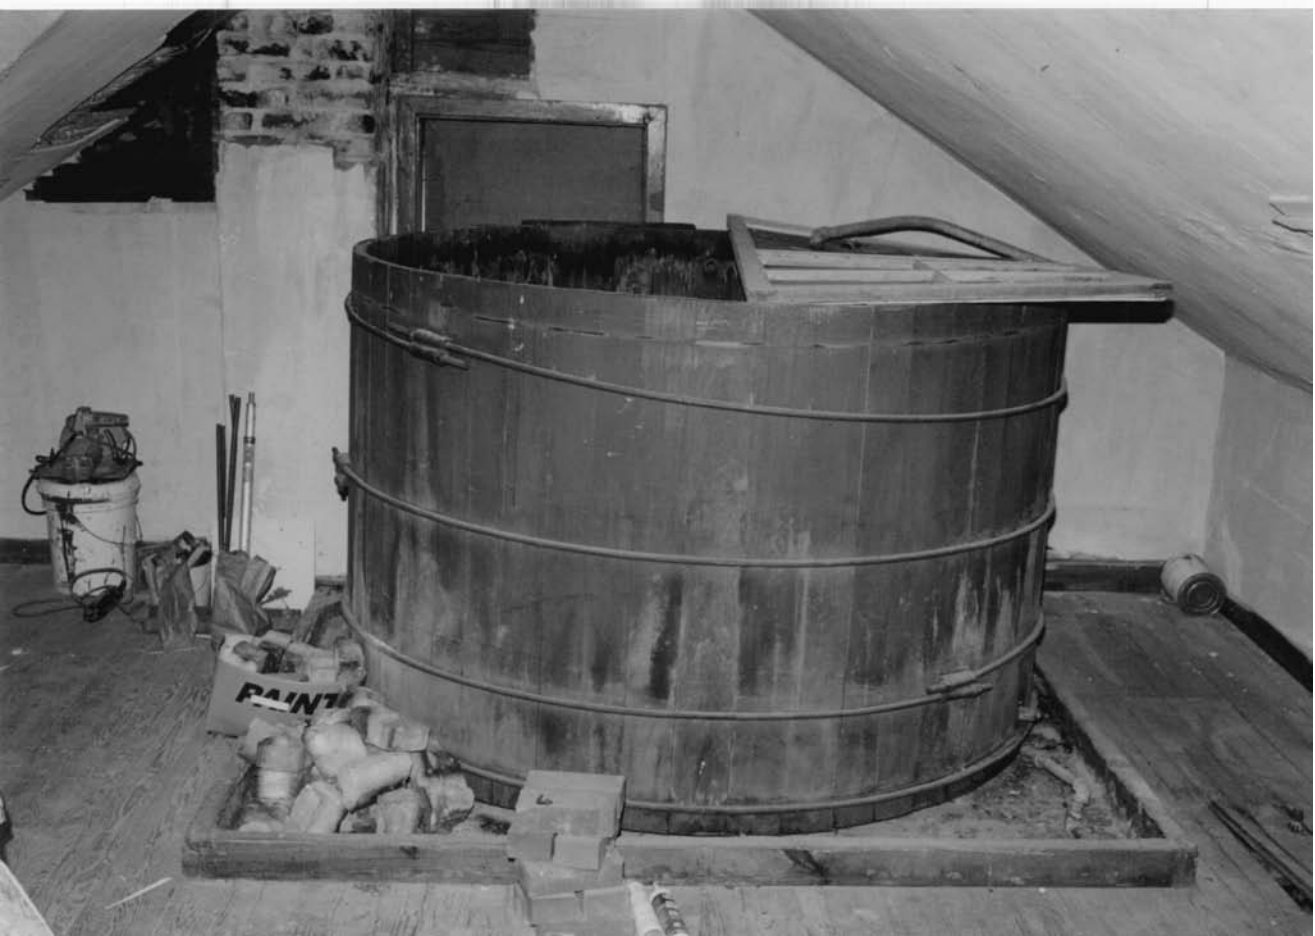
'8/21

Attic cistern in N. end

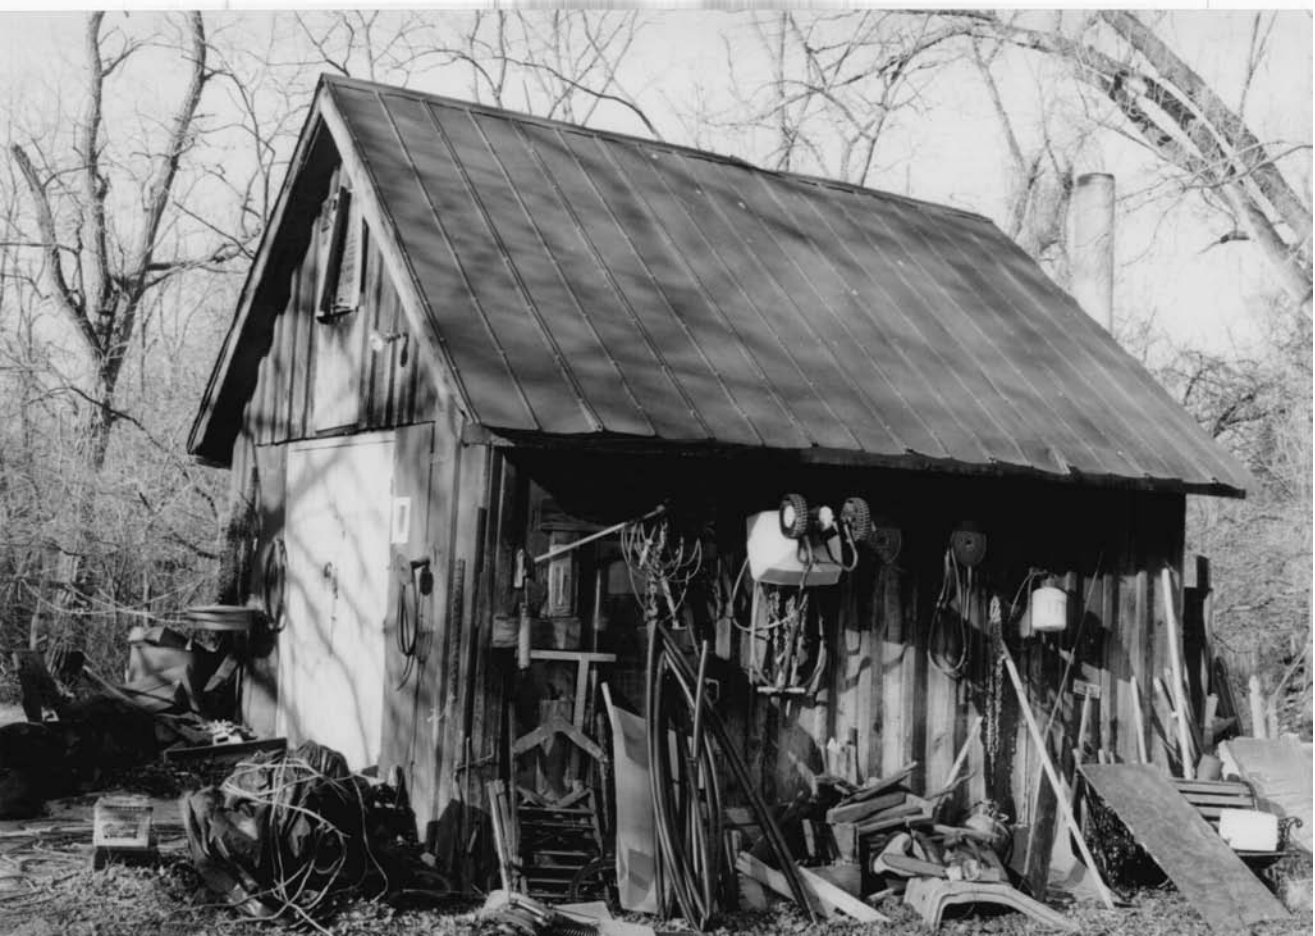
19/21

Wagon Shed - S&E ekeus

About 38 feet northwest of the house is a wagon shed. It is a one-story, one-bay by one-bay structure with a rubble stone foundation, board and batten siding, and a gable roof of inverted-v-seam metal with a north-south ridge. The south elevation has two new metal doors and plywood in-fill in an original opening, and a boarded-up opening in the gable end. The east elevation has a door, hung on butterfly hinges, set to the south. The north elevation has been patched with corrugated metal and it is not possible to tell if there were ever any openings here. The west elevation has a new window cut into it. The interior has sheetrock on the ceiling and walls, and a plywood floor.

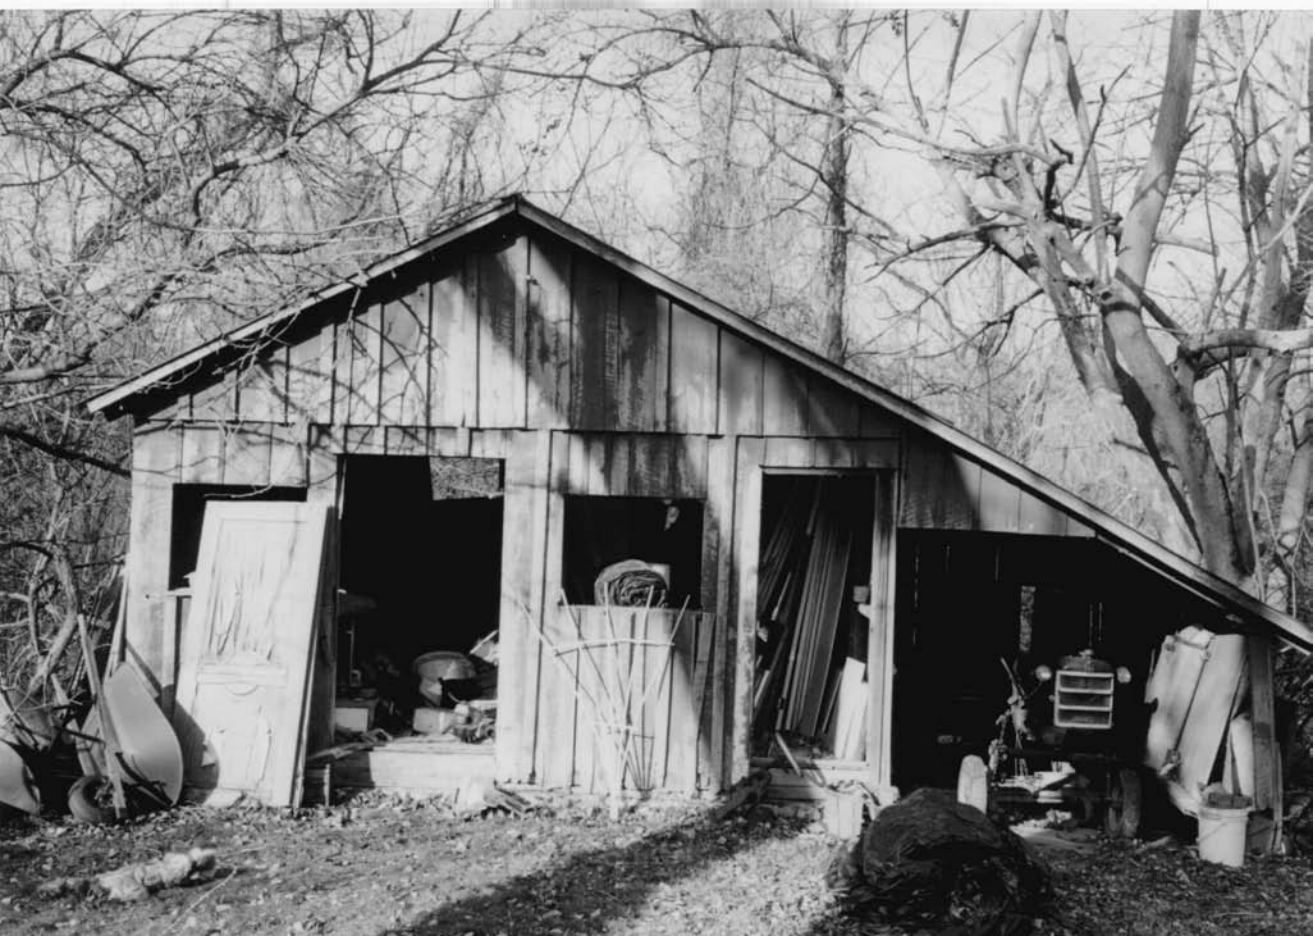
20/21

Granary, E. elev

There is a granary about 100 feet northwest of the house that is a one-story, four-bay by one-bay frame structure on a rubble stone foundation. The board and batten siding is circular sawn and fastened with wire nails, and the gable roof has inverted v-seam metal with a northwest-southeast ridge. The southeast elevation, from south to east, has a window opening, a door opening, a window opening, and another door opening. There are no openings on the southwest and northeast elevations. There is a shed roof addition on the northeast that is open on its southeast. The northeast wall of this addition is collapsing. The northwest elevation has two window openings. On the interior, the northwest two-thirds of the building is divided in half by a horizontal board and batten half wall, creating two bins. The northwest, northeast, and southwest elevations of the bins have horizontal board and batten siding that is about four-and-a-half feet high. The southeast ends of the bins would have been closed off with loose boards that slid down in grooves on each side of the bin, stacking one board on top of the other. There is a tongue-and-grooved wood floor that runs northwest-southeast. Beneath it is an ice house.
