HO-123

The George Chase Brick House  
Glenwood  
Private

INVENTORY FORM FOR STATE HISTORIC SITES SURVEY

The George Chase Brick House

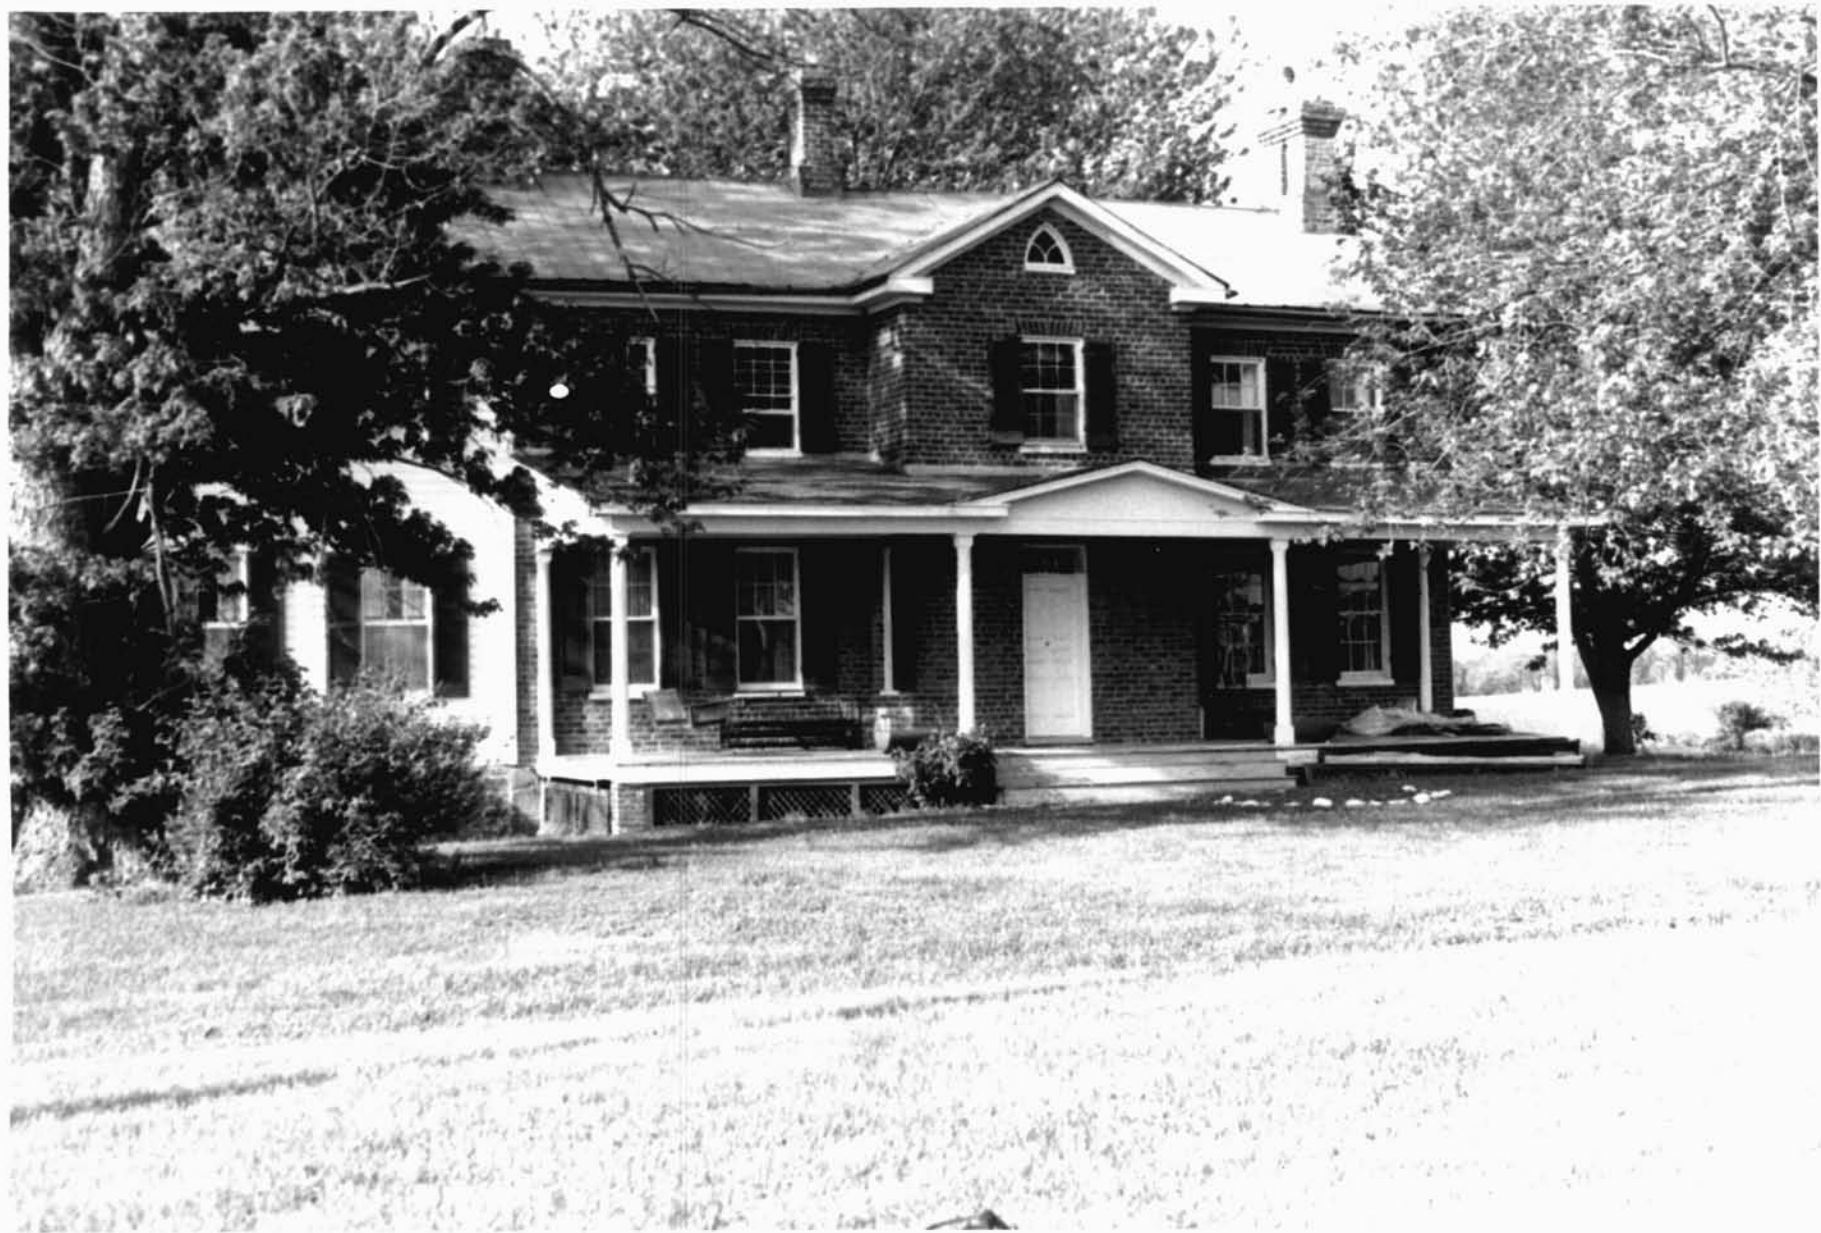
Ho-123  
George Chase Brick House  
South -  
May, 1979  
CB Thompson, ALCP

The brick section's south elevation features a central projecting bay with open bible and cross paneled rectangular entrance, surmounted by a three light transom and stretcher brick flat arched lintel, crowned by an intersecting gable, holding a Gothic arched, three light attic window. A one story high, hipped roof, open porch with central pediment, runs along this brick section's south elevation.

A one story high, hipped roof, open porch, with pediment decorating its roof-line at the central entrance point, and supported by wooden posts runs along the entire south elevation of the brick section.

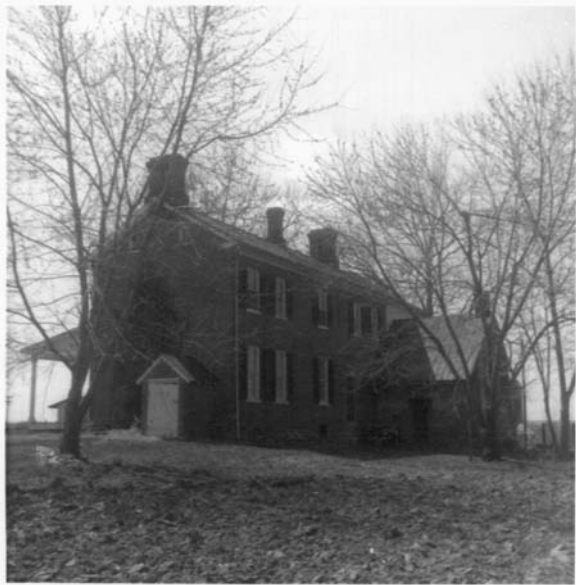
It is a five bay wide, one room deep, two story high, gabled roof (running east-west) brick (laid in English garden wall brick bond) house, resting on a stone foundation, with wide, brick, corbeled edged chimneys, inset into its east and west walls and another square, brick chimney west of center. A two bay wide, one room deep, two story high, gabled roof (running east-west) German siding frame kitchen wing, resting on a stone foundation, is placed along the building's west wall. Extending north, from the center of the north wall of the brick-frame building is a one-story high, rectangular, one room deep, gabled roof (running north-south) old stone kitchen wing, with square brick chimney inset into its north wall.

Fenestration is proportionally scaled, vertically aligned and double-hung, holding six-over-six lights, underlined by projecting wooden sills and decorated with green shutters. Those windows of the brick house are also decorated with stretcher brick, flat arched lintels.
