Ho-138  
THE GERWIG-LINTNER HOUSE  
Ellicott City  
Private

circa 1830

The Gerwig-Lintner House

10101 Frederick Road

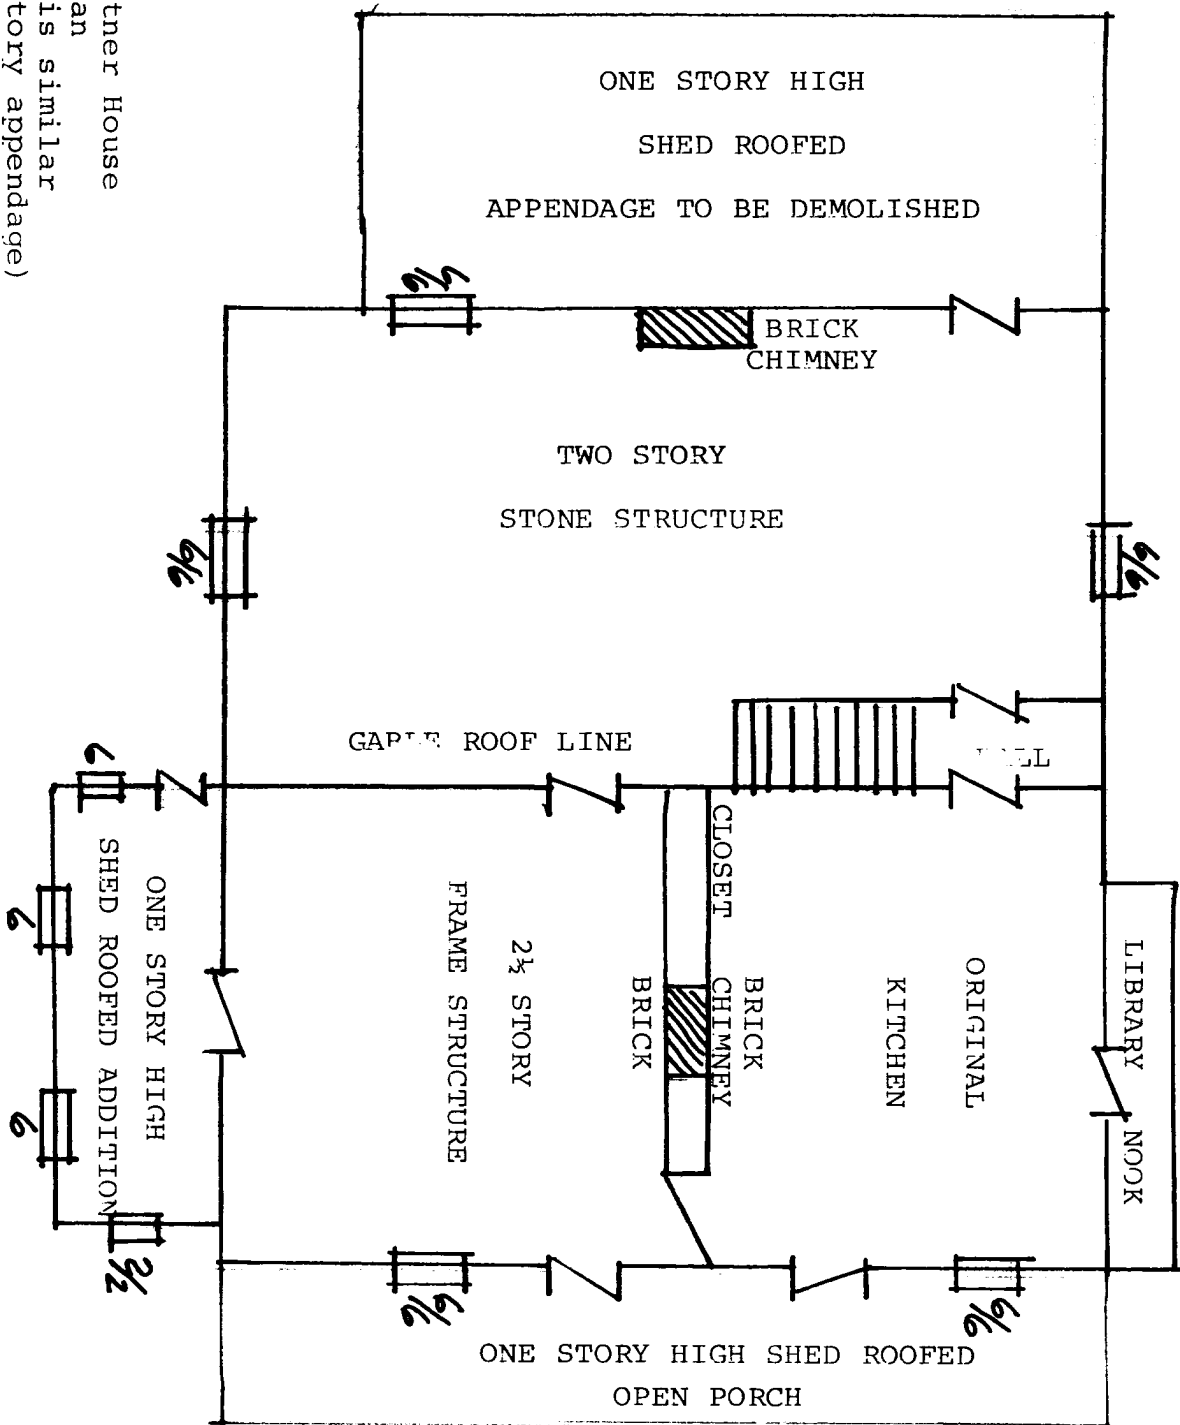
Figure 1  
 HO-138  
 The Gerwig-Lintner House  
 First Floor Plan  
 (Second floor is similar  
 without one story appendage)

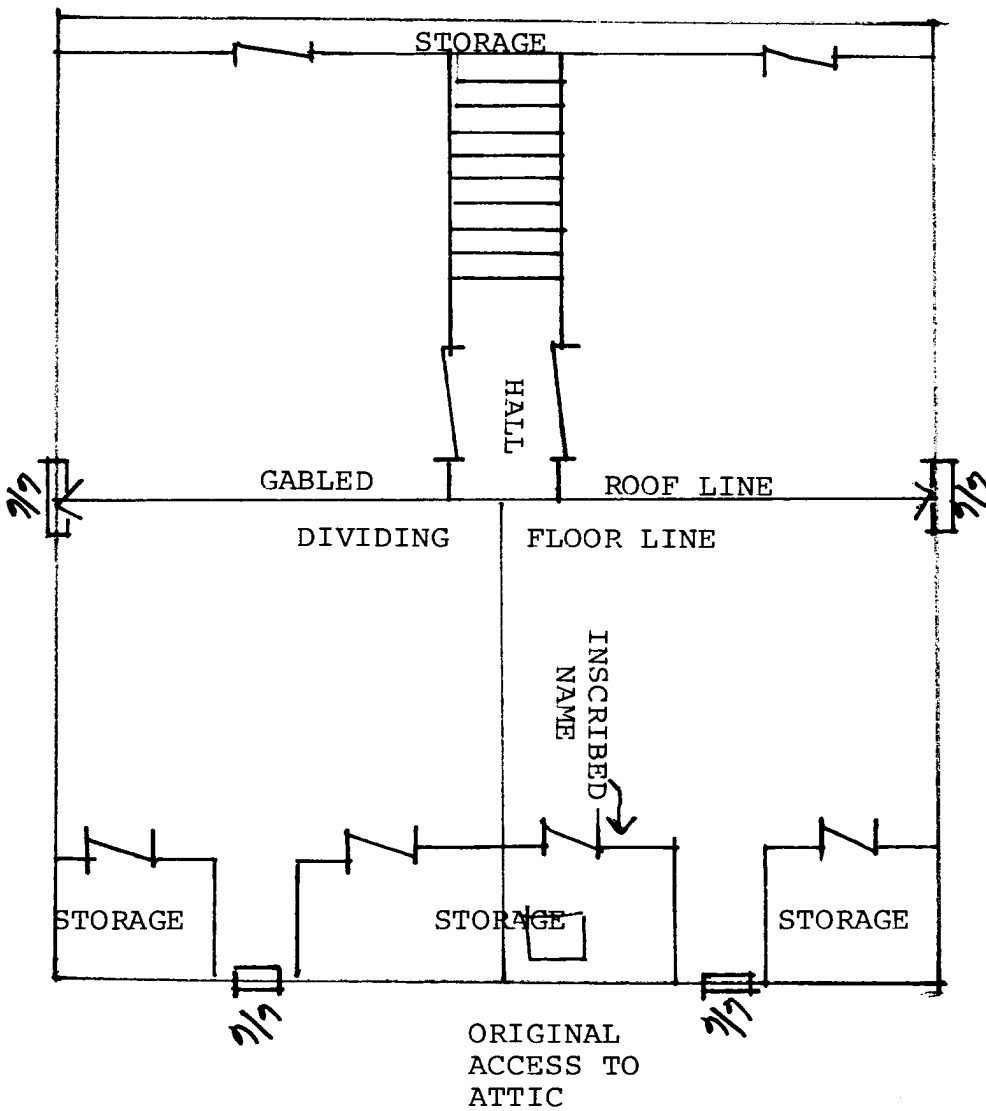
Figure 2  
Ho=138  
Gerwig-Lintner House  
A floor plan of attic

house leading to the second floor which holds two large bedrooms over the frame first floor and a bedroom and large bath over the stone first floor. The attic is divided into two large rooms with storage space on each side of each dormer and along the south side of the eave line.

A name, J. Yingst, 1871, is inscribed on the inside of the batten wood door of the storage area on the east side of dormer window in the west room. This probably indicates the date when the present high pitched gable roof was added to cover both the stone and frame sections of the house. The roman arched windows, indicative of the romanesque revival of this period, further substantiates this. A hole, in this same storage area floor, indicates the initial access to the earlier attic over the frame building.
