MARYLAND HISTORICAL TRUST

HO-287
Woodbine
District 4

INVENTORY FORM FOR STATE HISTORIC SITES SURVEY

Cattail Farm

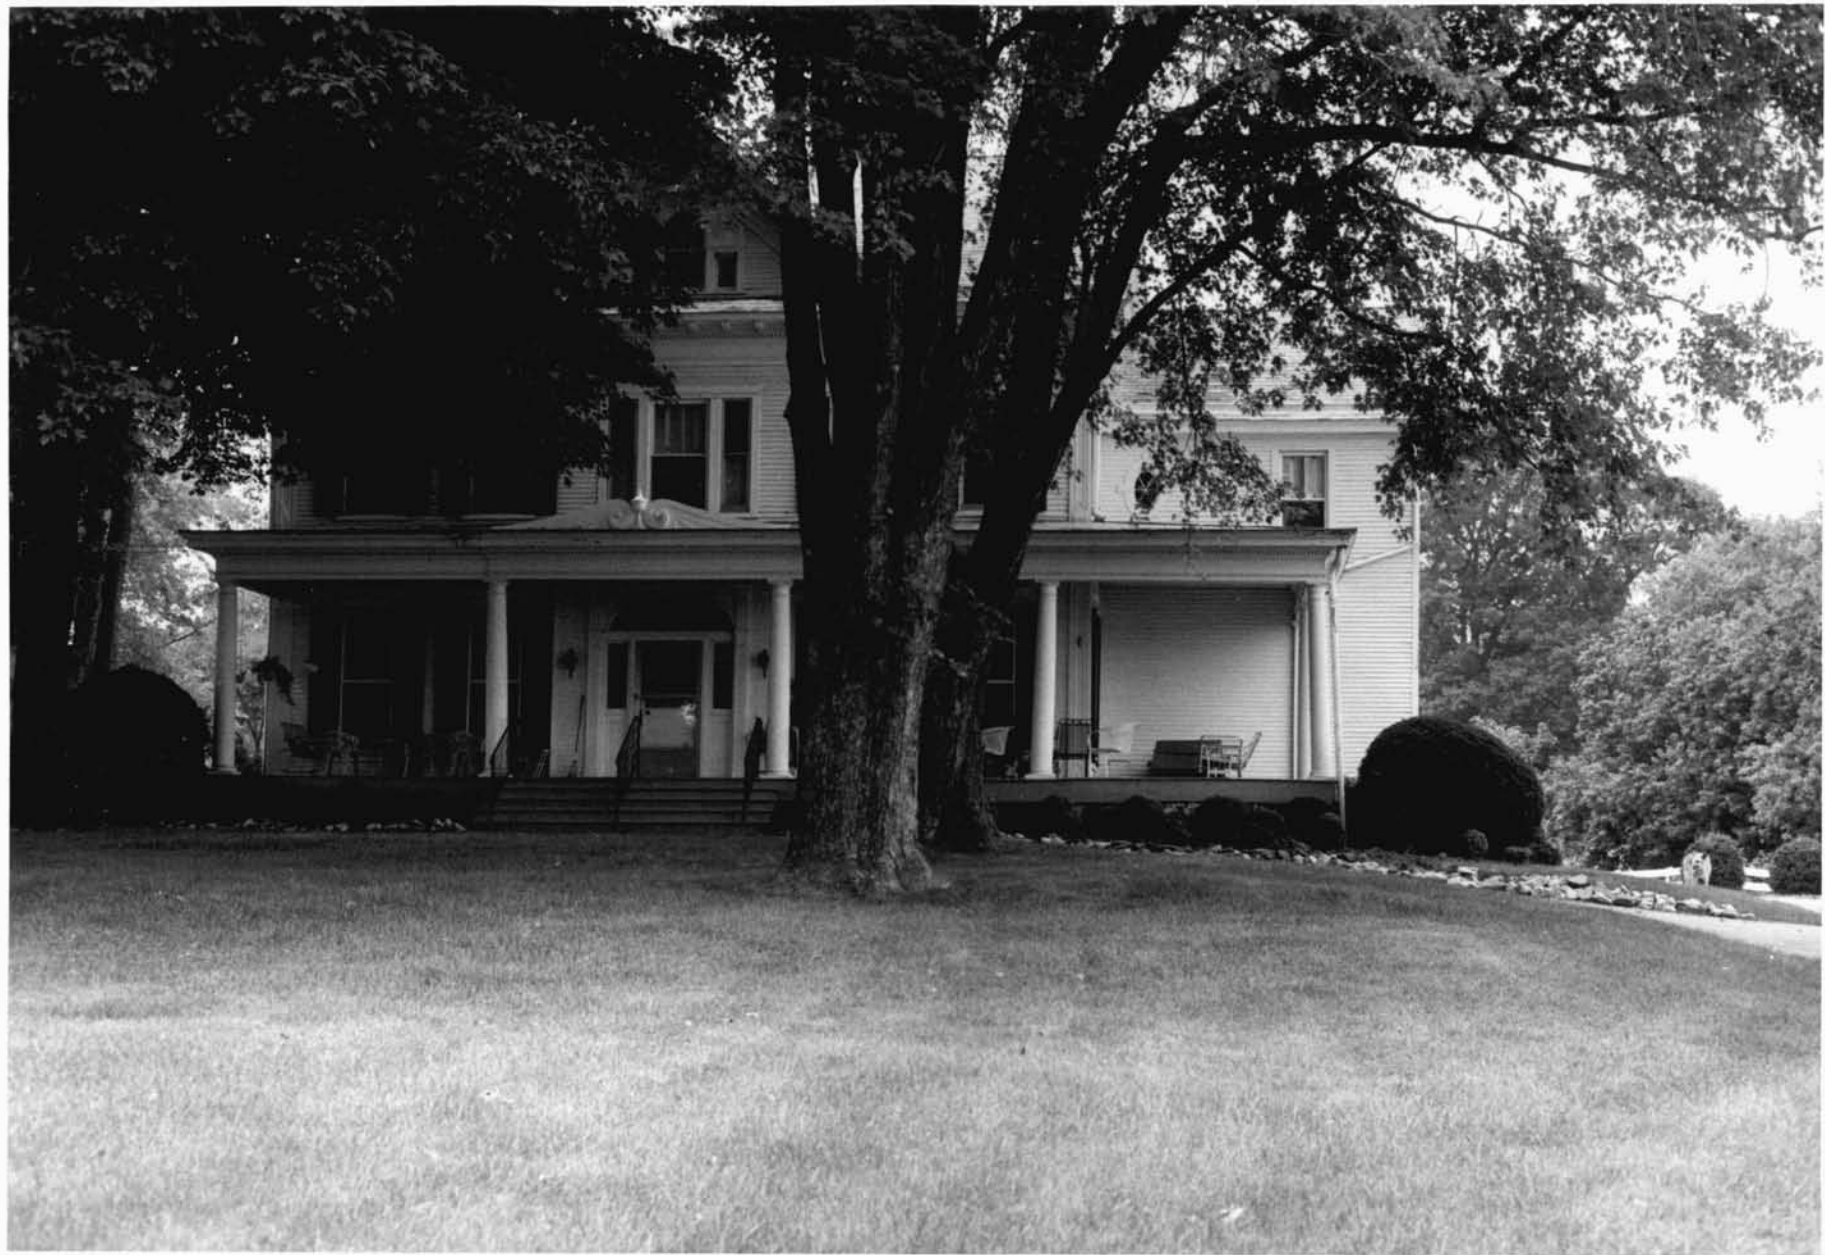
Photograph number: 1 of 1

THE EAST FACADE

The main building block features a slightly projecting, central, first floor entrance bay, which holds a wide, central, rectangular, one light entrance door, flanked by vertical leaden paned, side lights and surmounted by a leaden paned fan light. Fluted, flat pilasters flank this entrance, rising to square blocks, upon which rest fluted pilasters, which in turn hold a cornice. Two tall, floor-to-ceiling, rectangular, double-hung windows, holding one-over-one lights, are surmounted by flat wooden lintels with cornices and decorated with wooden shutters. A one story high, hipped roof, open porch runs along the entire east elevation of the main building block, with scroll work directly over the central entrance way. It also runs along almost all of the east wall of its service wing. The porch is held by six doric columns and two pilasters

and features a row of dentils, which decorate its box cornice.

The second floor central bay of the east facade holds a tripartite window composed of a large, one-over-one light, rectangular window, flanked by tall, narrow, rectangular, one-over-one light windows, separated and flanked by pilasters, surmounted by a flat lintel with a cornice. Two second floor windows, proportionally scaled and vertically aligned to those below, rest on each side of this tripartite window.

View: East

Photographer looking: West
