HO-319, The Tilghman-Ferraro House 5741 & 5745 Main St., Elkridge Surveyed by: Kristin Hill February 2003

HO-319, Tilghman-Ferraro House Elkridge, Howard County, MD USGS Topographic Quadrangle, Relay 7.5 Minute Series, 1957 (PR 1966 and 1974)

INVENTORY FORM FOR STATE HISTORIC SITES SURVEY

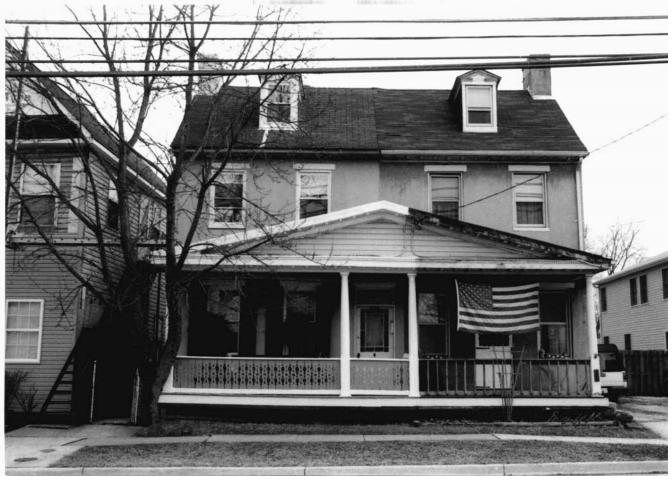
40-319 The Thomas Temper Tongs STATE - 2795 Main St. I'm y Lind & Article Day Lt Howard Courty MD February 2003 heapthe at ME 1400 Torth torane 7 1 /

The front (north) façade has been stuccoed and painted two different shades of gray. The fenestration of the first story shows the alterations which occurred around the end of the 19th century when the building was converted into a duplex. The eastern part of the building retains the original fenestration – two windows in the easternmost two bays and a door in what would have been the center bay. But the western half of the first story has been altered, and the original two window openings have been replaced by two narrower windows flanking another door. On the second story, four windows were originally aligned over the original four window openings on the first story. All of the original windows in the front façade have been replaced with vinyl windows which are all 1/1 sliding sash. Some of the replacement windows on the eastern half of the house have snap-in 6-light muntins. The door in the original centered entry is a Queen Anneera replacement with a single light transom. All of the windows and the doors have heavy rectangular wood lintels. The two gabled roof dormers have raking cornice detail in the pediment but the windows themselves are vinyl replacements. The cornice has delicate modillion and dentil detail indicative of the Greek Revival era. The single story full-width pedimented front porch dominates the front façade and the modillion and dentil decoration is repeated in the raking cornice of the pediment. Four slender Tuscan style columns support the porch and a pierced Queen Anne-era balustrade on the eastern half of the porch. The balustrade on the western half of the porch has been replaced and is currently composed of pressure treated 2x4's with 1x1 balusters.
