HO-423  
THE BRICK HOUSE FARM  
Private  
Ellicott City

INVENTORY FORM FOR STATE HISTORIC SITES SURVEY

Brick House Farm

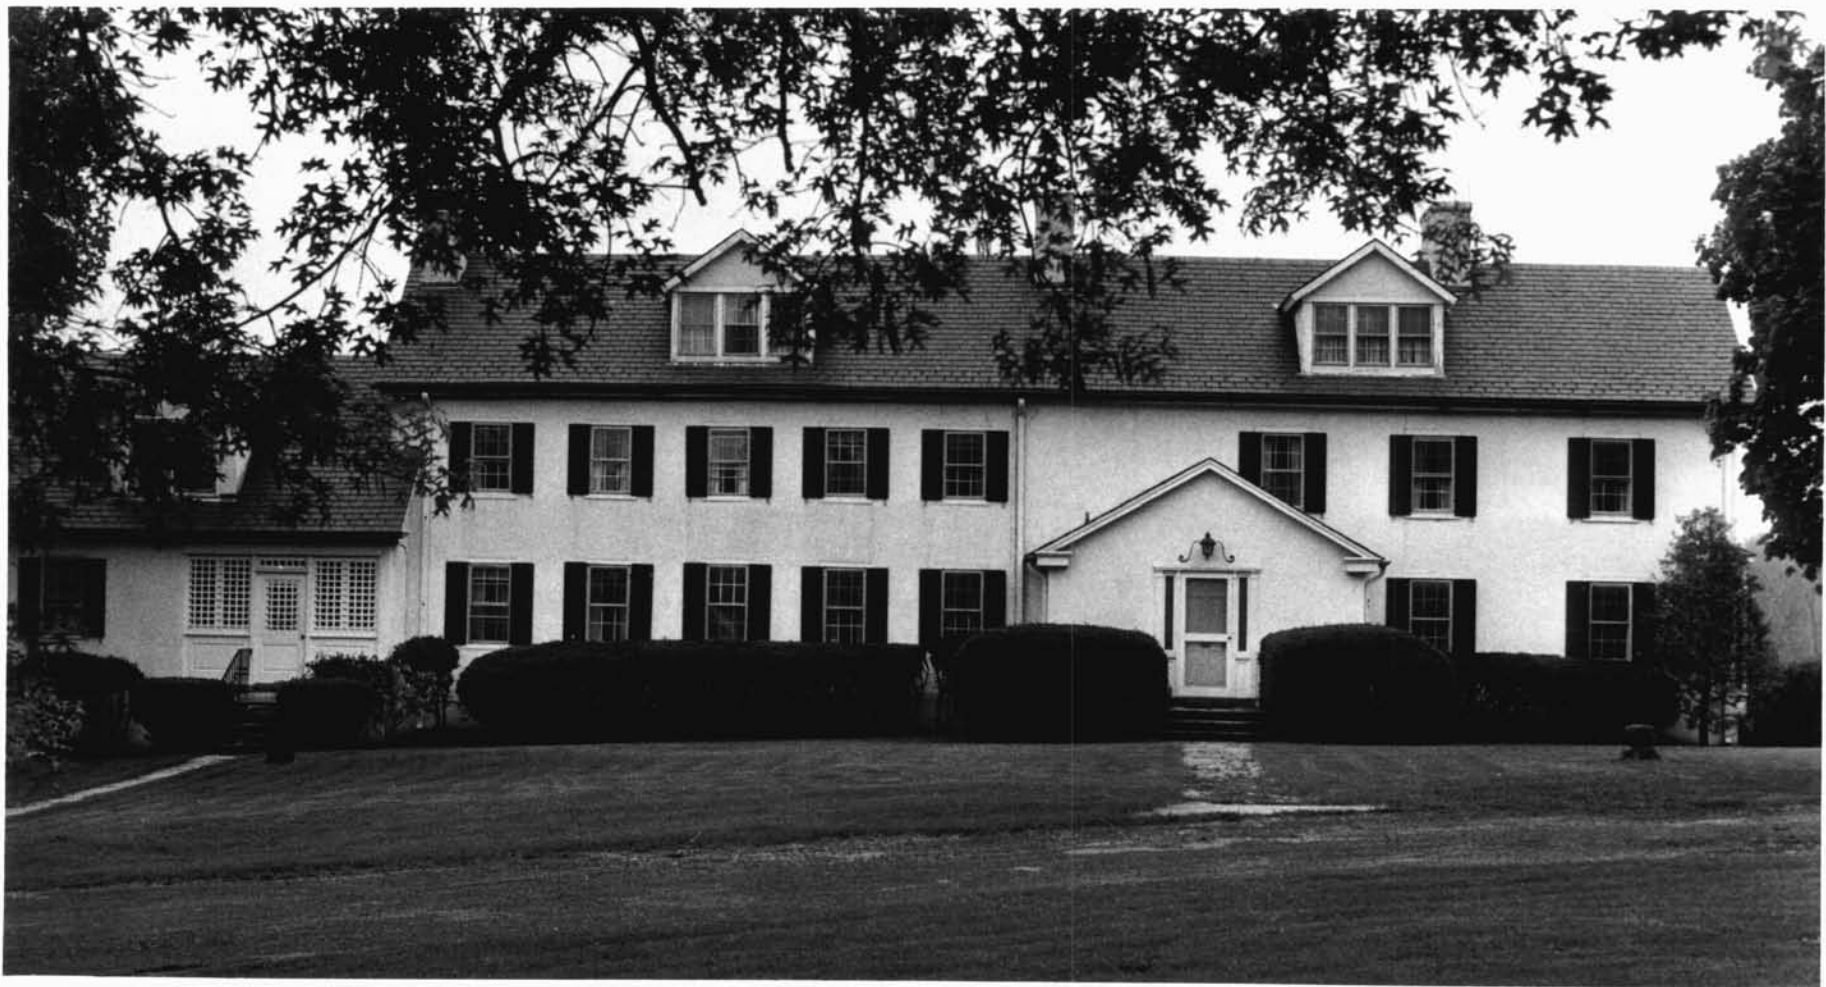
HO-423  
BRICK HOUSE FARM  
MAY-1978  
CB THOMPSON, AID

The Brick House Farm faces north on the east side of Sheppard Lane, 7/10 of a mile south of its intersection with Folly Quarter Road. It is approached by a long drive which turns south as it passes the frame tenant house on the north side of the driveway. This drive then becomes circular on the north or main elevation of the house which was once a part of Doughoregan Manor whose five bay, 2 story high section was constructed first. It is now a long, narrow, nine bay wide, one room deep, two and a half story high, slate gabled roof (running east-west), stuccoed structure which features three wide brick chimneys covered with stucco and on its north elevation two gabled roof dormer windows holding tripartite windows, each component a rectangular six-over-six light window separated and flanked by flat pilasters, with the whole surmounted by a flat wooden lintel. A one and a half story high, slate gabled roof (running east-west) stuccoed east wing extends from the east wall of the two and a half story house. A slate gabled roof dormer is centered into its north wall, holding a double window, each component a rectangular, double-hung window, holding six-over-six lights. A stone stoop, composed of five steps leads to a westbay entrance to this wing, whose first floor west corner holds a latticed, overglass vestibule.

The main gabled roof entrance vestibule is located in the fourth west bay of the main building. Three wide stone steps lead to the open bible and cross paneled main entrance door which is flanked by leaden paned vertical lights separated from the entrance, and flanked by, flat and fluted pilasters, respectively. A cornice crowns the entire entrance frame.

Fenestration is proportionally scaled and vertically aligned. All the windows on the north elevation are rectangular and double-hung, holding six-over-six lights. They are decorated with flat wooden lintels and sills.
