HO-468

The Sarah Richardson Farm (The Lambing Meadow Bank Barn)
Clarksville,
Private

INVENTORY FORM FOR STATE HISTORIC SITES SURVEY

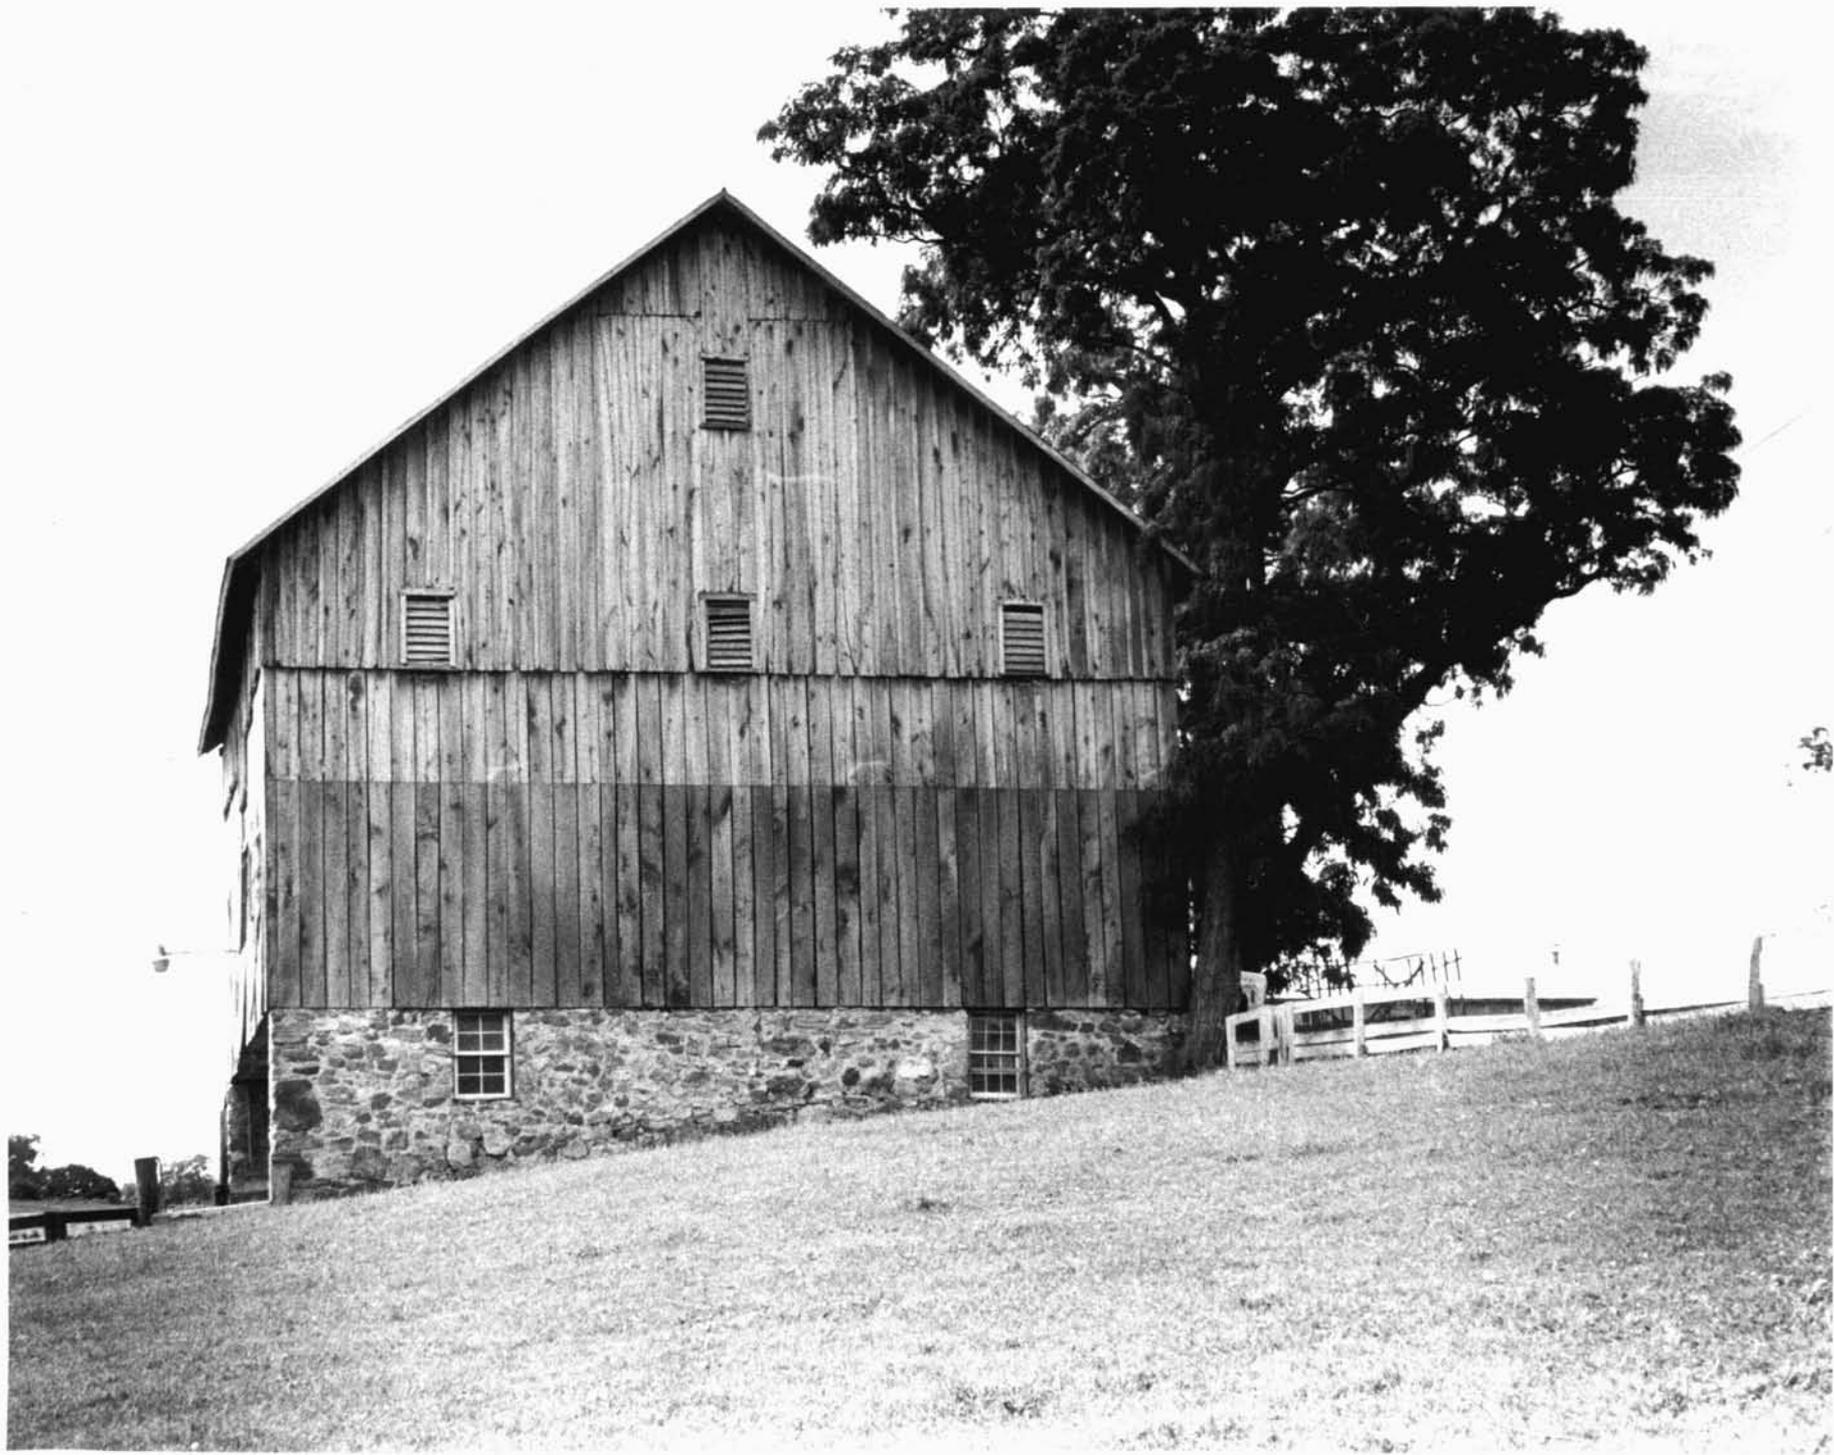
Ho-468
THE LAMBING MEADOW
BANK BARN
JUNE 1978 EAST
CB THOMPSON, AIP

The Bank Barn is built into the slope of the land so that its north wall is almost entirely insulated by the earth, while the foundation of its south wall is relatively open and almost a full story high.

The barn features a stone foundation, frame walls of twelve inch barn siding, a gabled roof (running east-west), two large 12" x 6" hand-hewn first floorsupporting beams and other hand hewn, chestnut four by eight inch beams. Two louvered rectangular windows lying on the east and west sides of the north and south walls are an additional feature of the barn,as well as the tall wide north and south openings.
