H0-490

Lisbon Post Office (1978)

circa 1922

INVENTORY FORM FOR STATE HISTORIC SITES SURVEY

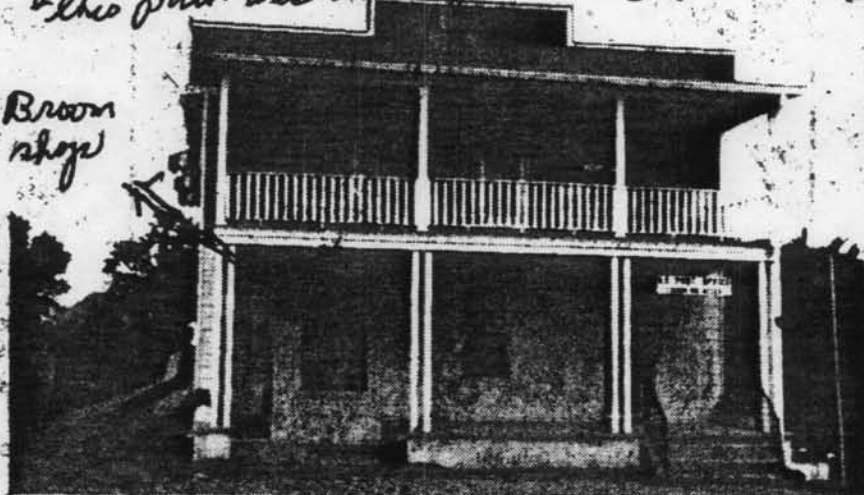
The post office was entered from East side until the porch could be put in and other work done inside.

A picture of Post Office when bought from Mr. Grimes by Frank & Reba Warner in Sep 41

order this porch was ground no floor and after Post Office came to Mrs Warner Dec 1, 1941 this porch was built finished 1955

Broom shop

Public entrance to office

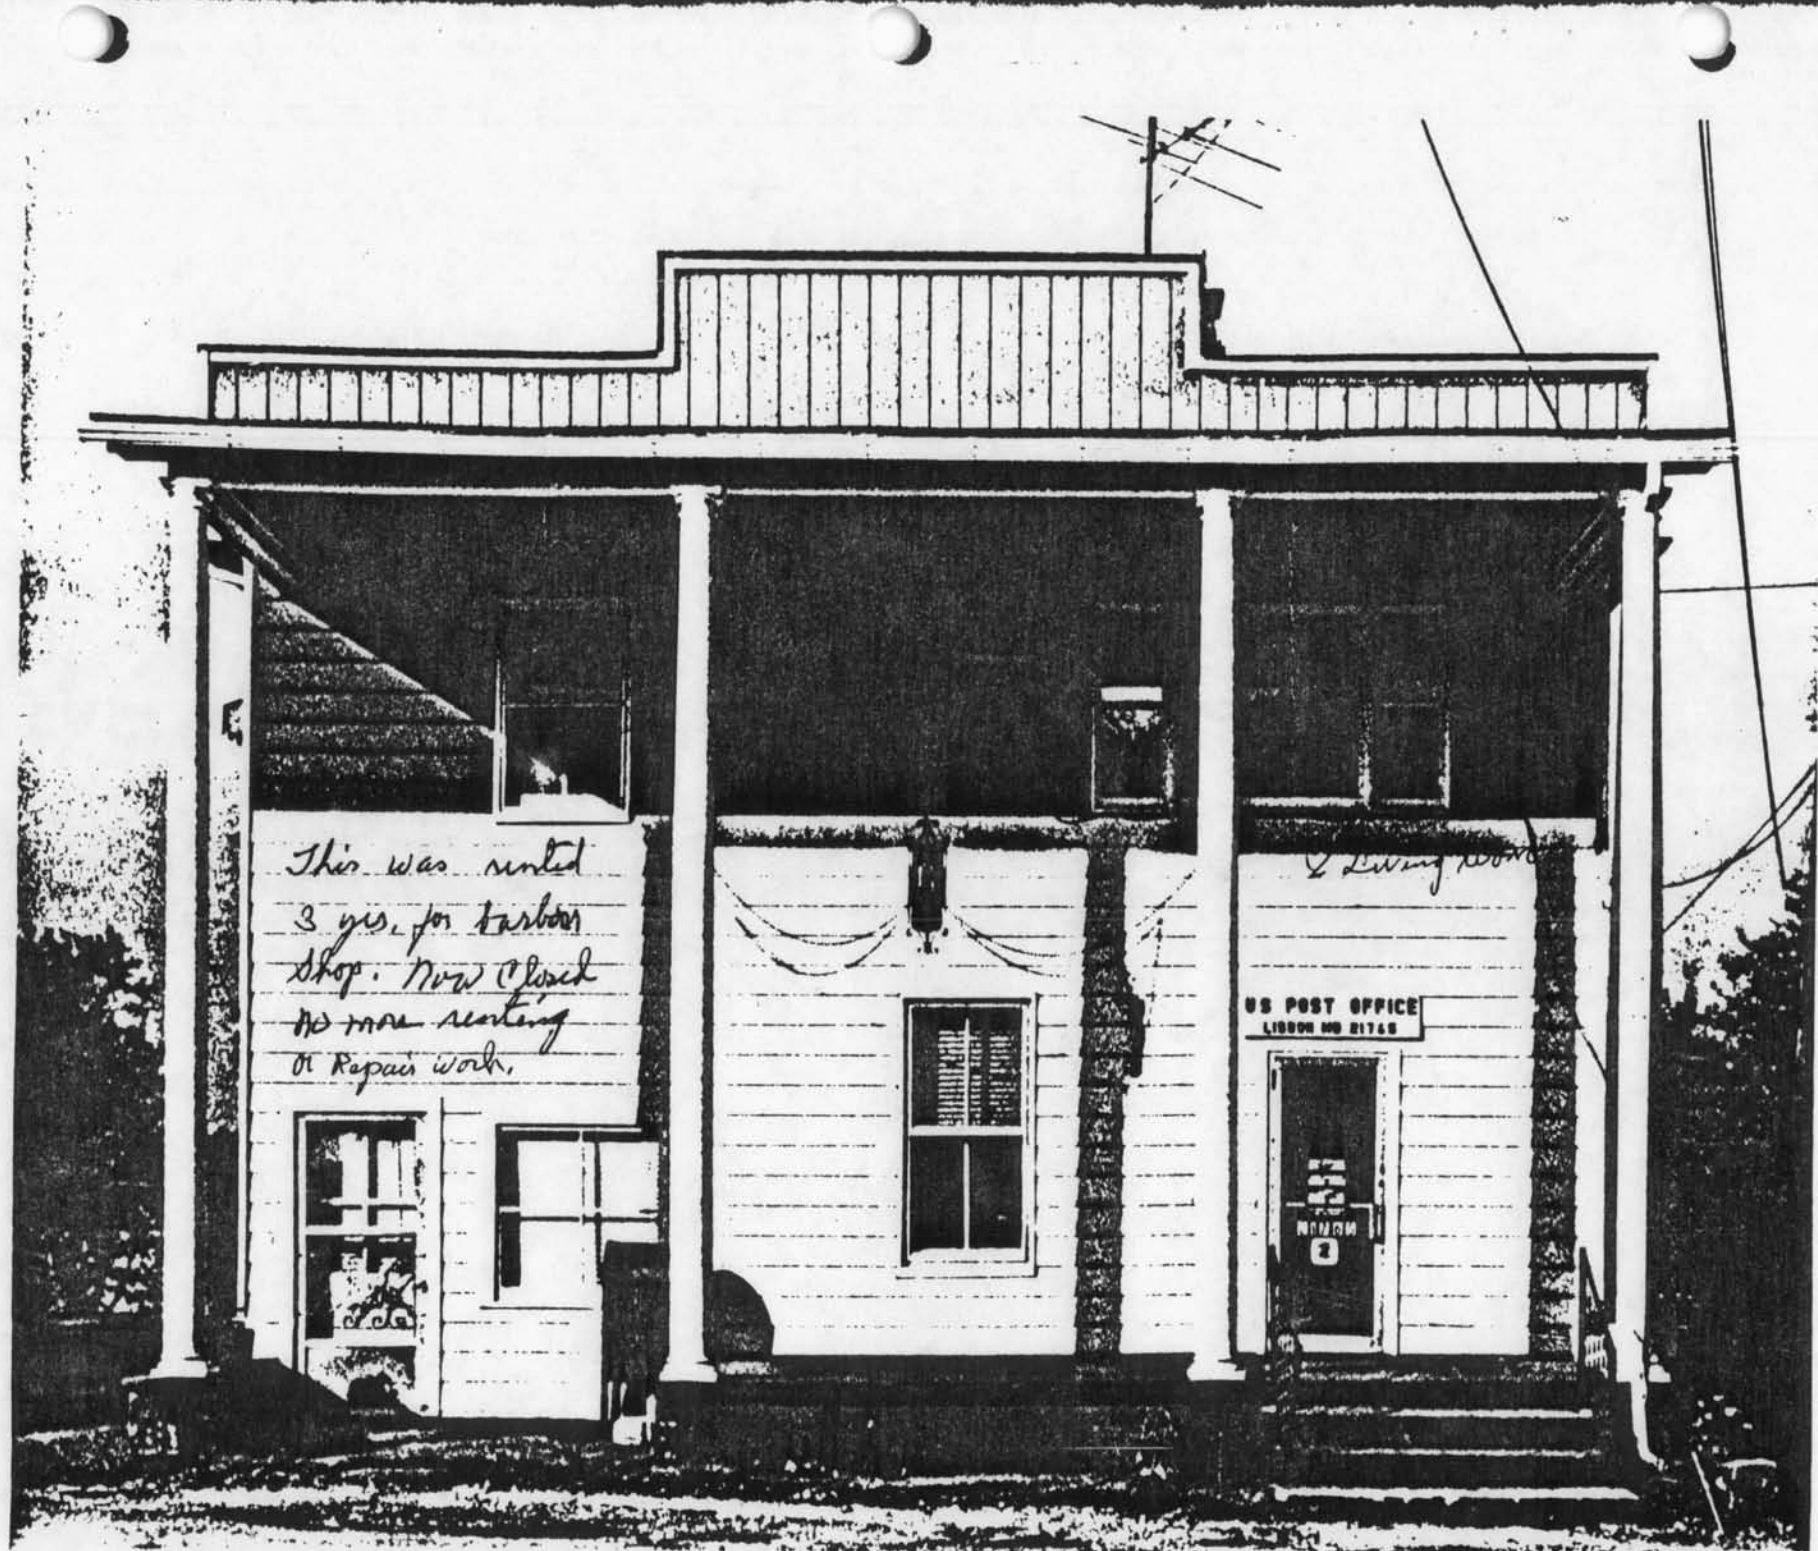
Lisbon's present Post Office is reminiscent of early buildings found in the old West.

The presnet first floor entrances, as well as the parapet, appear the same in the photograph featured in The Times, Ellicott City article in three parts, "Out of the Past: Lisbon," written by Mrs. Celia Holland, local historian, before the 1974 remodeling.

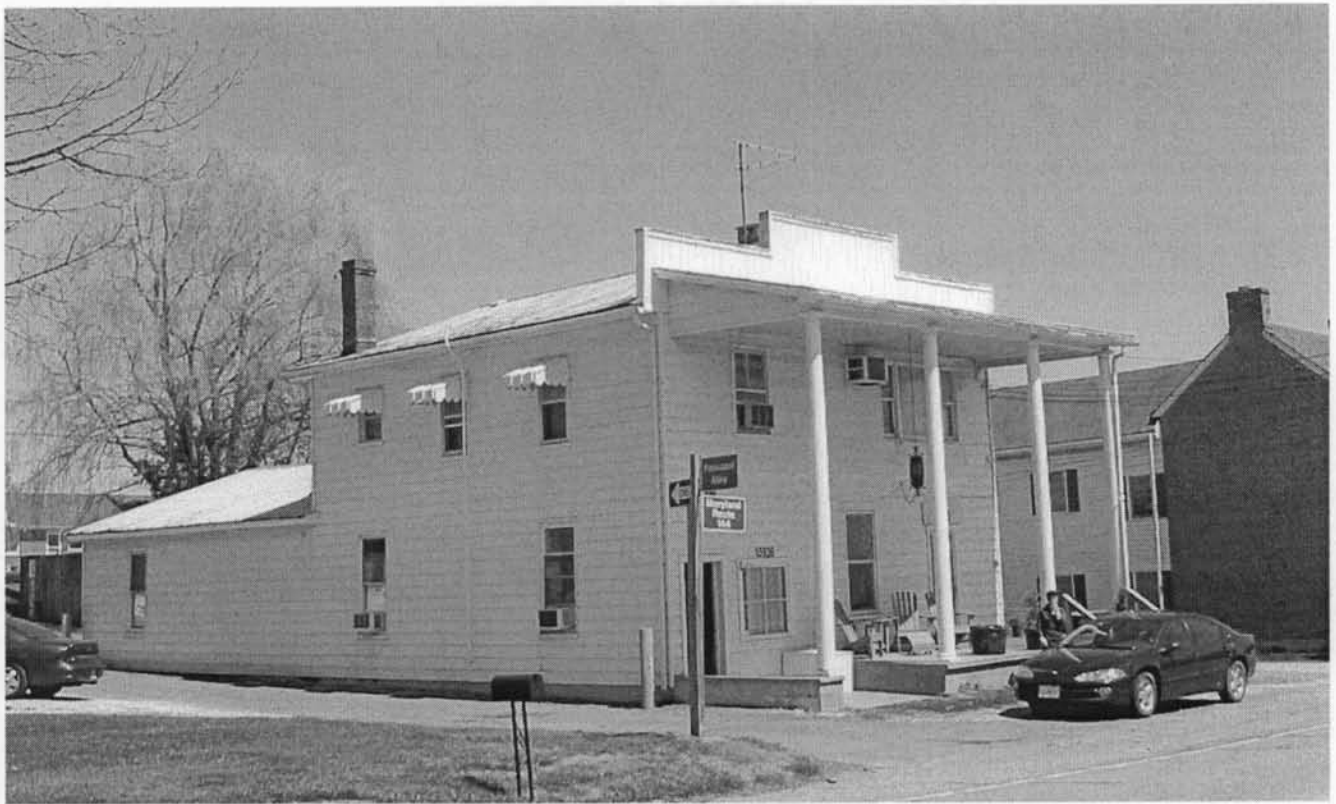
HO-490
Lisbon Postoffice

Jennifer K. Cosham
April 16, 2004
Digital color photo on file at MHT

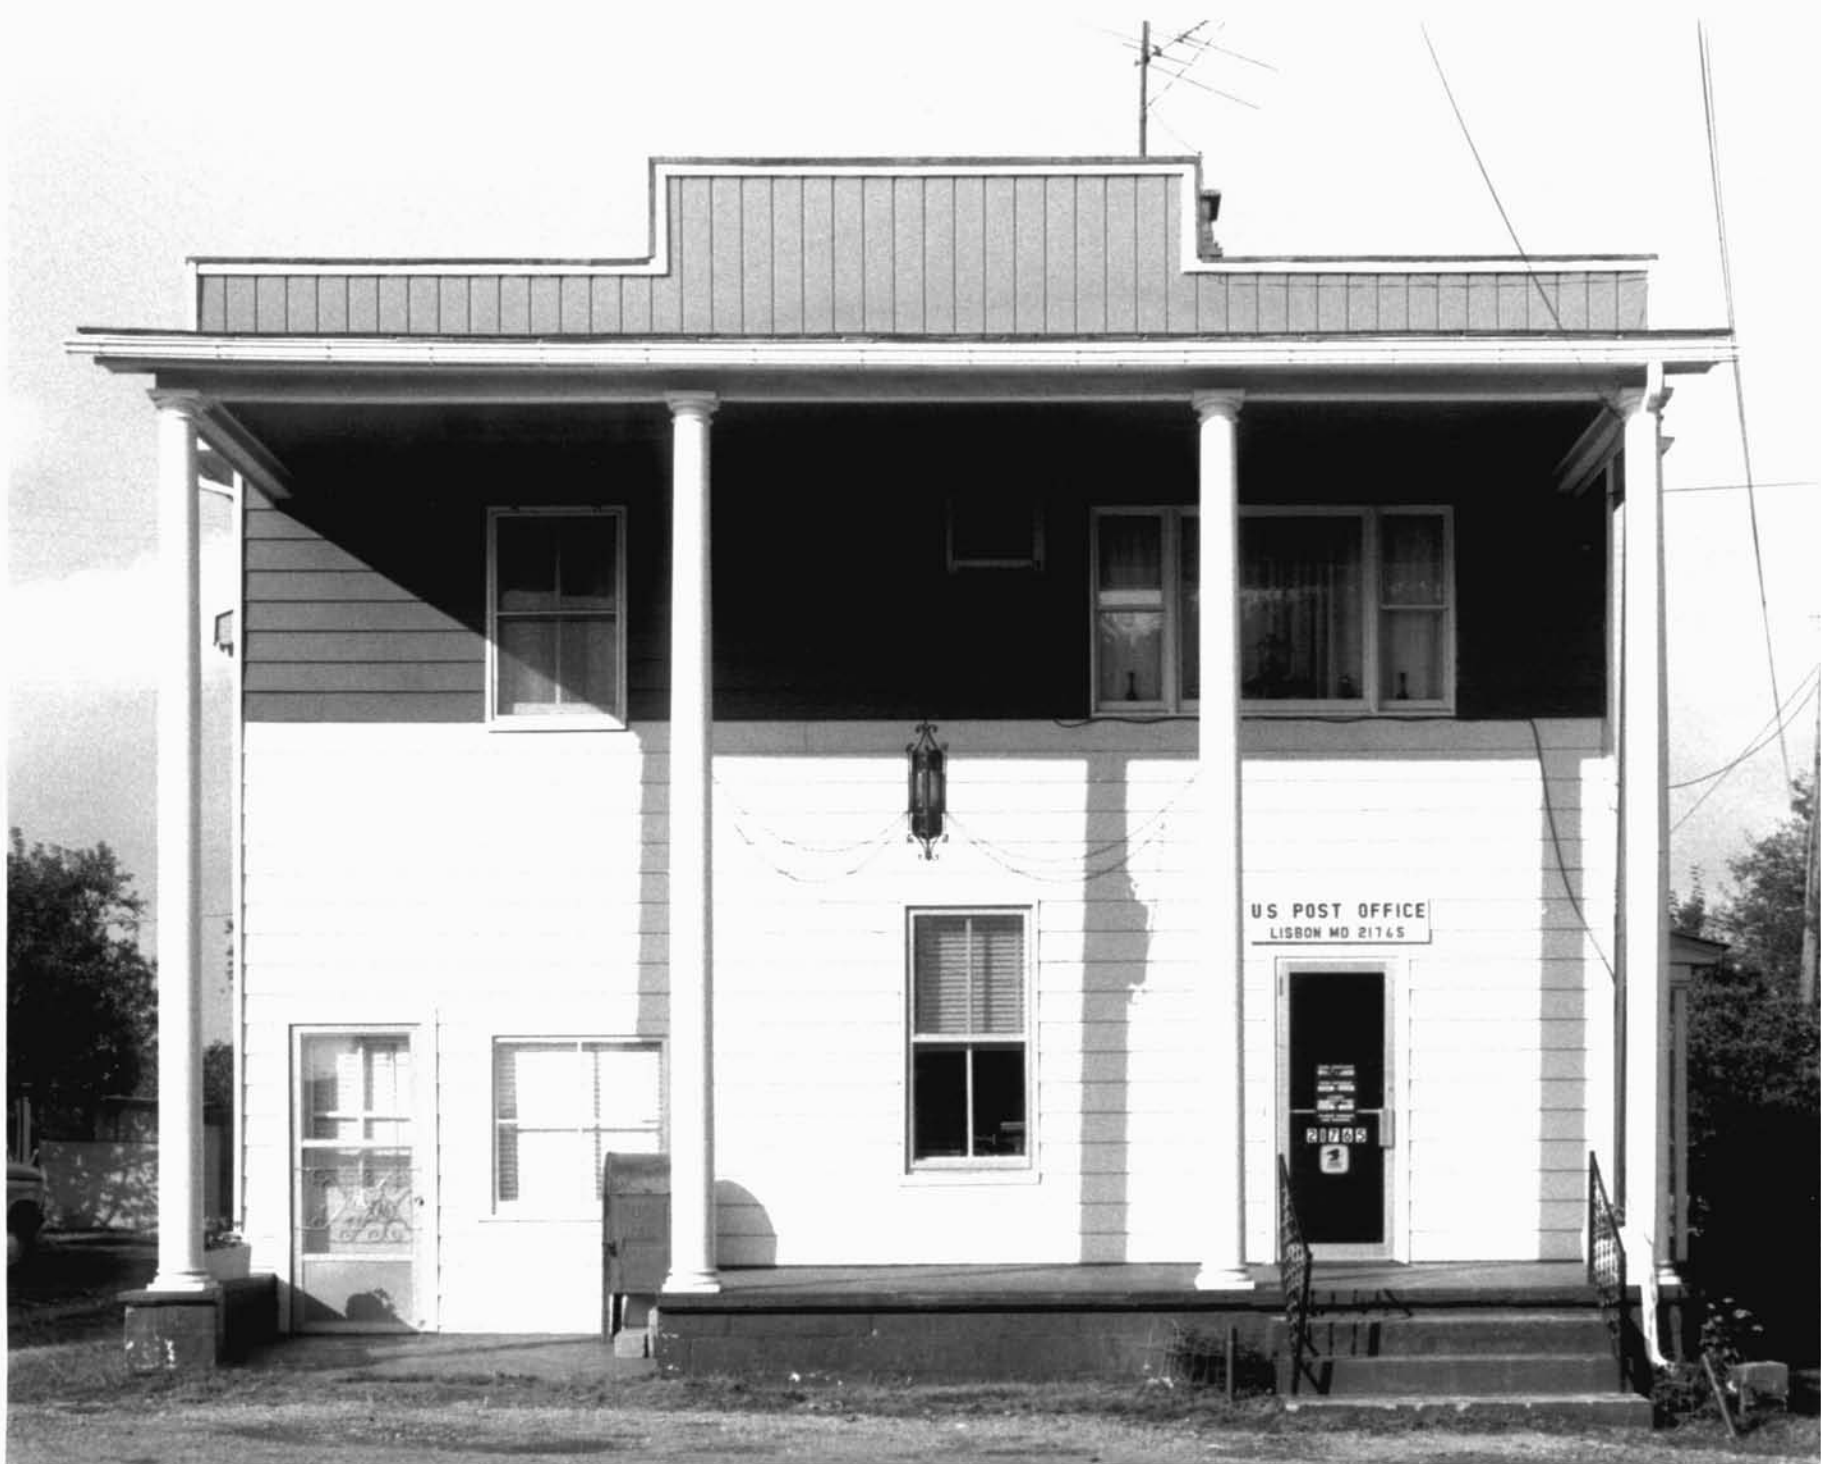
HO-490
WISBON P.O. BLDG,
SOUTH
CB THOMPSON, A.I.C.P

US POST OFFICE
LISBON MD 21745

The Lisbon Post Office Building faces south on the northeast corner of Route 144 and Pancoast Alley. It is a three bay wide, three bay deep, two story high, gabled roof (running north-south) frame building (covered with aluminum siding), whose south elevation features a two story high, shed roofed portico, supported by four doric columns, as well as a parapet which gives the building the feeling of a mid-west town. Rectangular, first floor south entrances are located on the east and west sides of the south elevation which features a four light, squarish window east of the west corner entrance and a two-over-two light, double-hung rectangular window, just west of the east corner south entrance. Four poured-in-place concrete steps lead to the cement landing, running along three fourths of the south elevation. Above rest two second floor windows; on the west a rectangular, double-hung, two-over-two light, window; on the east a picture window, flanked by rectangular, double-hung windows of the same height, holding one-over-one lights.
