Ho 545

John Layman Farmhouse

DRAFT--JOHN LAYMAN HOUSE

**Maryland Historical Trust
State Historic Sites Inventory Form**

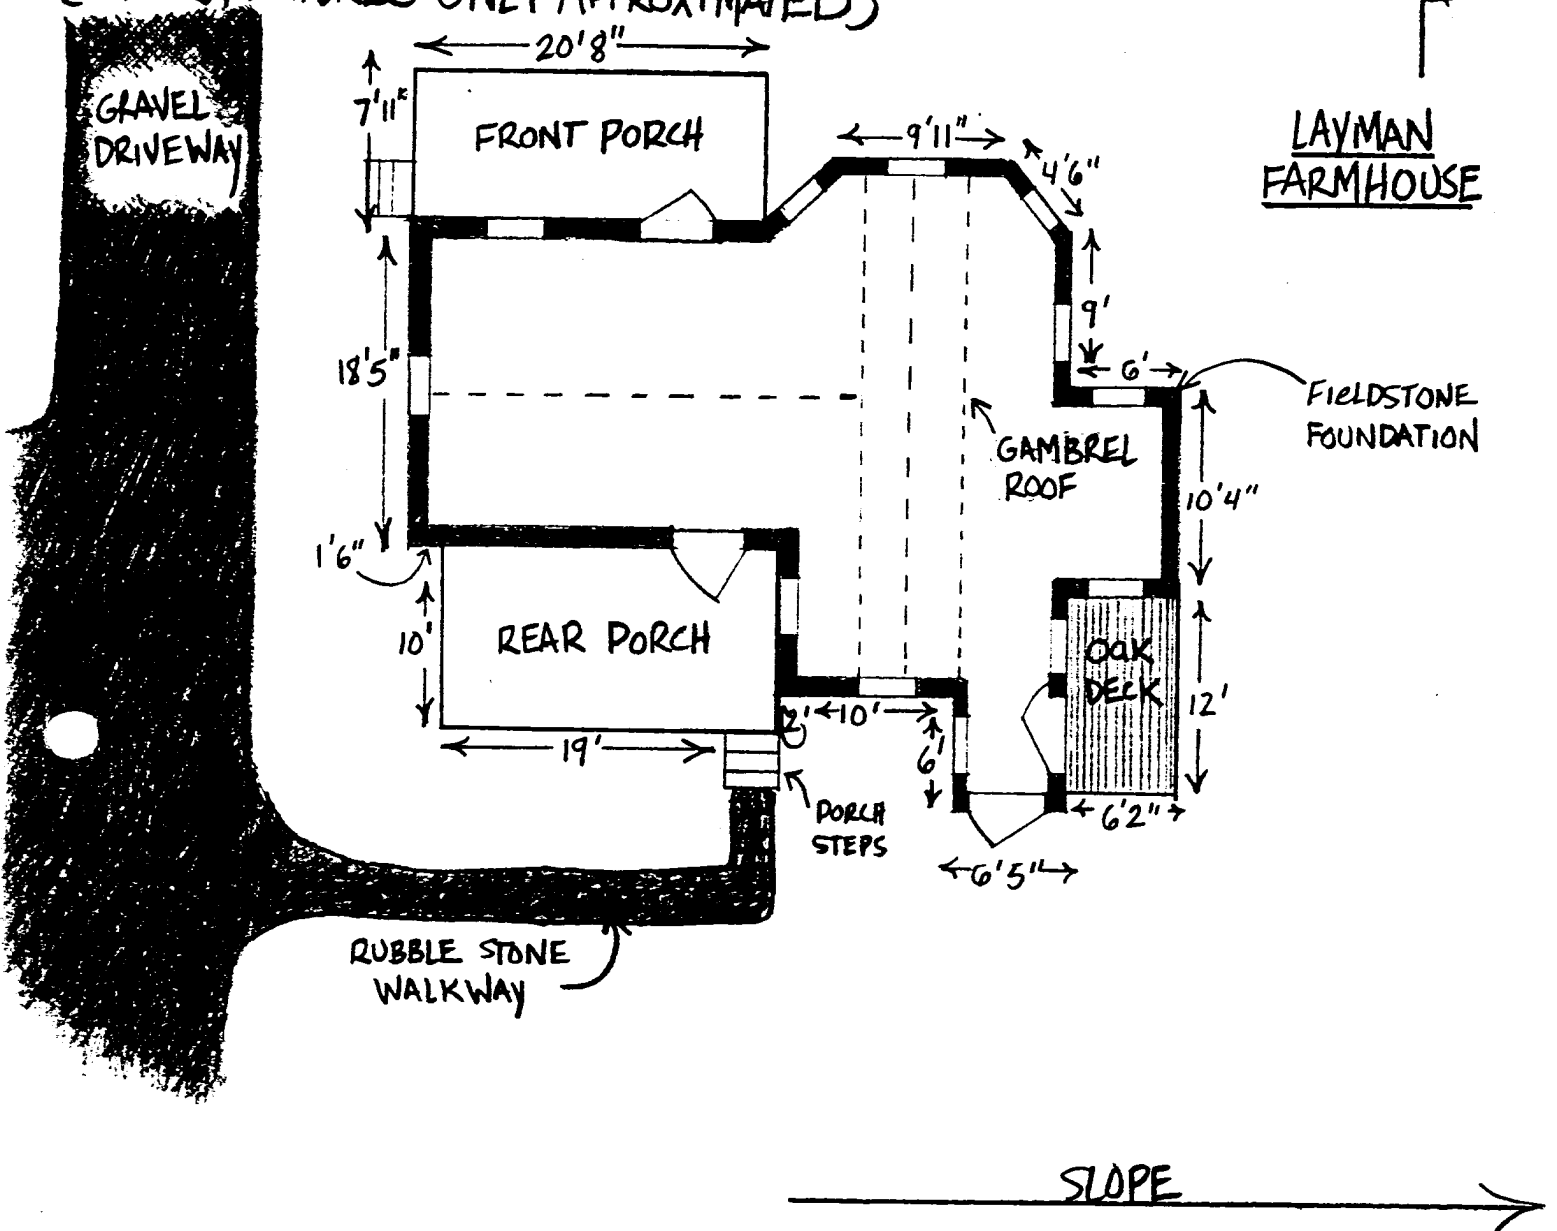
JOHN LAYMAN FARMHOUSE HO-545
 HOWARD CO., MD; VICINITY OF HIPSLEYS MILL
 DRAWN BY C. MAZUREK, JAN 21, 1997
 3/32 SCALE, GROSS MEASUREMENTS
 (OTHER FEATURES ONLY APPROXIMATED)

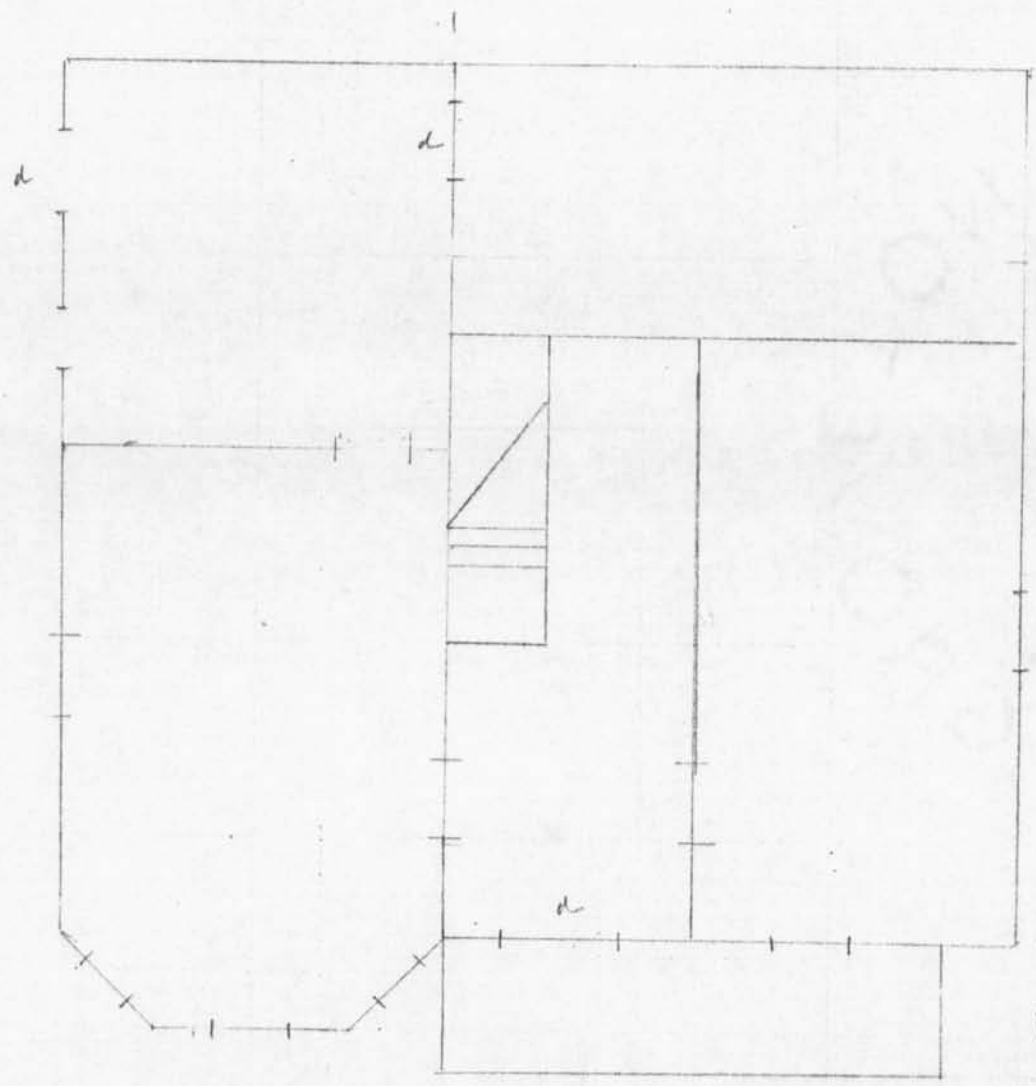
first floor plan

The interior space (see attached plan) is organized axially around a central hall, entered via the front porch and centered doorway. To the left facing the stair is the door to the parlor. On the opposite side is a living room or study. Both rooms feature fireplaces but the parlor version is the more elaborately detailed with a wooden, carved Victorian surround. Additionally, the parlor features mahogany wainscoting to the level of the chair rail. Door surrounds throughout the house consist of bullseye corner blocks hinged into straight sections of plain molding.

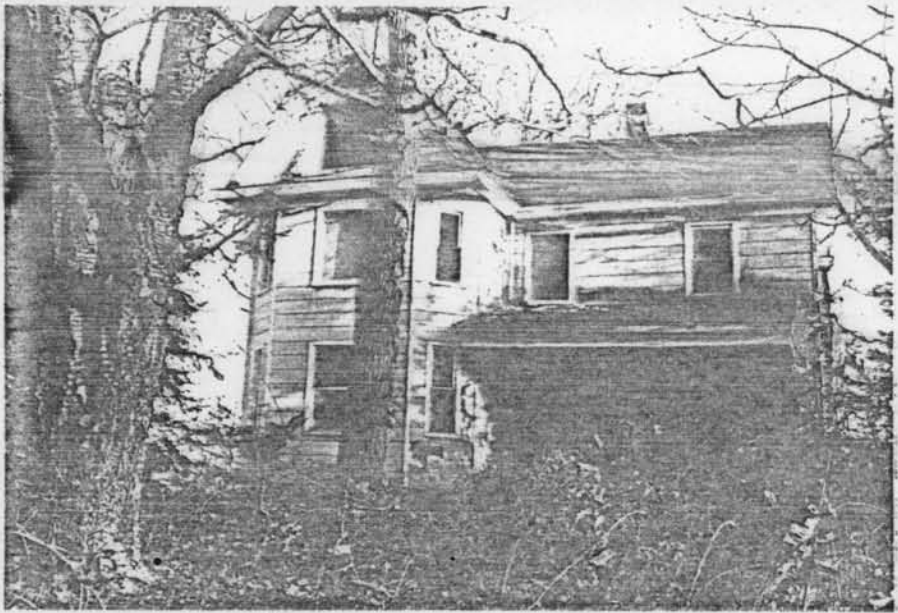
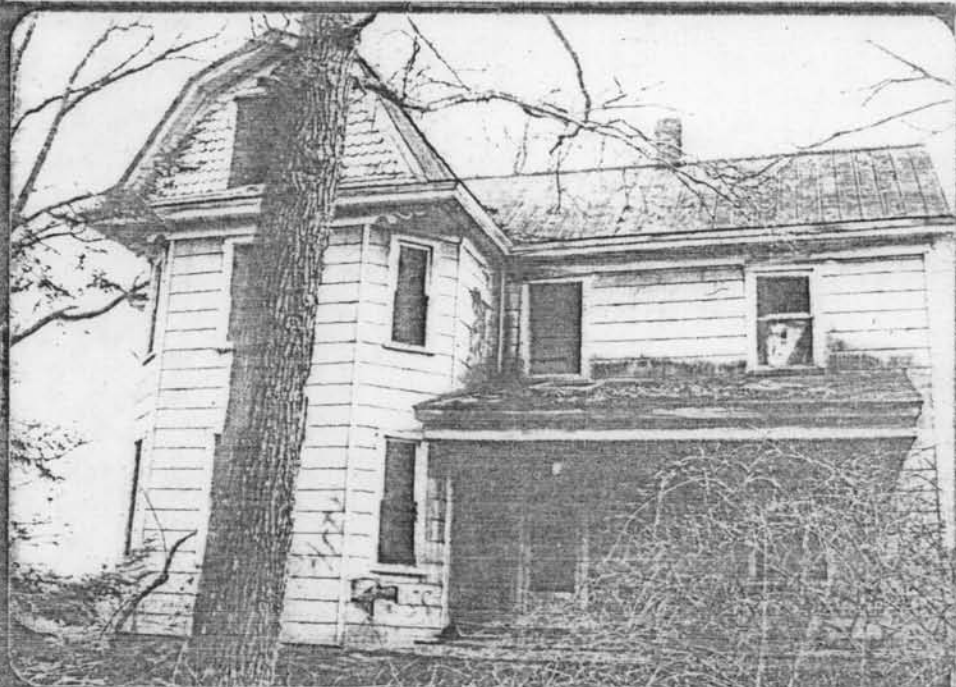
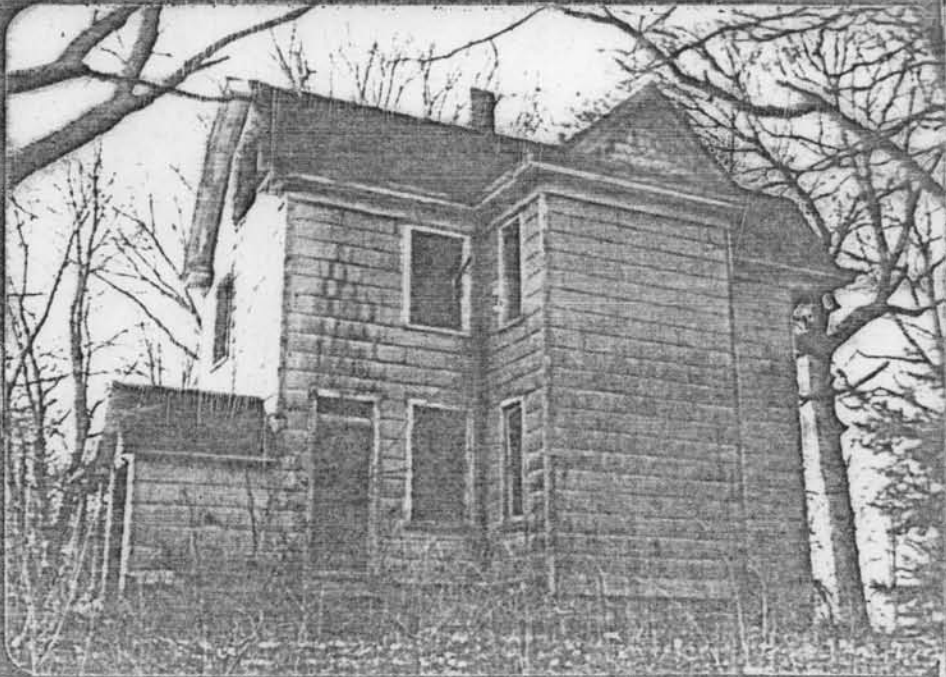
HO-545 John Kayman House

This tripartite bay is gambrel-roofed on the west facade and divides this 5-bay facade into two unequal parts so that the resultant progression from left to right is on the first story level; window, window, window (all with one/one sash) within the projection, thence to the door which is topped with plain transom and flanked by another one-over-one window. The door and southwest window are sheltered by a one-story high, shed roofed porch supported by three Tuscan columns and approached by a short flight of steps.

Top - West Facade
Middle - West Facade
Bottom - North Facade

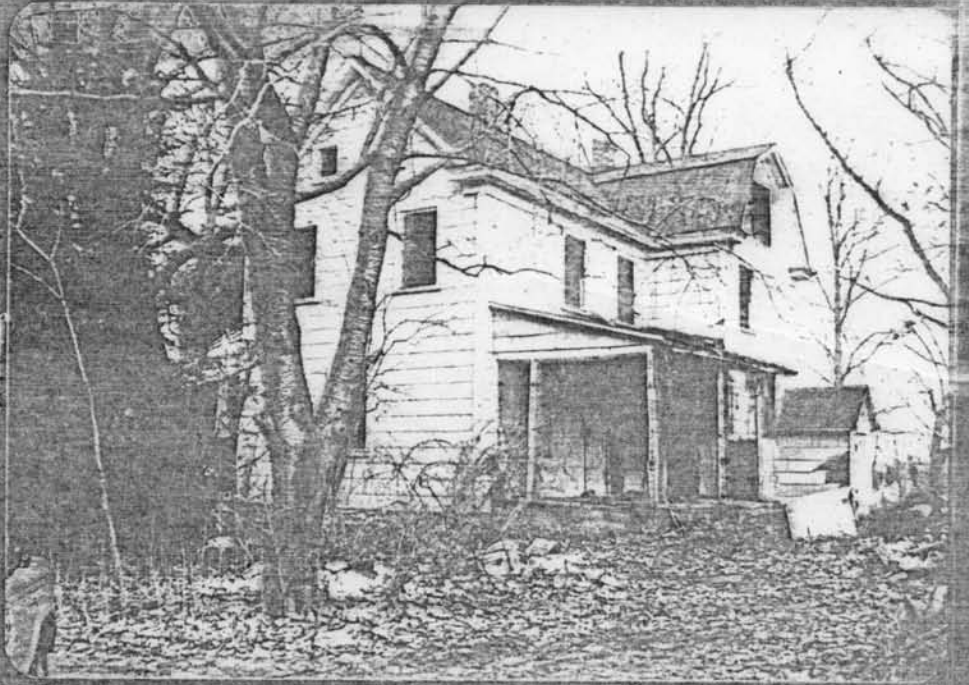
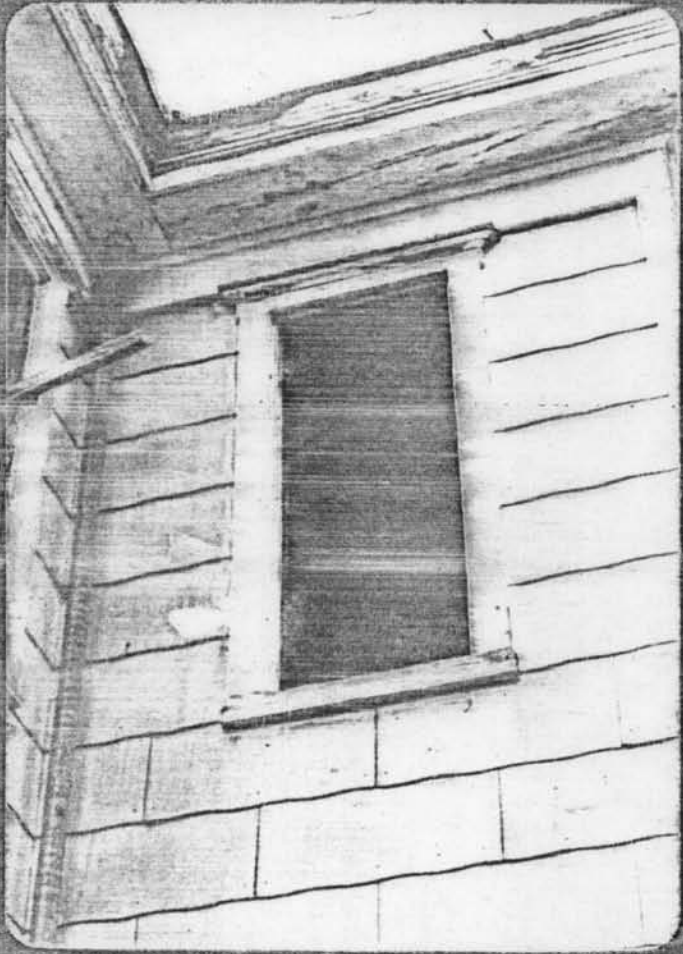
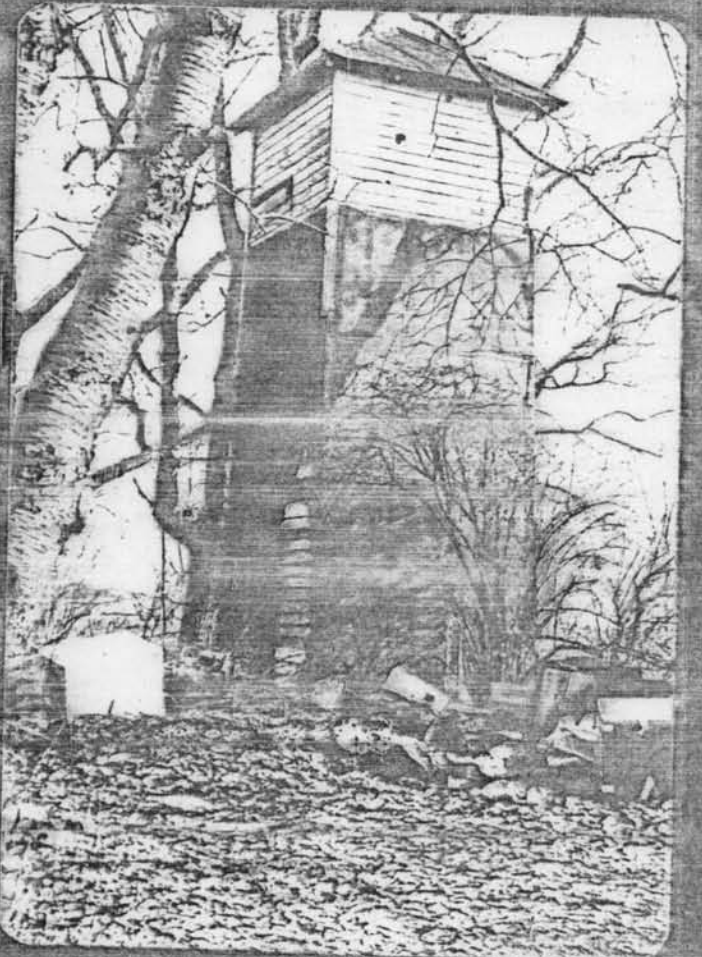
H0-545 John Hayman House

Water Tower. Immediately behind the house (on the east side) is a two-story square water tower. It is a frame structure covered in weatherboard. It has a hipped roof and a single doorway on the west side. The walls taper up at a slight angle to the roof line. The structure appears to have contained a cistern to provide a gravity feed water system for the farmhouse. (See U.S. Department of Agriculture Farmers Bulletin No. 1448, Issued August, 1925 entitled "^{Fa}Armstead Water Supply" for description of cisterns and gravity-fed systems)

top - South + East Facades

out. rt. - West Facade Window Frame Detail

out. left - Outbdy - Water Tower

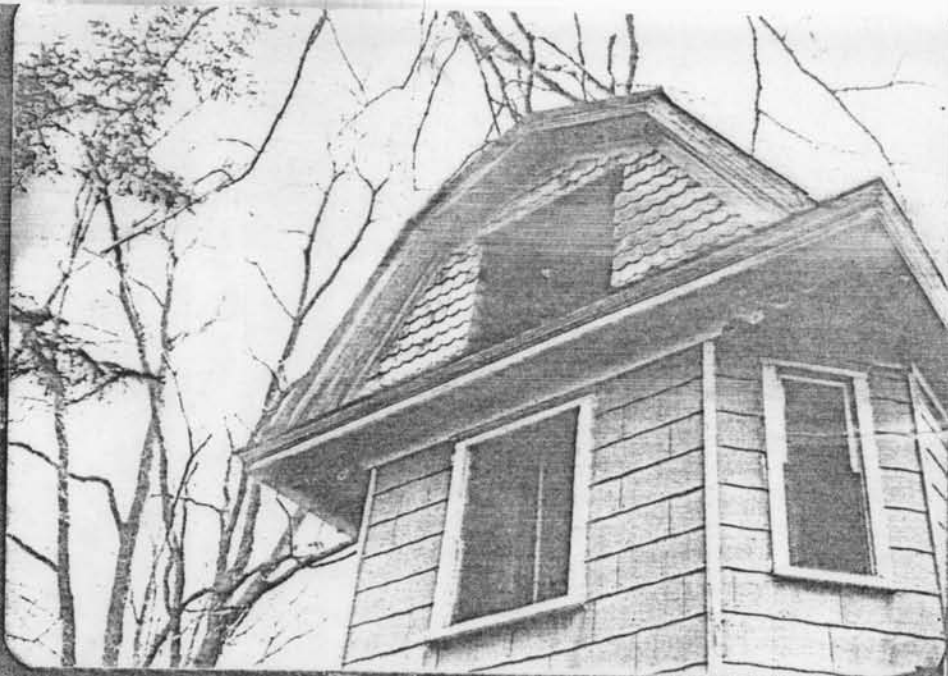
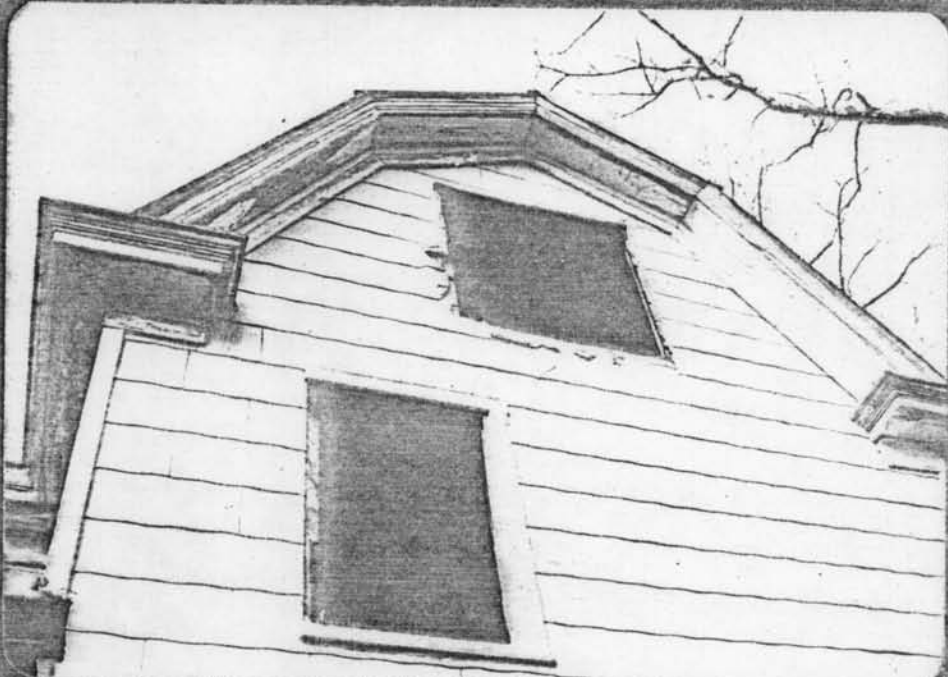
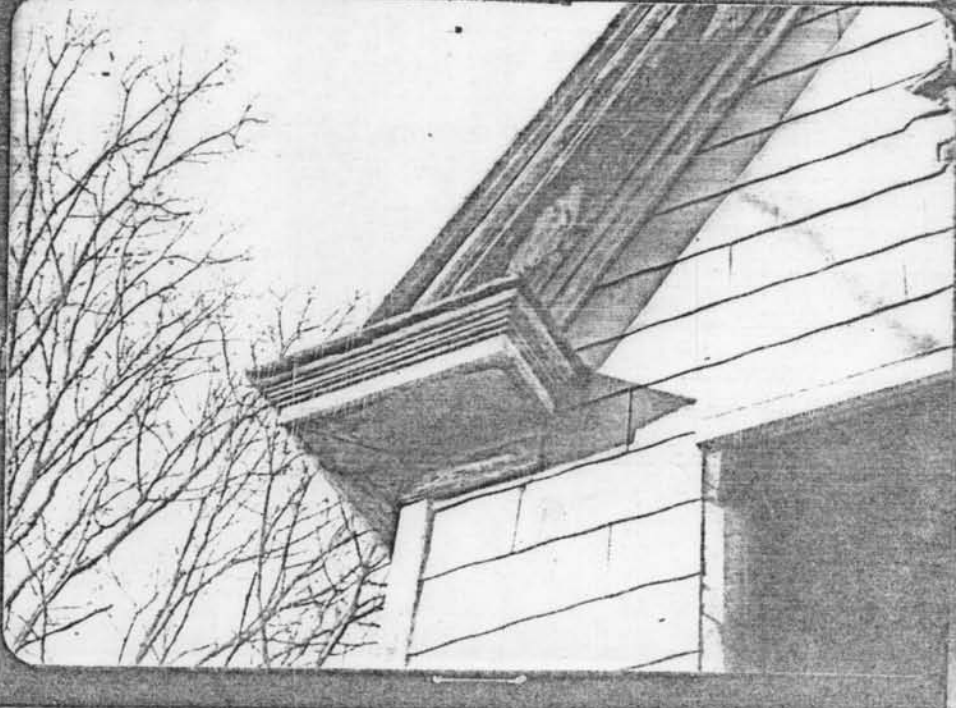
Sheafman House

In corresponding positions in the second story level are: three windows (same one/one sash) in the projection and two windows (with 2/2 sash) located directly above the first floor entrance and southwest window. A small window on axis with the central bay of the projection is located in the pediment of the gable of the gambrel roofed portion; this pediment area is sheathed in imbricated or beveled shingles. The remainder of this frame structure, once simply clapboarded, has since been covered with neutral gray asbestos shingling. The cornice is characterized by a plain fasciaed frieze which wraps around the building continuously just below the moderately overhanging eaves.

top - West Facade - Gambrel Roof over Bay

middle - East Facade " "

bottom - " " cornice detail

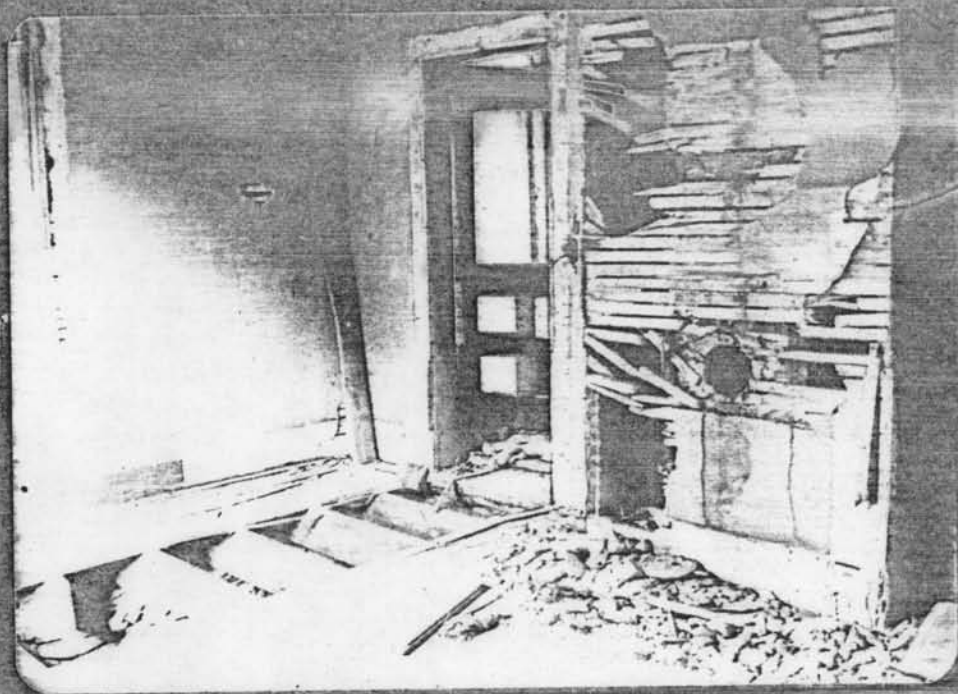
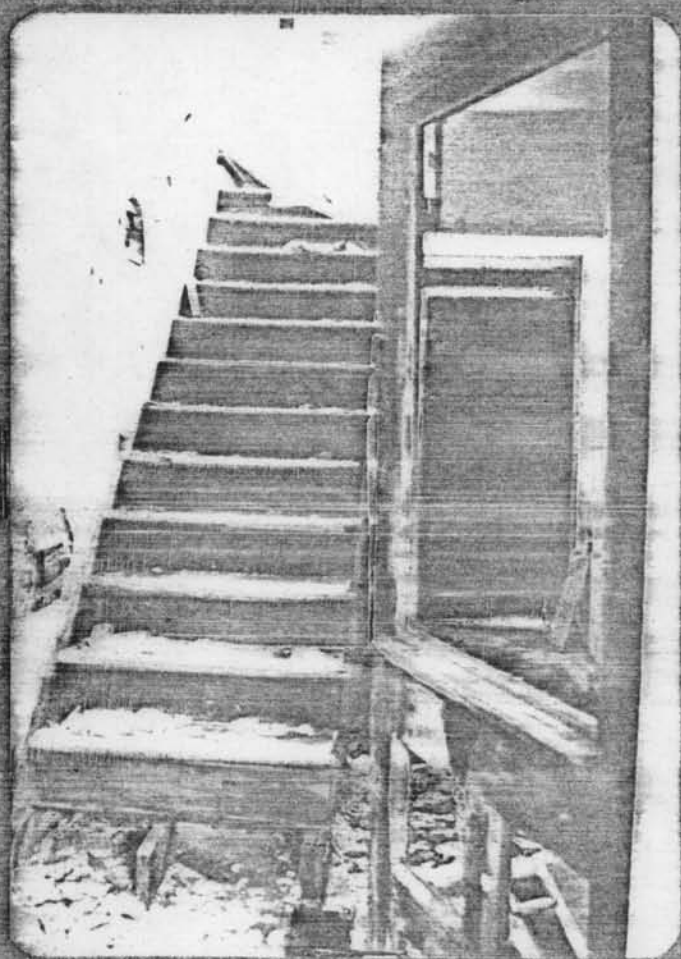
north room with wainscot paneling. The structure has been severely vandalized and the interior woodwork stripped out from the house.

0-545 John Layman House HO-545
top - Interior South Room
bottom - Interior - Stair Hall

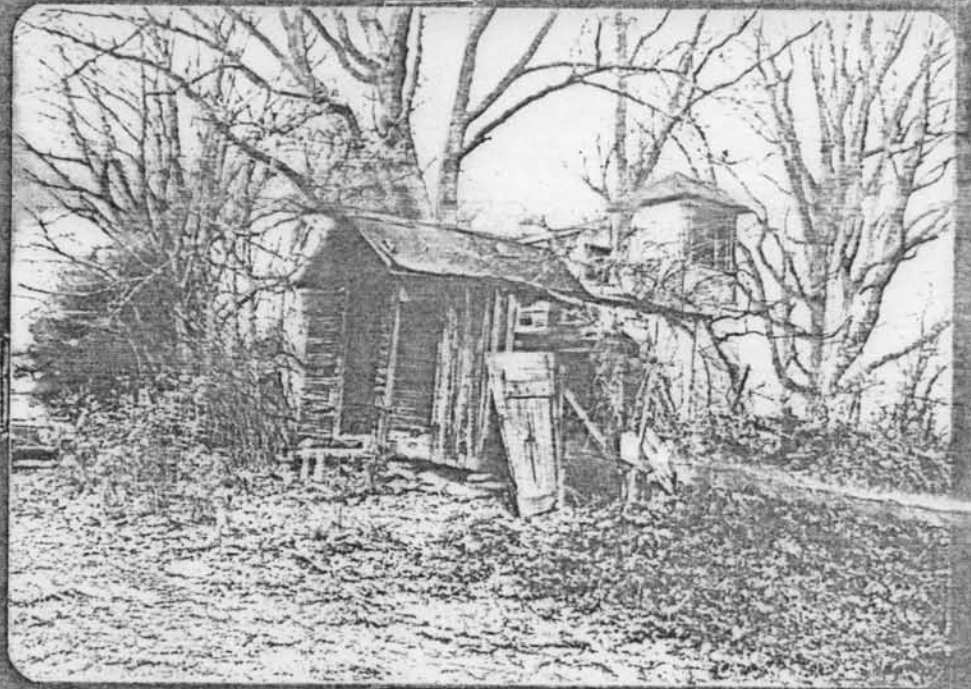
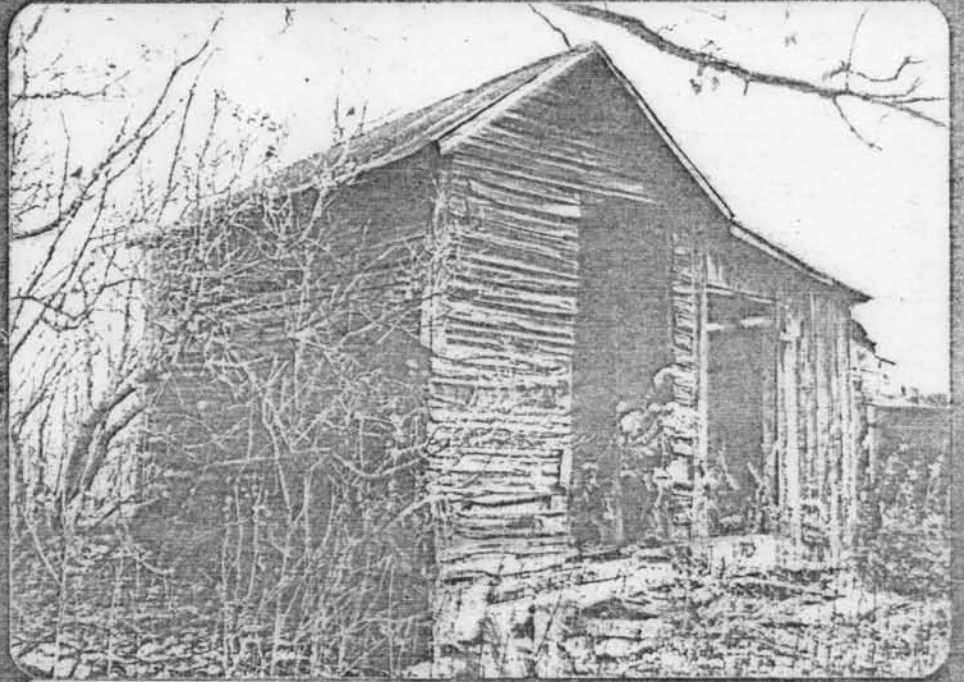
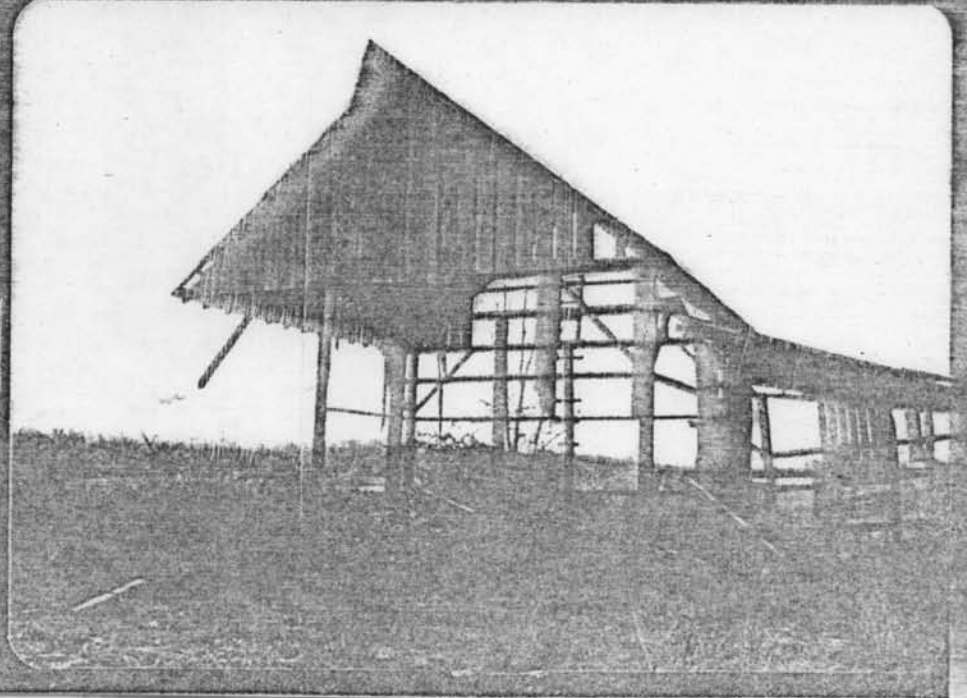
-545 John Hayman House HO-545

Shed. A frame shed is located south of the water tower and has a gable roof covered in sheet metal. The shed is a rectangular structure that has a gable front with a single entrance. It is a frame structure on stone piers that is covered in German siding. On the east side is a shed addition constructed of frame with a vertical siding. A smaller shed addition was also attached on the east side of the earlier shed. These sheds were used as a woodshed and for storage of tools.

Frame Barn. A vertical siding has been removed from a small frame barn that stood southeast of the shed. The exposed framing shows an unelaborate early twentieth century structure with a gable roof. On its south side was a shed addition that served as a livestock pen.

ap - Oct 1845 East of House

ca - Sued

on - Ban frame

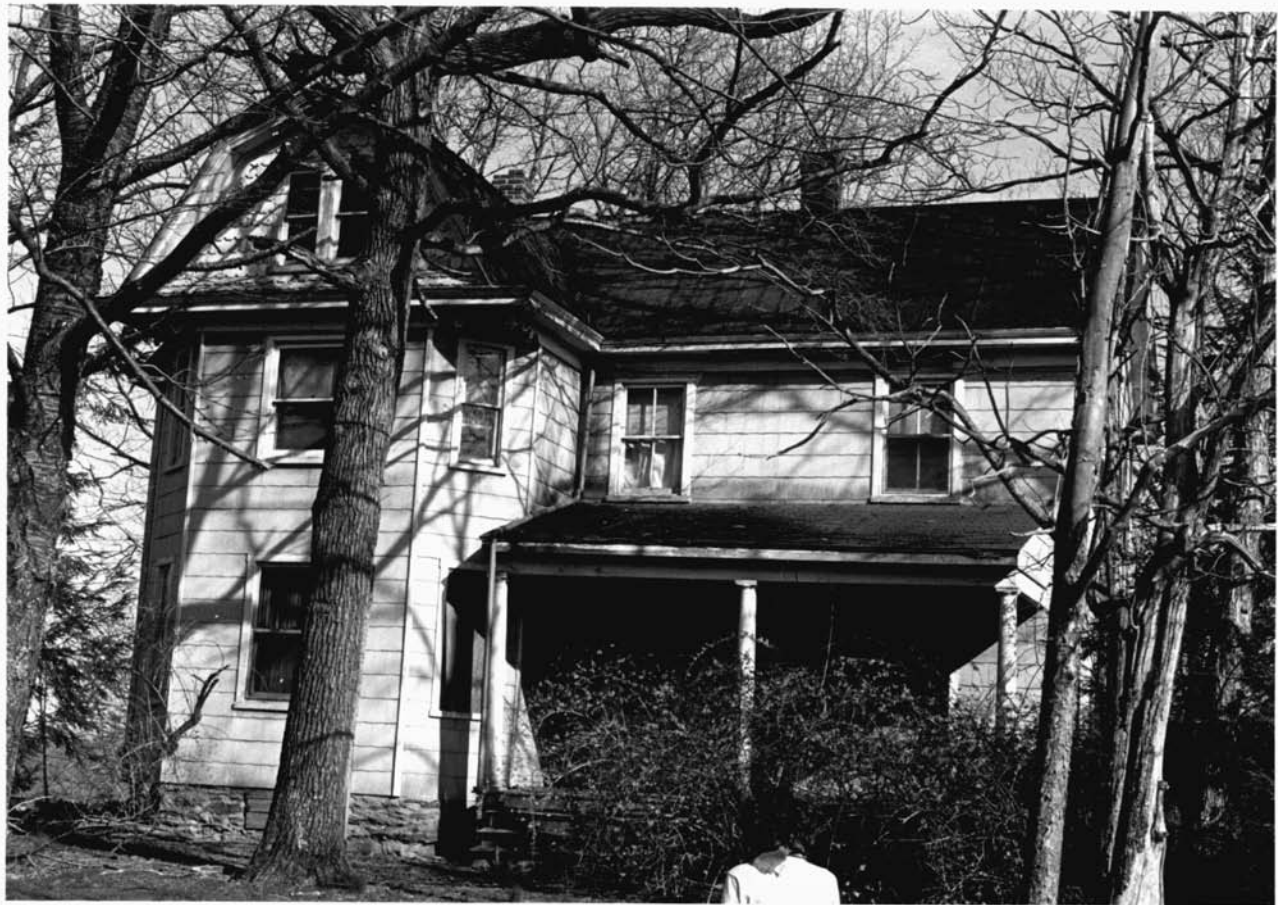
HO-545

The John Layman house, located on the east side of Hipsley Mill Road, is a two-story frame farmhouse set on a stone foundation. Its plan consists of two intersecting blocks in a "T" configuration distinguished by the triple sided bay system on the asymmetrical east facade which contains the main entrance.

east facade, B. Deale 4/79

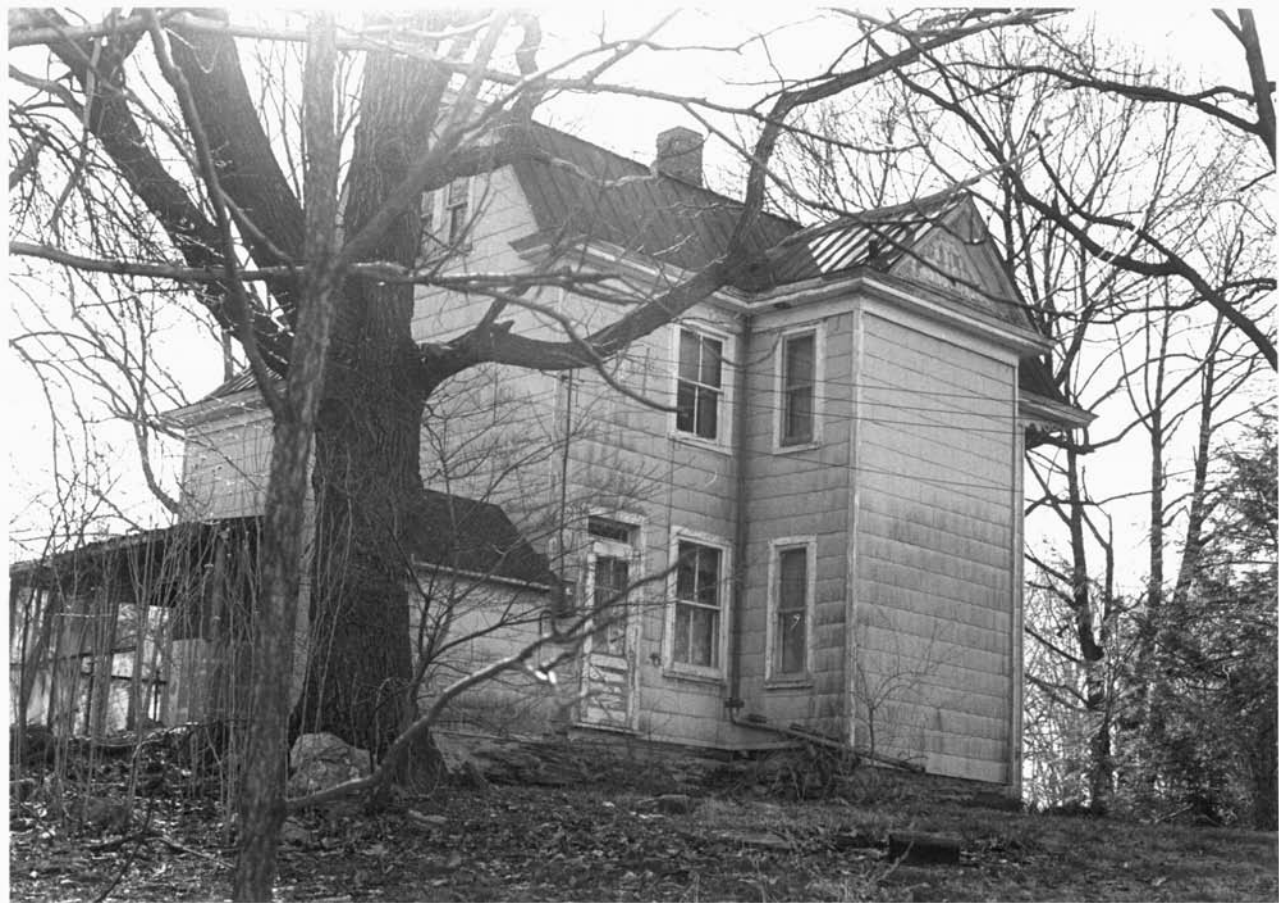
HO- 545

northwest elevation
B. Deale 4/79

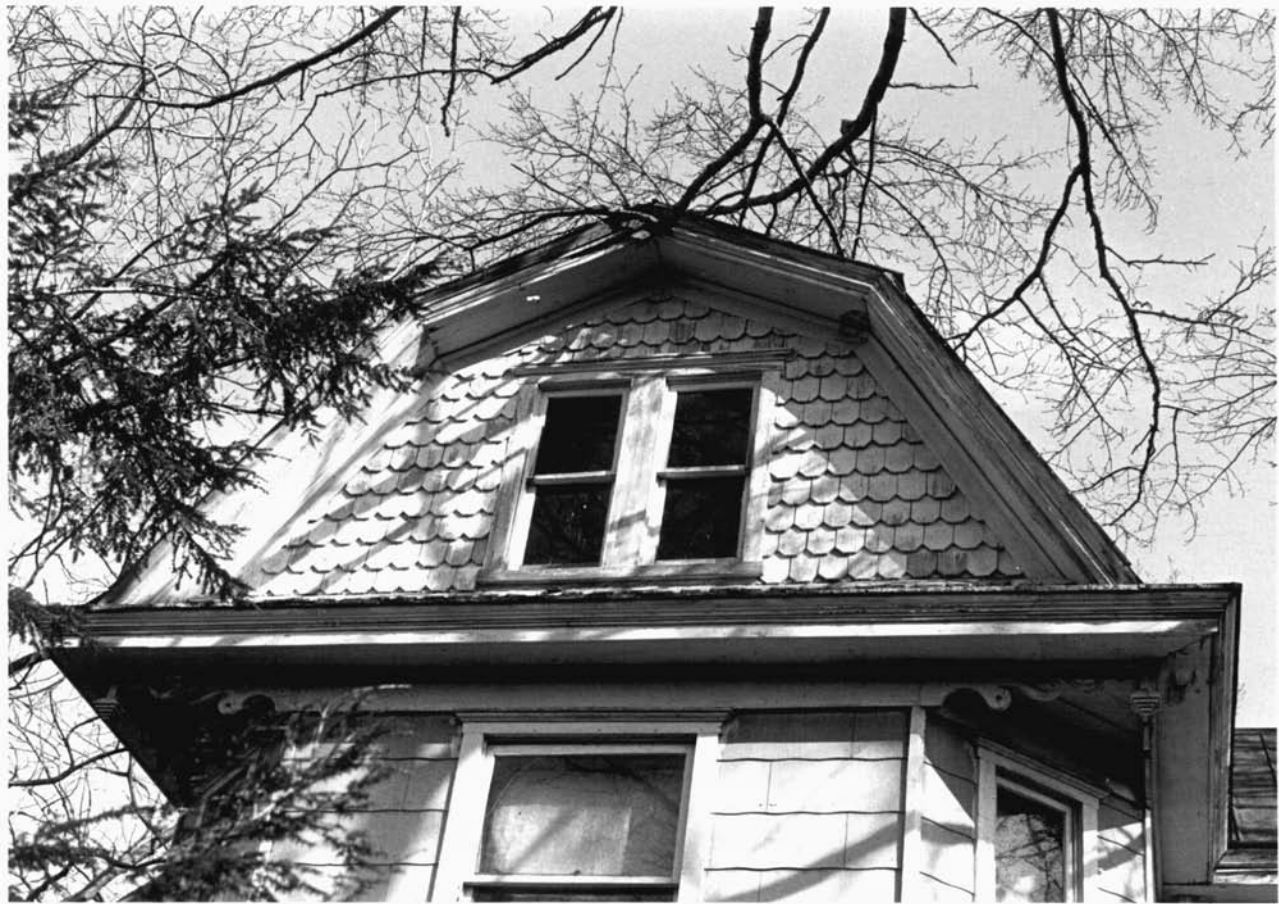
HO-545

east gable; B. Deale 4/79

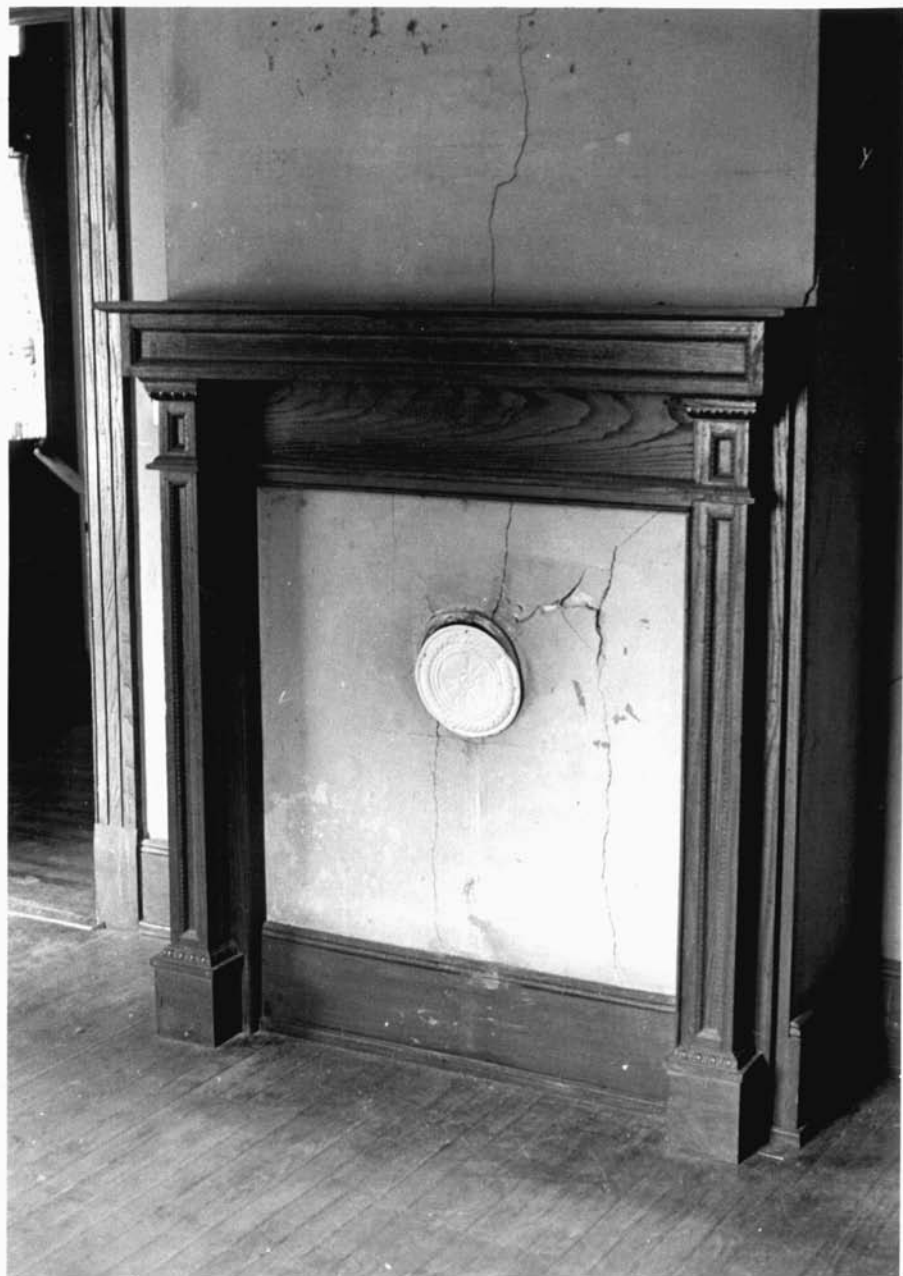
John Layman Farmhouse
Hipsley Mill Rd.,
Patuxent River State Park

int.: parlor fireplace
B. Deale 4/79
