**MARYLAND HISTORICAL TRUST
DETERMINATION OF ELIGIBILITY FORM**

Property Name: Farmer/Kittner House Inventory Number: HO-626

**Maryland Historical Trust
State Historic Sites Inventory Form**

1. Name (indicate preferred name) Farmer/Kittner House

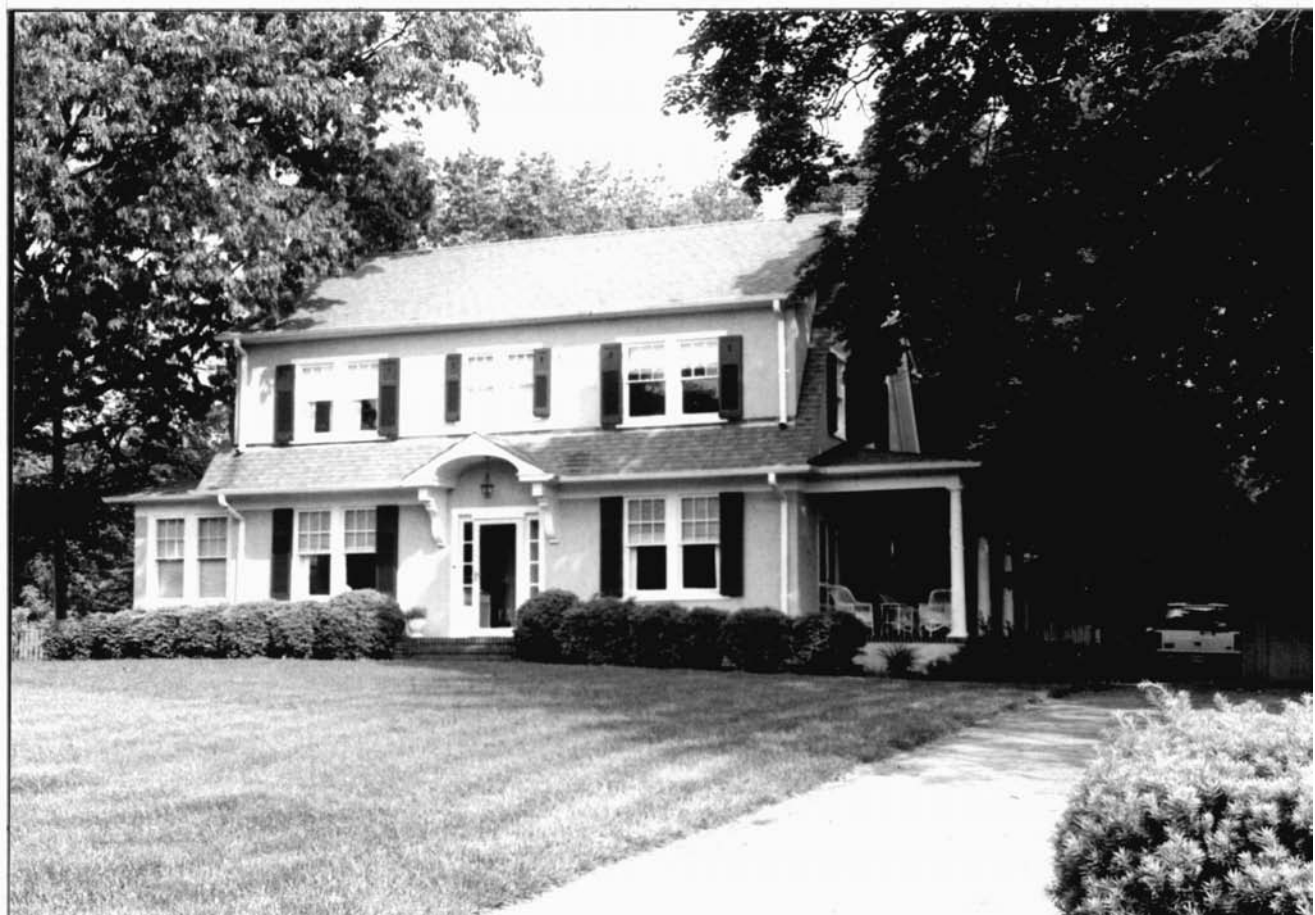
Farmer/Kittner House
Old Columbia Pike
Ellicott City MD (Howard County)
L Jensen Wingate
6/03
MD SHPD

Front facade and garage
