Maryland Inventory of Historic Properties number: HO-677

Name: Bonne Branch Rd over Bonne Br

MARYLAND INVENTORY OF HISTORIC BRIDGES
HISTORIC BRIDGE INVENTORY
MARYLAND STATE HIGHWAY ADMINISTRATION/
MARYLAND HISTORICAL TRUST

SHA Bridge No. HO-2 Bridge name Bonnie Branch Road over Bonnie Branch

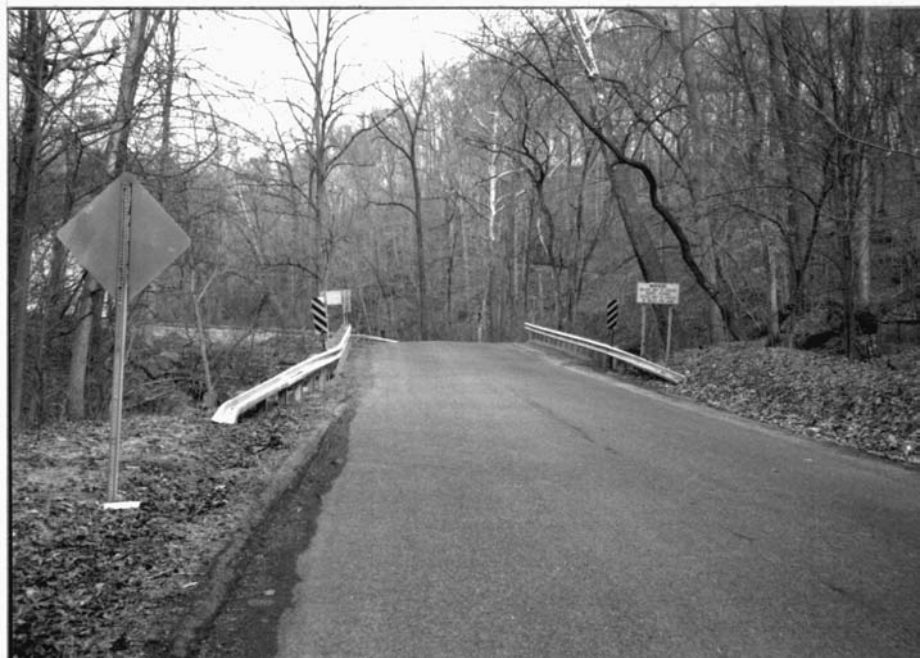
- 1 HO-677
2. Benvue Branch Road over Bonnie Branch
- 3 Howard Co., M.D.
4. Tim Tamburino
- 5 3-97
6. MD SHPO
7. South approach
8. 1 of 6

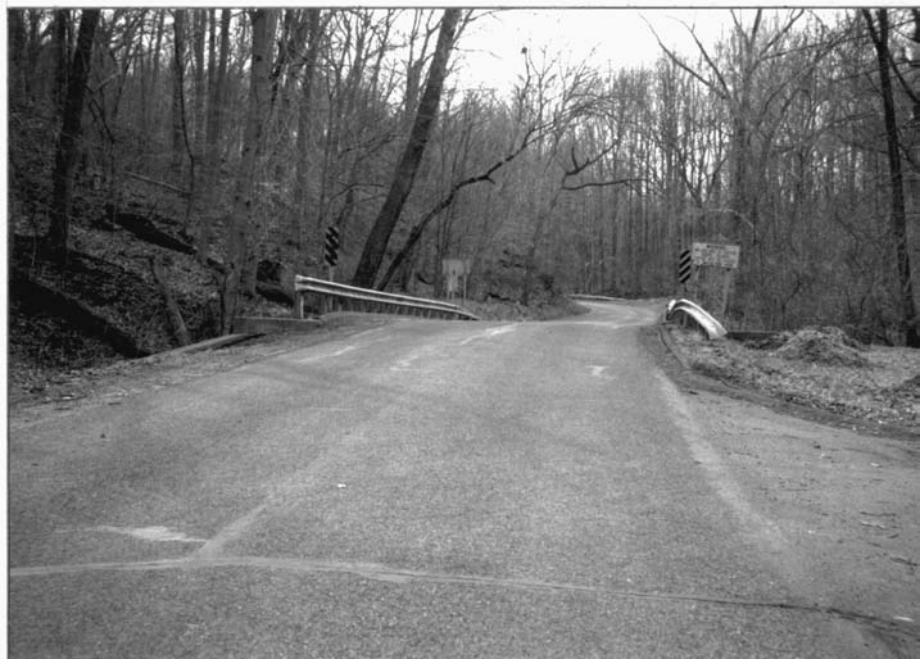
8. 2 of 6

7. Scout approach

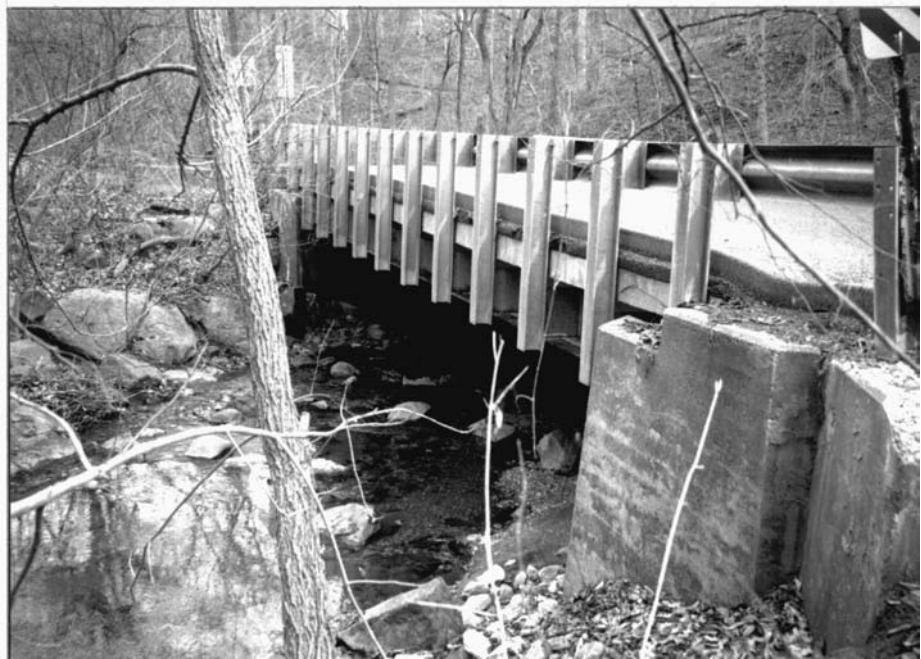
1. Ho - 677
2. Donnie Branch Road over Donnie Branch
3. Howard Co., M.D.
4. Tim Tamburino
5. 3-97
6. MD SHPO
7. East elevation
8. 3 of 6

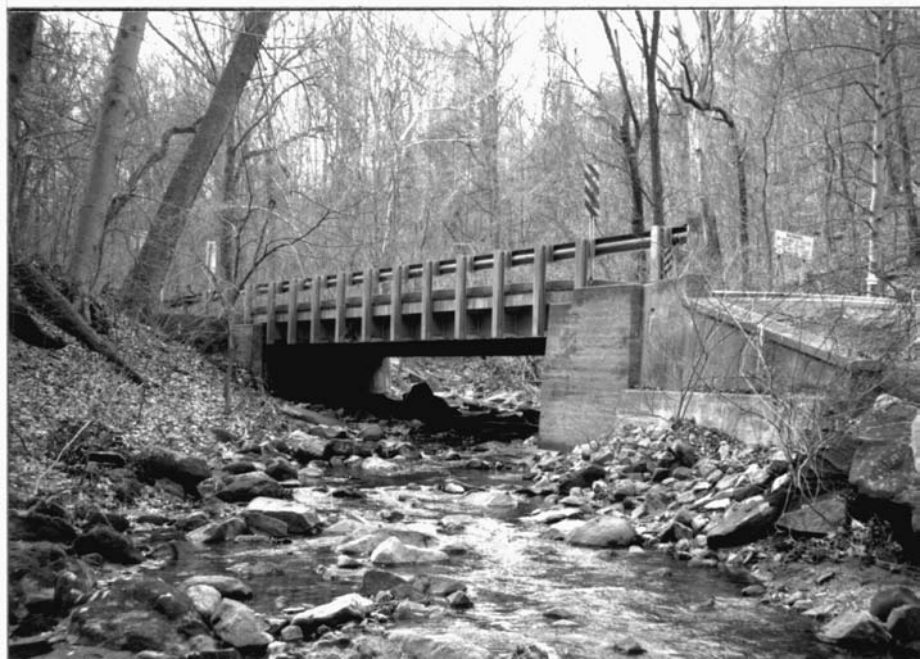
8. " of 6

According to the 1992 inspection report, this structure was in fair to poor condition with spalling, cracking and section loss. The underside of the deck has a 6 foot spall with exposed and corroded reinforcing steel. The west abutment has numerous hairline cracks with efflorescence. The approach roadways have an abrupt change in the vertical alignment at both ends of the bridge.

7. West elevation

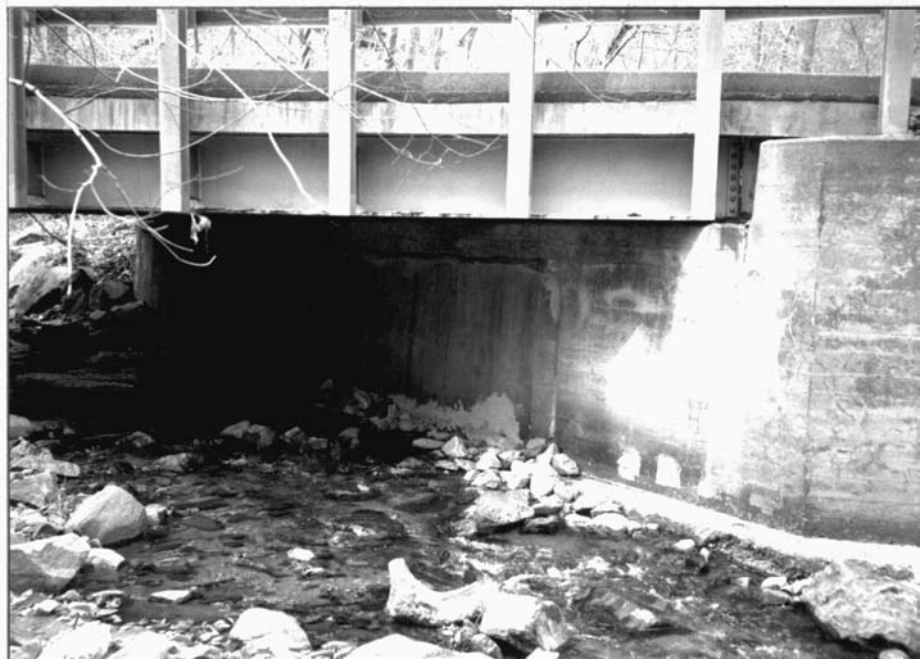
8. E of 6

7 North abutment

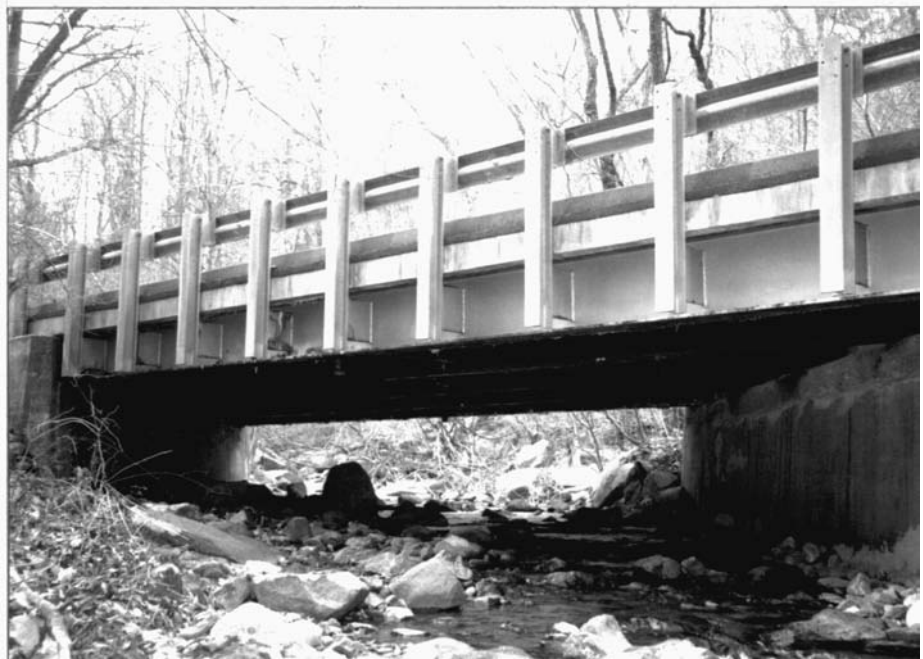
8. 6 of 6

7. North abutment
