**INDIVIDUAL PROPERTY/DISTRICT
MARYLAND HISTORICAL TRUST
INTERNAL NR-ELIGIBILITY REVIEW FORM**

Property/District Name: 10571 Scaggsville Road Survey Number: HO-701

Project: Maryland 216/29 Project Planning Study Agency: MDOT-SHA

CAPSULE SUMMARY
10571 Scaggsville Road
(HO-701)

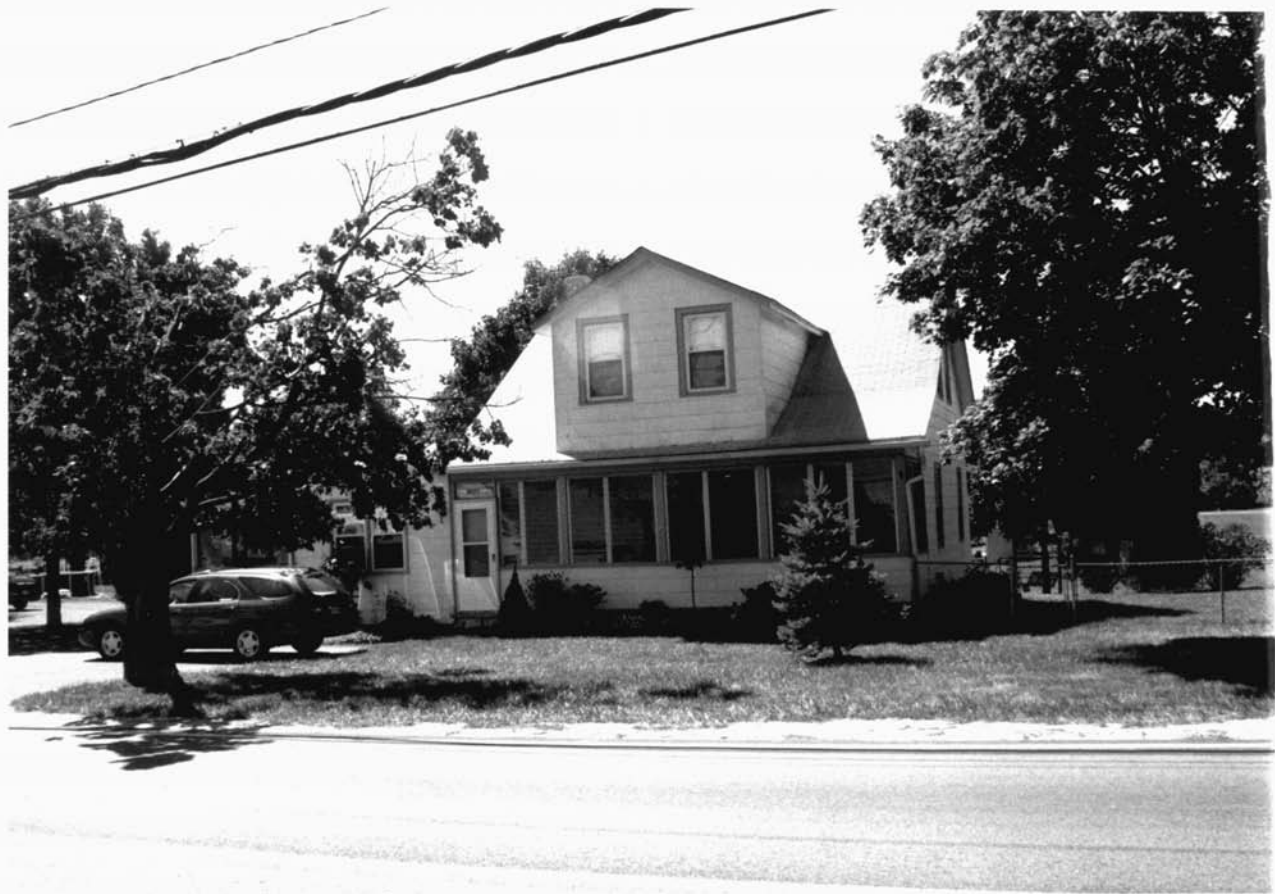
1 of 5

House, NE 1/4 Elevation

The northeast elevation, the facade of the house, is one-and-one-half stories in height and contains a one story enclosed porch at the first story. The side gable roof with a hip extension features a centered, front gable dormer. The one-story southeast addition is flush with the front elevation on the eastern corner of the house. The entrance to the house, within the enclosed porch, is marked with a single leaf, flush metal door with a metal surround. The first story is pierced by two replacement, 1/1 metal sash windows with wood surrounds and molded sills. The porch is enclosed by nine non-original, jalousie windows. The dormer is pierced by two replacement, 1/1 metal sash windows with wood surrounds and square-edged sills.

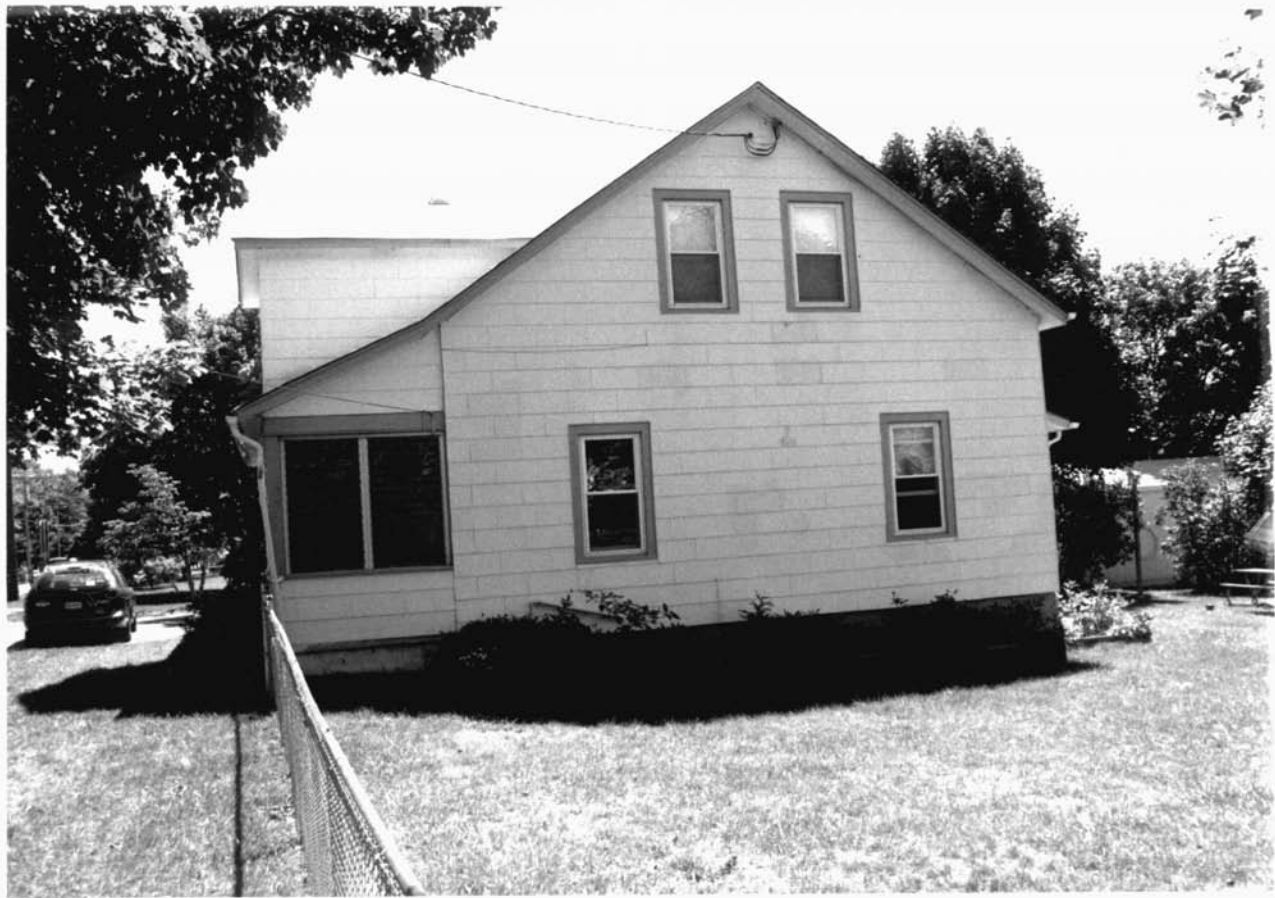
2 of 5

House, NW - Elevation

The northwest elevation is pierced at the first story by two non-original, jalousie windows on the enclosed porch, two replacement, 1/1 metal sash windows with square-edged casings on the original section of the house, and one non-original, 1/1 metal sash window with square-edged casings on the southwest addition. The upper half-story of the original house is pierced by two replacement, 1/1 metal sash windows with square-edged casings.

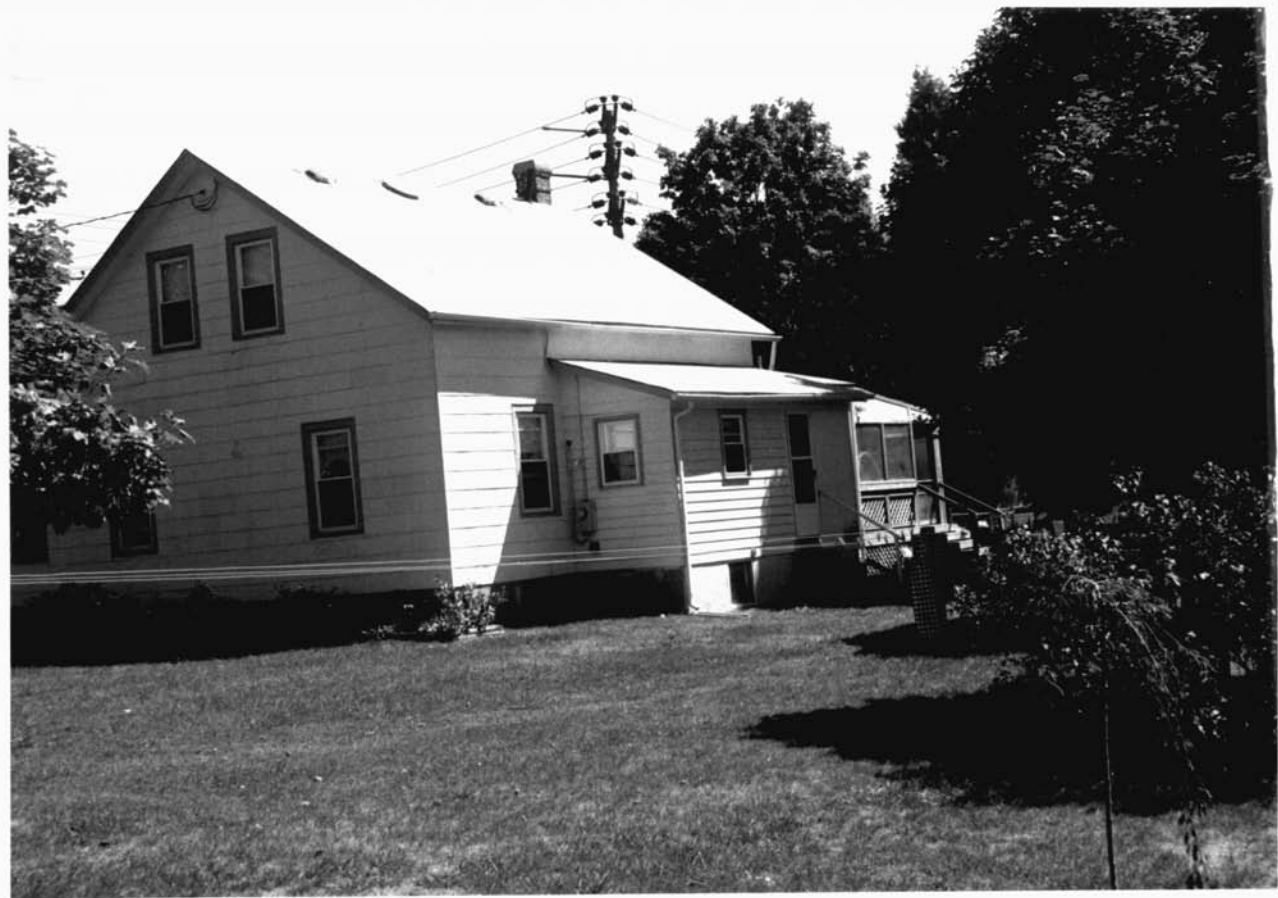
3 of 5

House, W Corner

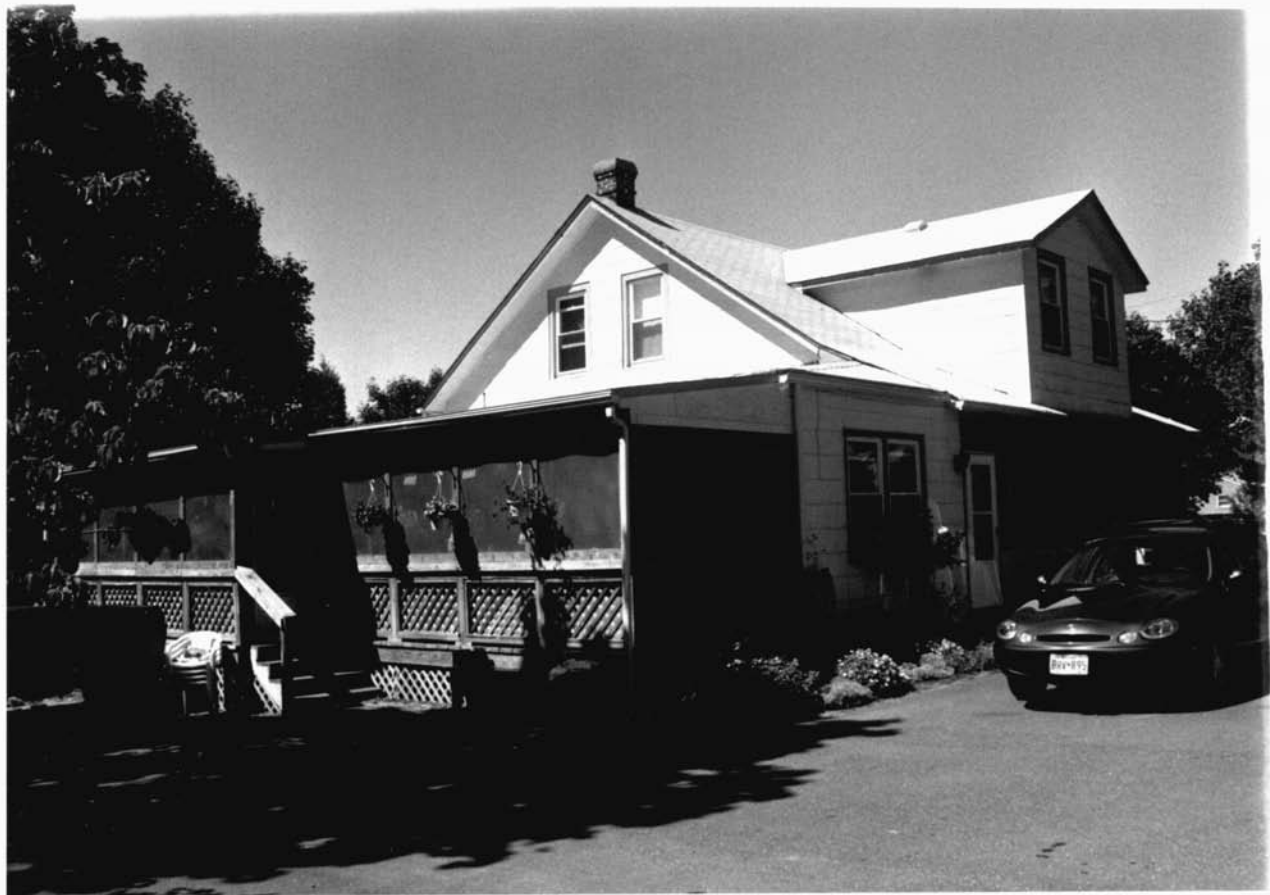
4 of 5

House, E corner

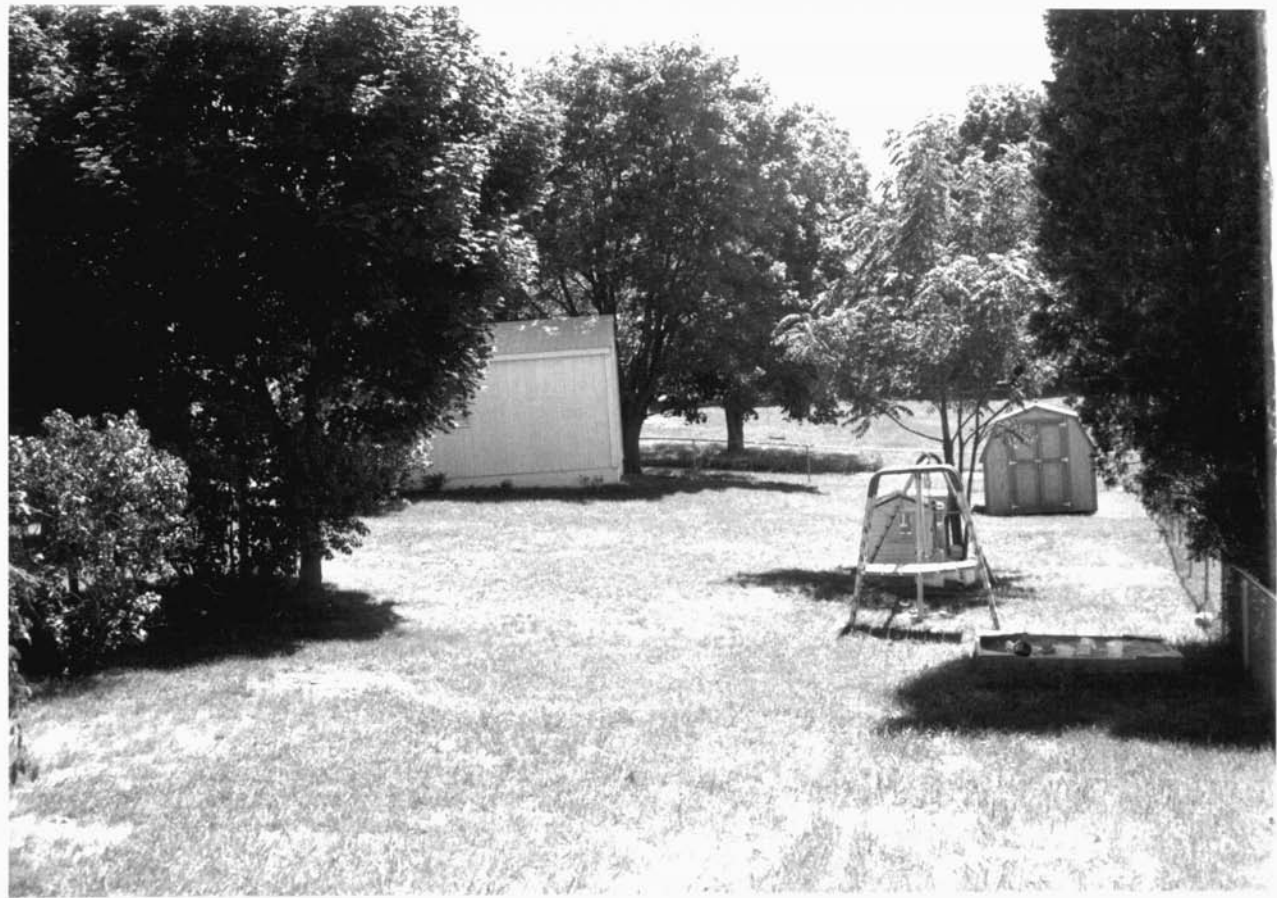
5 of 5

Sheds, looking SE

Two outbuildings stand to the south of the main house. The first one is a wood frame garage constructed in the 1950s with a front gable roof and vertical board siding. The second outbuilding is a pre-fabricated wood frame shed with a gambrel roof and vertical board siding.
