INDIVIDUAL PROPERTY/DISTRICT MARYLAND HISTORICAL TRUST INTERNAL NR-ELIGIBILITY REVIEW FORM

10600 Shaker Drive (HO-723)

MARYLAND HISTORICAL TRUST MD INVENTORY OF HISTORIC PROPERTIES	Inventory No. <u>HO-723</u>
1. Name of Property	
historic name	
2. Location	
street & number 10600 Shaker Drive not city or town Columbia vicinity state county Howard code 027 zip code	for publication Maryland code _MD
3. State/Federal Agency Certification	N/A
4. National Park Service Certification	N/A
5. Classification	
Ownership of Property (Check all that apply X private public-local public-State public-Federal)
Category of Property (Check only one box) X building(s) district site structure object	
$\begin{array}{c c} \underline{0} & \underline{0} & \text{site} \\ \underline{0} & \underline{1} & \text{str} \end{array}$	uctures ects
Is this property listed in the National Reg Yes Name of Listing No \underline{X}	ister?

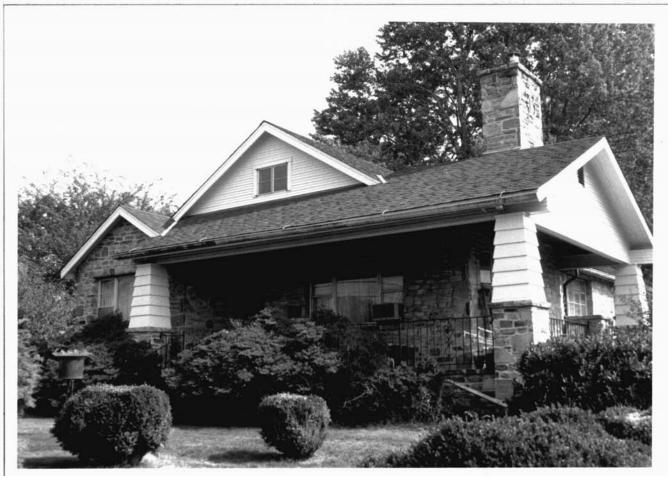
HO-723 10600 Shaker Dr Howard County, MP Traceries October 1997 Maryland SHPO House, NW Elevation 1 of 6

Two of the three bays of the northwest elevation, the facade, are covered by the one-story, gable roof porch with Craftsman-style supports. The main entrance is marked by a single-leaf, paneled door with lights. The first story is pierced by two sets of windows. Each set is formed by a fixed single-light flanked by two 2/2 metal sash windows. Each window opening at the first story is set on a stone sill. The upper half story contains a pair of 1/1 metal sash windows with square edged sills.

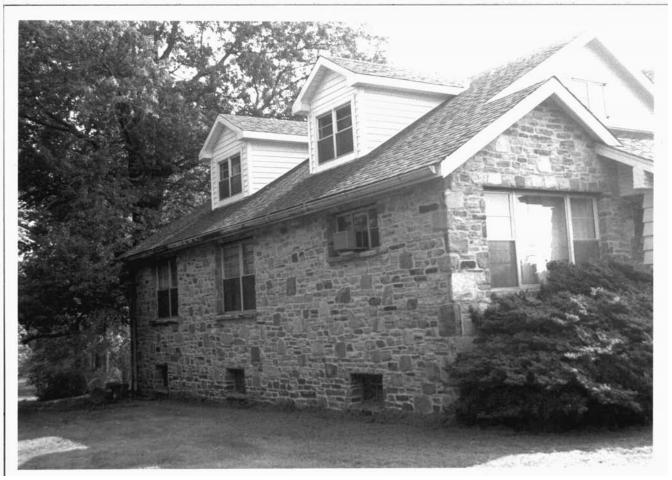
HO-723 10600 Snaker Dr. Howard County, MD Traceries October 1997 Maryland SHPO House, NE Elevation 2 d 6

The foundation wall of the northeast elevation is pierced by three window openings with stone sills. Two of the openings are filled with a two-light metal awning window while the third holds one three-light metal awning window. The first story is marked by two pairs of 2/2 metal sash windows with stone sills and by a group of three smaller two-light metal casement windows. The roof is pierced by two front gable dormers clad in vinyl siding. Each dormer holds a pair of 2/2 metal sash windows.

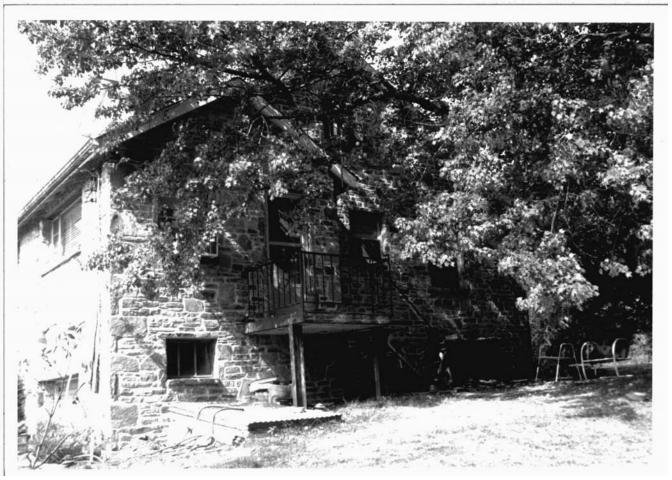
HO-723 10600 Snaker Dr Howard County, MD Traceries October 1997 Maryland SHPO House, SE Elevation 30+6

The southeast elevation is pierced at the foundation by two three-light metal awning windows with stone sills. The first story is marked by three 2/2 metal sash windows with stone sills and a by single leaf, wood paneled door with lights and a stone sill. Within the upper half-story is a 2/2 metal sash window with a stone sill.

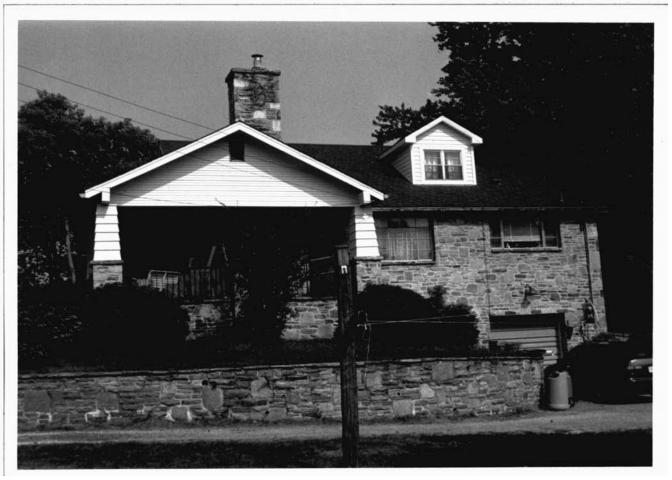
HO-723 10000 Shaker Dr Howard County, MD Traceries October 1997 Maryland SHPO House, SW Elevation 4 & 6

The basement level of the southern end of the southwest elevation is on grade and holds an overhead rolling metal garage door. To the north of this door, the foundation wall is also pierced by one three-light metal awning with a stone sill. The northern half of

the first story is covered by the one-story, wood frame, front gable, portion of the L-shaped porch. Here the first story is pierced with two two-light metal casement windows and by a group of metal windows -- a six-light metal window flanked by two three-light casements and crowned by a fixed four-light transom above. Also at the southern end of the first story is a second group of windows -- a single fixed light that is flanked by three-light metal casement windows. All the windows at the foundation and first story rest on stone sills. The upper half story at this elevation is marked by a pair of 2/2 metal sash windows set within a gable roof dormer.

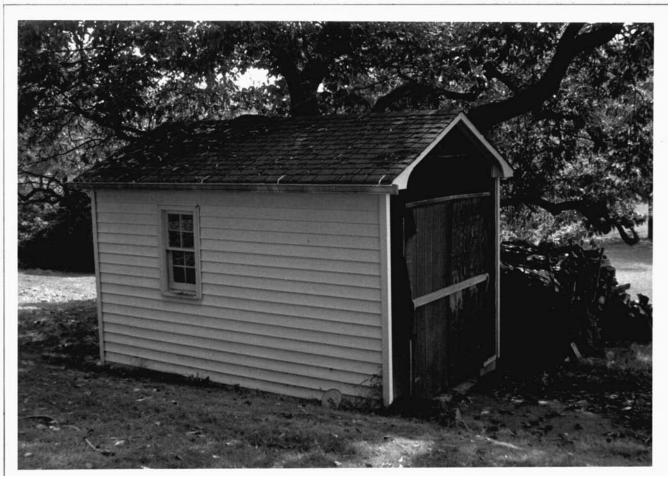
HO-723 10600 Shaker Dr Howard County, MD Traceries October 1997 Maryland SHPO Garage, N Corner 546

A front gable garage with a concrete pad sits to the south of the main house. Dating to the 1940s, the garage is clad in vinyl siding, has one 4/4 window, and a double-leaf vertical board door.

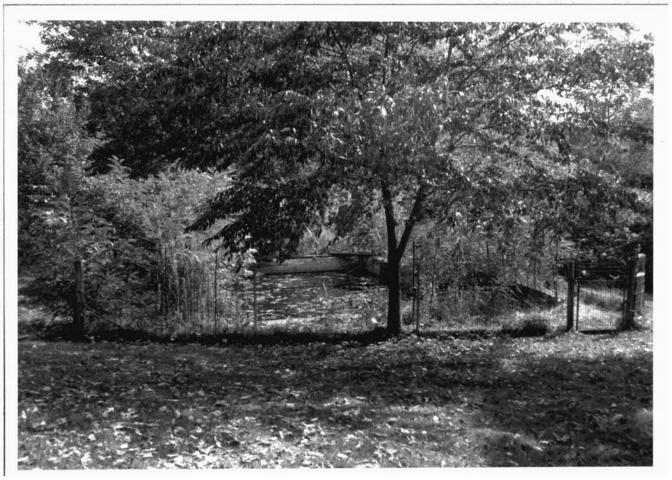
HO-723 10600 Staker Dr Howard County, MD Traceries October 1997 Maryland SHPO Inground pool, Looking SE 6 of 6

An in-ground concrete swimming pool sits to the southeast of the main house behind the garage.
