Maryland Inventory of Historic Properties Number: 10-725  Name: 10-725  The bridge referenced herein was inventoried by the Maryland State Highway Administration as part of the Historic Bridge Inventory, and SHA provided the Trust with eligibility determinations in February 2001. The Trust accepted the Historic Bridge Inventory on April 3, 2001. The bridged received the following determination of eligibly.								
MARYLAND HISTO								
Eligibility RecommendedX								
Criteria:ABCD Considerations:	ABCDEFGNone							
Comments:								
	D							
Reviewer, OPS:Anne E. Bruder	Date:3 April 2001							
Reviewer NR Program: Peter E Kurtze	Date: 3 April 2001

Maryland State Highway Administration  Maryland Historical Trust
SHA Bridge No. HO 8 Name: Sheppard Lane over Middle Patuxent River
Location:
Street/Road Name and Number: Sheppard Lane
City/Town: Clarksville Vicinity X
County: Howard
Ownership:State_X_CountyMunicipalOther
This bridge projects over:Road_Railway_X_WaterLand
Is the bridge located within a designated district: _yes X no
_NR listed district_NR determined eligible district _locally designated_other Name of District
Bridge Type:
Timber BridgeBeam BridgeTruss-CoveredTrestleT

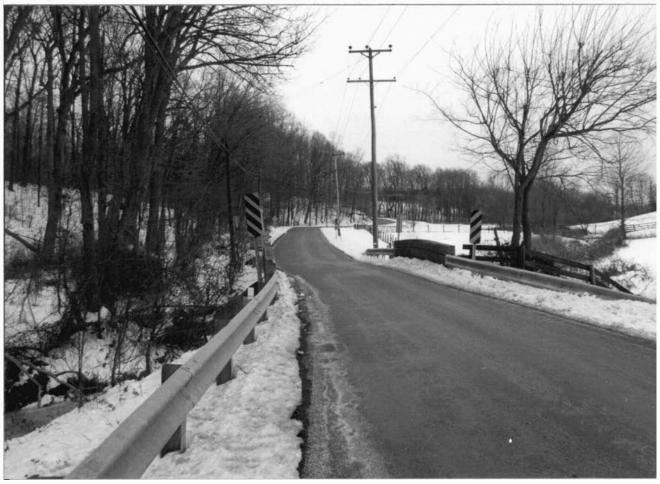
Inventory # Ho 725
Name HO8-SHEPPARD LIN OVER PATURENT RIVER  County/State HOWARD / MO  Name of Photographer DAVID DIEAL  Date 2 95
Location of Negative SHR
Description NORTH APPROACH
Number Vof 36

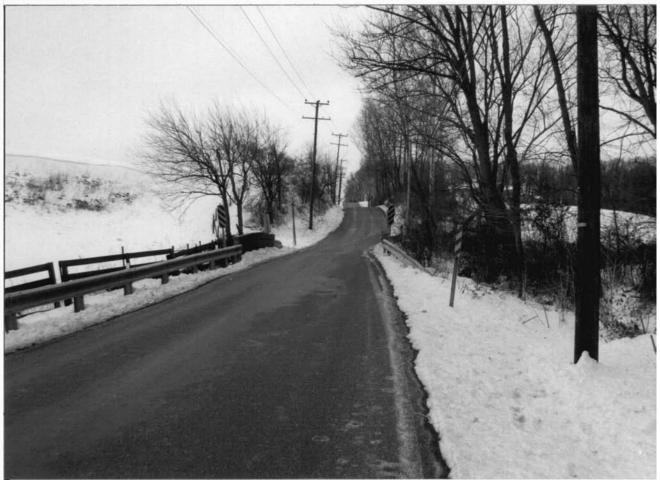
Name HO8 - SHEPPARD LANE OVER PATIVENT RIVER County/State HOWARD IMP  Name of Photographer DAVID OIEHL	2
Name of Photographer DAVID OIEHL	
Date 2/95	
Location of Negative SHA	
Description South APPROACH	
Number 25 of 36

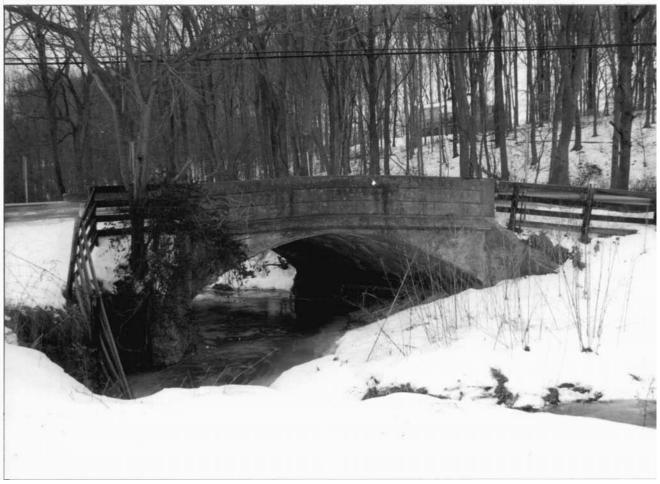
Inventory # _#0-725
Name HO8-SHEPPARD LANE OVER PATLICENT RIVER County/State HOWARD MO  Name of Photographer DAVID DIEHL  Date 195
Location of Negative SHA
Description WEST EXEVATION
Number <u>H</u> of <u>36</u>

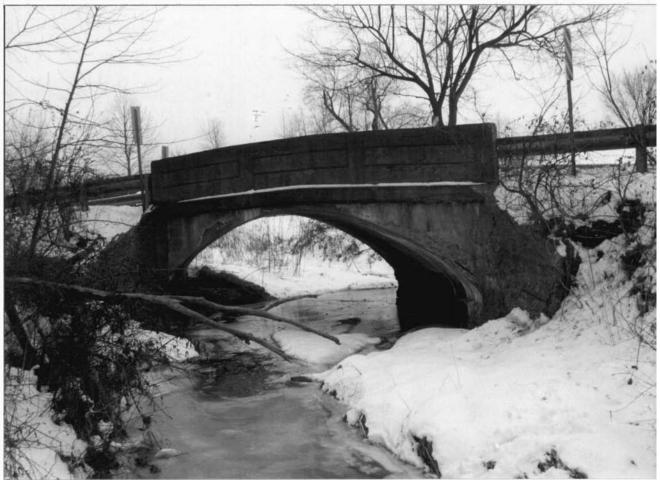
Inventory # <u>HO -725</u>
Minnir
Name HOS - SHEPPARD LANE OVER PATUXENT RIVER
County/State Howard Mo
Name of Photographer DAVID DLENL
Date 2 95
Location of Negative SHA
Description EAST ELEVATION
Number 15 of 36

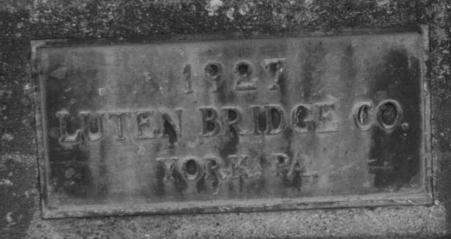
Inventory #	
Name HO8-SHEPPARD LAWE OVER PATUXENT R	IVER
Name HO8-SHEPPARD LATOR OVER FAIGHERST N	
County/State Howard mo	
Name of Photographer DAVID DIEHL	
Date	
Location of Negative SHA	
Description PLAQUE ON PARAPET	
Number 16 of 26
