HOWARD COUNTY: PIPE BREAKS - FIELD DATA

LOCATION: _____
 GPS LOCATION: 10369 Blue Arrow Ct.

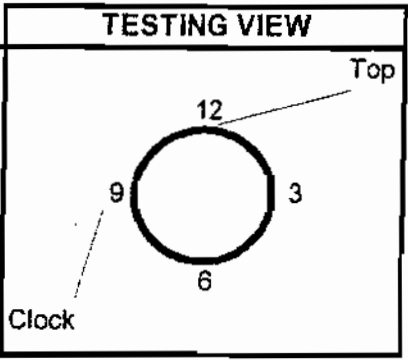
SKETCH OF SITE

Pipe Type: Cast Iron ___ Ductile Iron ___ Steel ___ PCCP ___ Plastic
 Pipe Size: 8"
 Repair Method: ___ Clamp ___ Weld ___ Cut Other
DETAILS: 8" Hymax 1 Bolt + 8" pipe D.I.

Form of Break: ___ Circular ___ Longitudinal Other
DETAILS: Hole in pipe
