Figure 42 - Stray Current Testing in Marble Hill (Branch B & C)

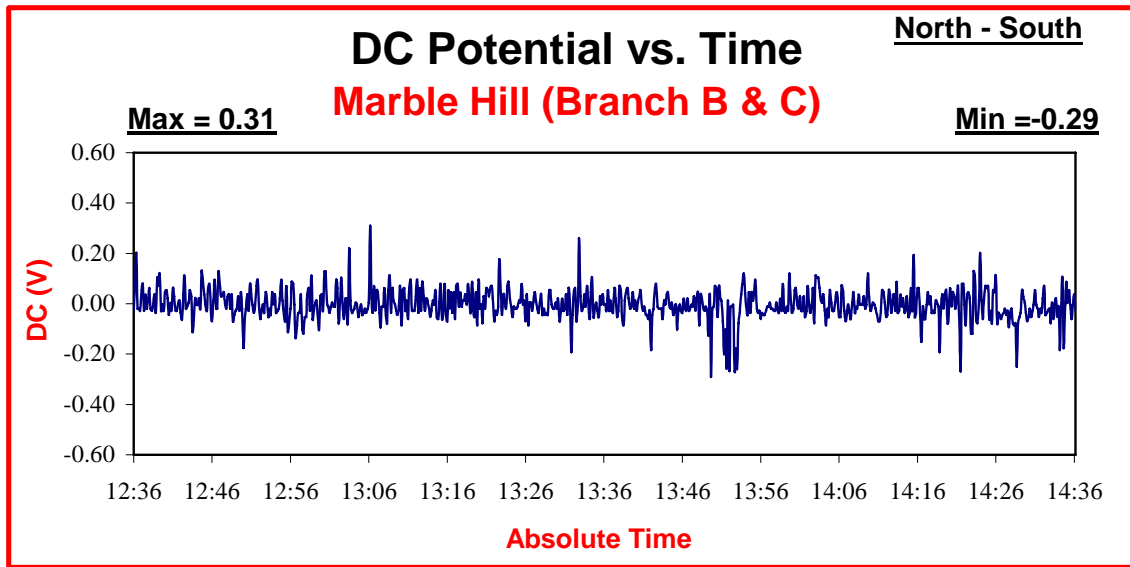
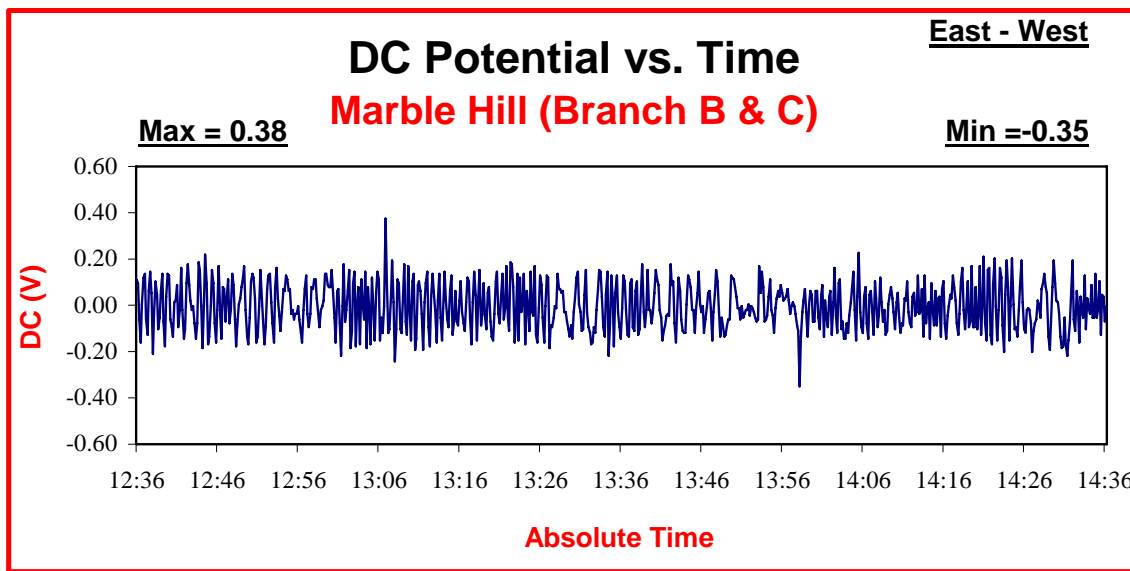
Location:	Marble Hill, near Ducketts Lane 6514	
GPS Location:	N 39° 11.971', W 76° 44.904'	
	North-South	East-West
Date:	10/26/2006	10/26/2006
Time:	12:36:39	12:36:39
Maximum (V):	0.31	0.38
Minimum (V):	-0.29	-0.35
DC Potential Shifts (V):	0.60	0.73

Figure 43 - Stray Current Result for Marble Hill (Branch B & C)
