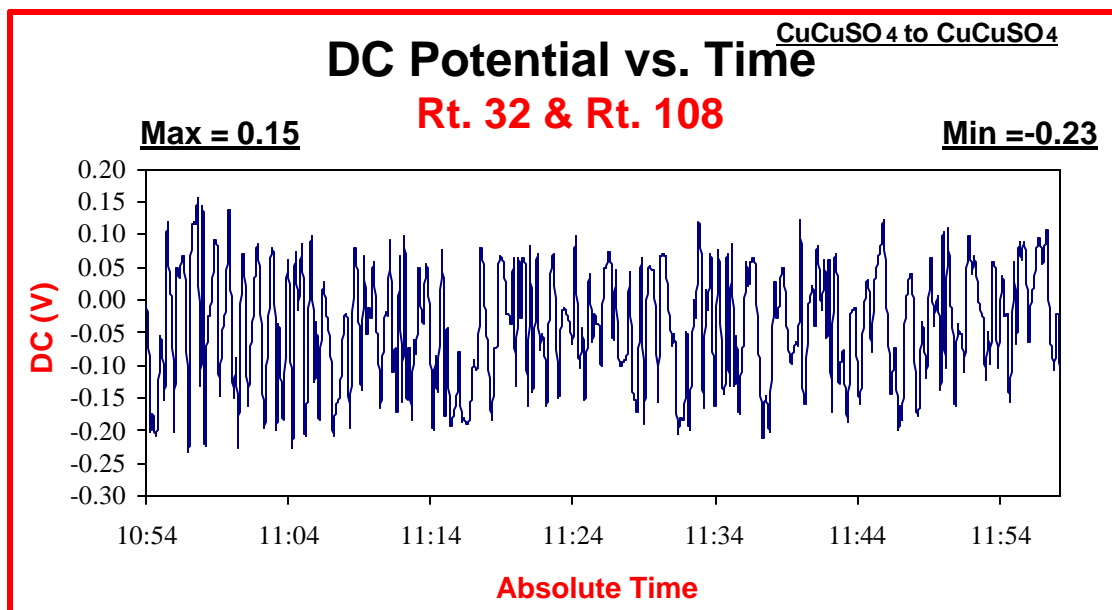
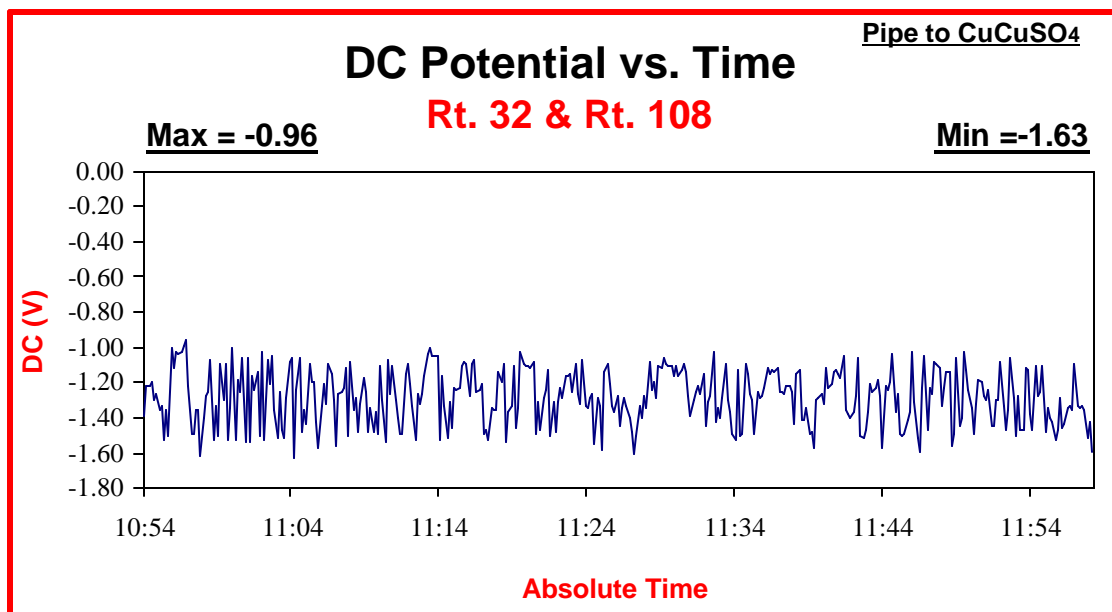
Figure 125 Stray Current Test Results for section 3231

<u>CuCuSO<sub>4</sub> to CuCuSO<sub>4</sub></u>	<u>Pipe to CuCuSO<sub>4</sub></u>
<b>Approximate Station #:</b>	(11+26)	(11+26)
<b>Date:</b>	3/24/2005	3/24/2005
<b>Time:</b>	10:54:07	10:54:07
<b>Maximum (V):</b>	0.15	-0.96
<b>Minimum (V):</b>	-0.23	-1.63
<b>DC Potential Shifts (V):</b>	0.38	0.67
<b>Location:</b>	South end Test Station	
<b>GPS Location:</b>	N 39° 12.439', W 76° 56.520'
