HOWARD COUNTY DEPARTMENT OF PUBLIC WORKS CORROSION CONTROL TEST STATION FIELD DATA SURVEY FORM

| TIEED DATA GORVET FORM | | | | | | | | |
|--|---|---|---|---|---|---|---|--|
| Location: | 19+70 | | | Date Surveyed | | 5/21/2007 | | |
| T/S #: | 12GS4 | | | Contract #: 369 Pipe Size: 12" | | 6 | | |

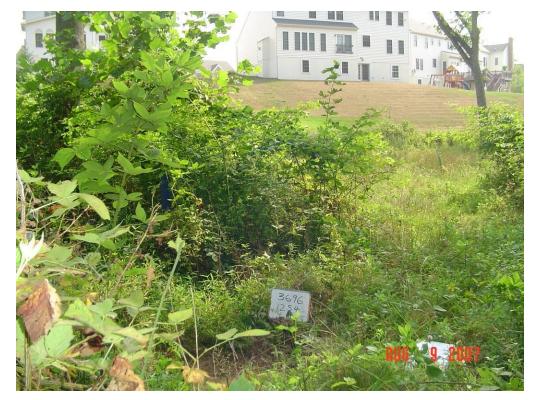
Figure 14 – Location of Test Station 12GS4

| TIEED DATA GORVET FORM | | | | | | | | |
|--|---|---|---|---|---|---|---|--|
| EAST SIDE OF WATER | | | R VALVI | | | MJ/DD | | |
| Test Box: GOOD, NATURAL OVERGROWTH | | | | | | | | |

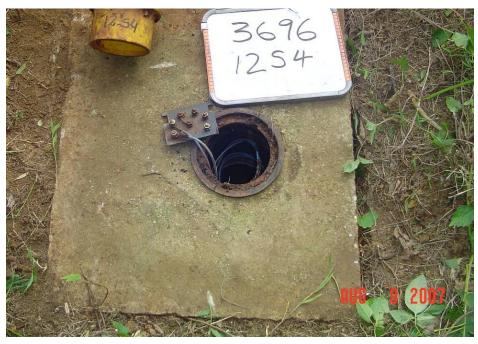
Figure 15 - Test Station 12GS4 close-up

| TIEED DATA GORVET FORM | | | | | | | | |
|--|---|---|---|---|---|---|---|--|
| Terminal Board: GOOD | | | | | | | | |
| Wires: | | OOD | | | | | | |
