**HOWARD COUNTY DEPARTMENT OF PUBLIC WORKS  
CORROSION CONTROL TEST STATION  
FIELD DATA SURVEY FORM**

Location: 01+70 Date Surveyed: 3/7/2005  
Near Manhole #11 Surveyed by: AC/MJ

T/S #: 12GS #6 Contract #: 10-3696  
T/S Type: ST Pipe Size: 12"

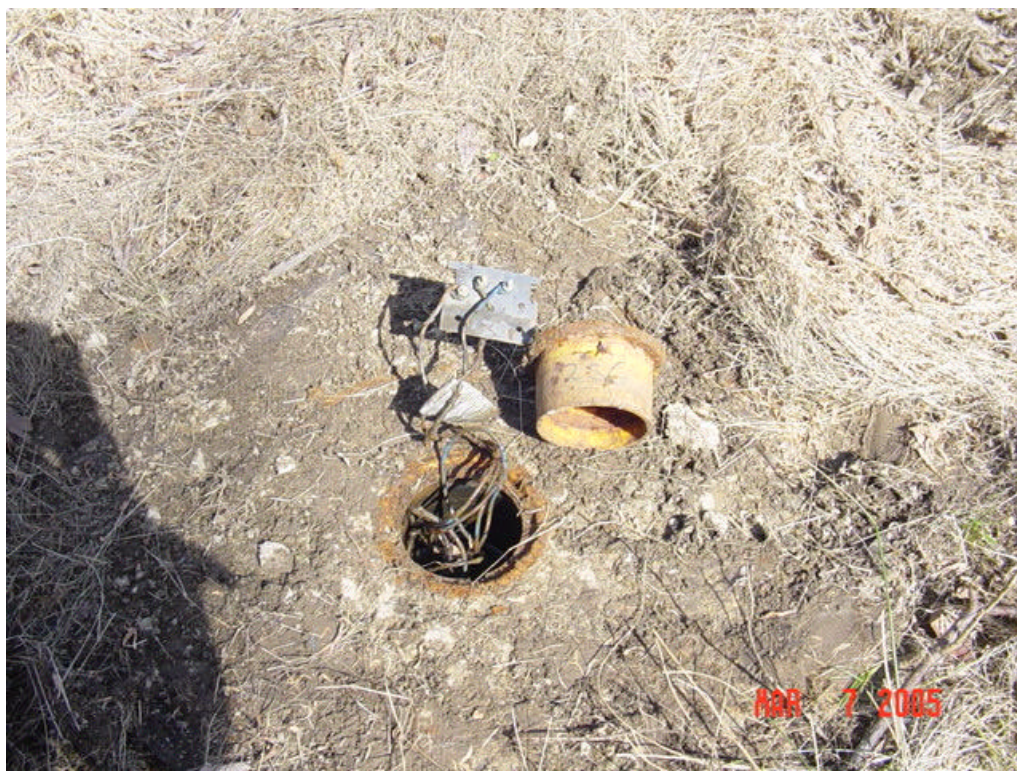
Figure 19 – Test Station 12GS6 close-up

Test Box : Covered with soil and grass  
Terminal Board : Good  
Wires : Good  
Other : \_\_\_\_\_

Test Box: Uncovered  
Terminal Board: \_\_\_\_\_  
Wires: \_\_\_\_\_  
Other: \_\_\_\_\_  
Additional Comments/Recommendations: \_\_\_\_\_  
\_\_\_\_\_  
\_\_\_\_\_
