**HOWARD COUNTY DEPARTMENT OF PUBLIC WORKS
CORROSION CONTROL TEST STATION
FIELD DATA SURVEY FORM**

Location: 03+00 **Date Surveyed:** 4/4/2005
South of US Rt. 29 Ramp **Surveyed by:** AC/MJ
T/S #: 04 **Contract #:** 44-3844
T/S Type: IJ **Pipe Size:** 30"

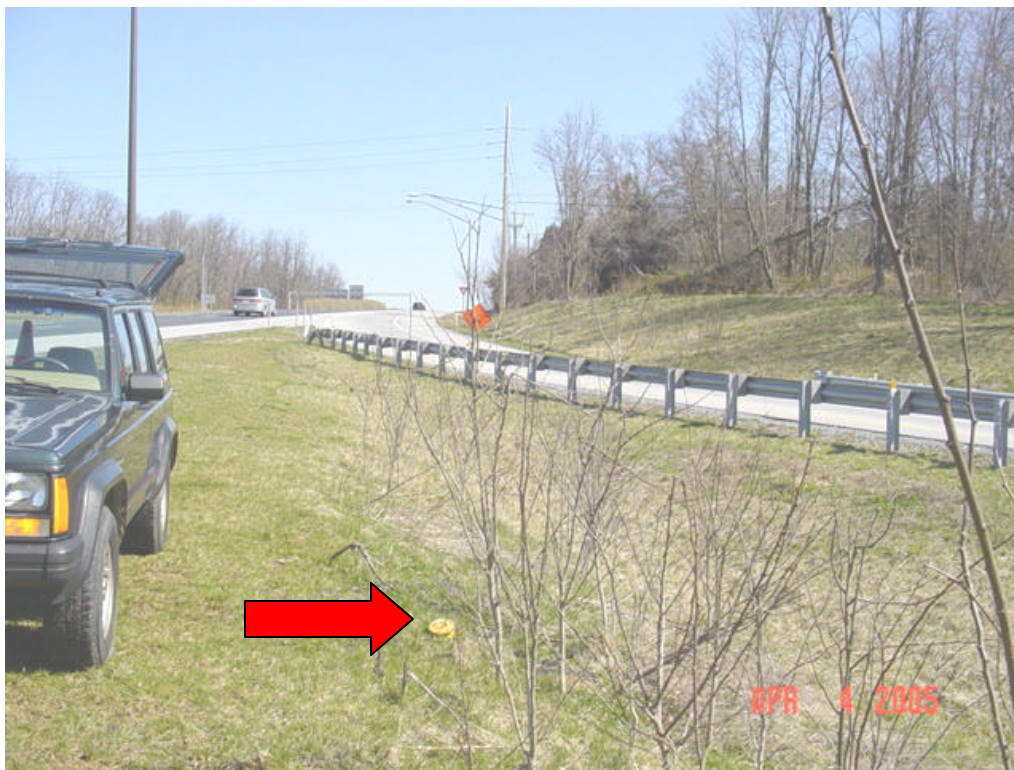
Figure 80 - Location of Test Station 3844-4

Test Box : No Concrete Pad
Terminal Board : Good
Wires : Good
Other : _____

Test Box: _____
Terminal Board: _____
Wires: _____
Other: _____
Additional Comments/Recommendations: IJ test indicated electrical discontinuity across the insulated joint.
